STRUCTURAL ENGINEERS APPRAISAL

Job Number 121212
22 January 2013

CROFT
STRUCTURAL
ENGINEERS

30 St Marks Crescent

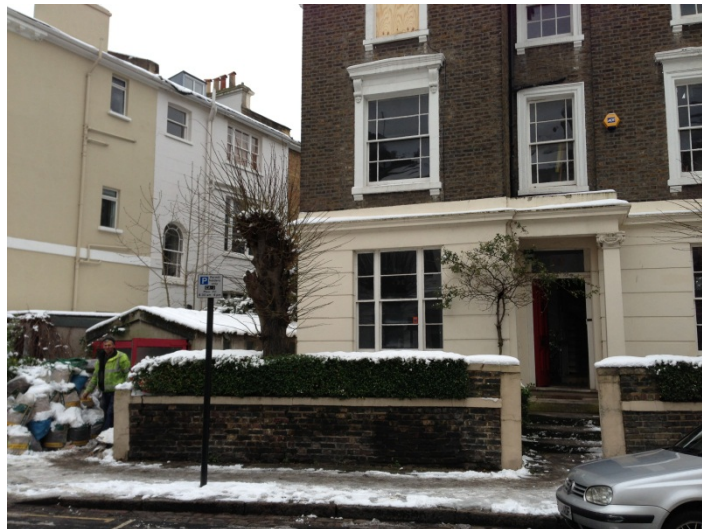
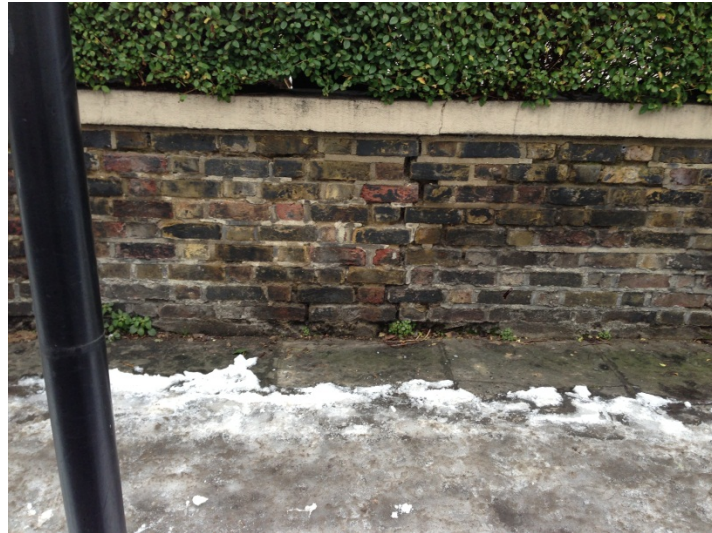
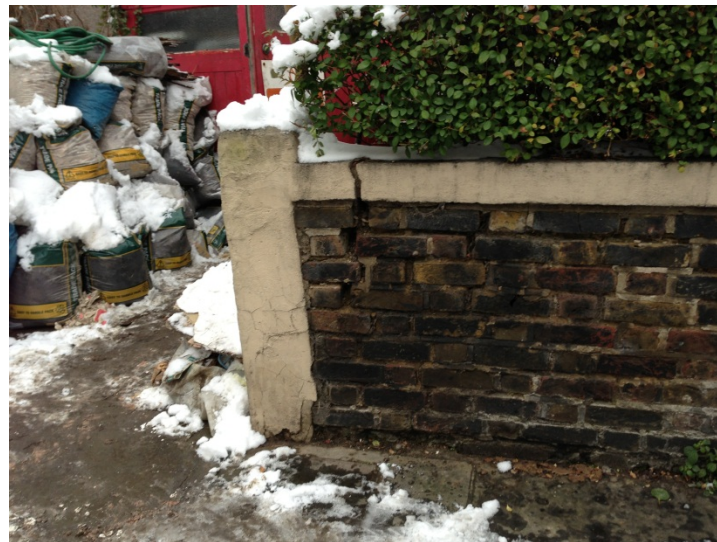
Figure 1 Front Wall Damage by Tree

The front garden has a garden wall against the pavement area; it can be seen that the front left hand tree is causing damage to the garden wall. The proximity of the tree and the boundary would require that any wall built in this location will be damaged by the tree; it is not possible to build a brickwork wall and prevent the tree from damaging it. Should the boundary wall need to be maintained due to planning then the tree should be removed.

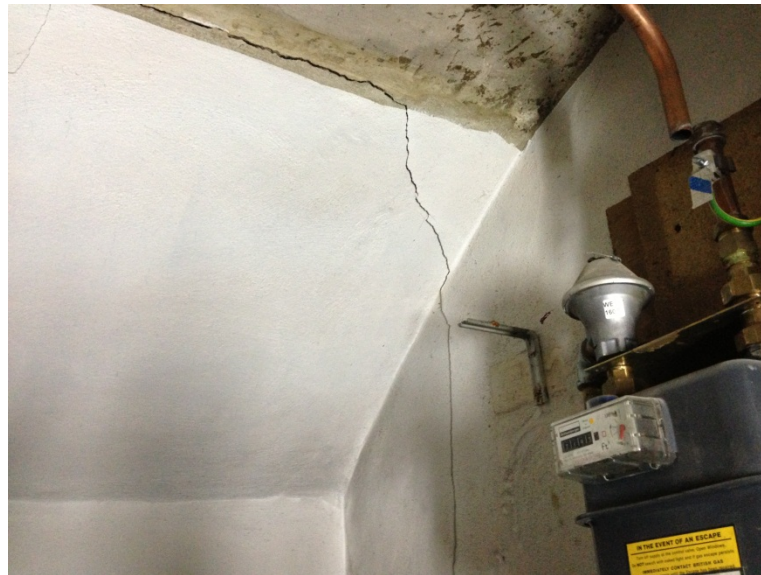
Figure 2 Cracking to Front Vault

Within the undercroft a significant crack was noted through the roof. There is a horizontal crack through the roof of around 3mm. It appears that either side of the arch has shifted causing the crack in the crown.

The trees have caused the soil around the arch to swell and shrink which has removed the buttressing effect of the soil for the arch. As the soil shrinks away from the arch the buttressing action is removed and the crown is placed into tension. To relief the stresses built up the crown deflects and cracks. This is a dangerous scenario as the crack can suffer from a scenario know as “snap through”. This is a sudden failure of the roof.

To the front of the property there is damage to the below ground vault. The cracking evident indicates that the arch is suffering from remove of the buttressing force of the soil. Either side of the arch two trees are present. These will have caused shrinkage of the clay soil. As the soil shrinks around from the arch any buttressing effects are removed and the arch can move.

This is a dangerous scenario as it can lead to snap through; i.e. sudden failure of the arch. Due to this we believe the trees should be removed to prevent any further removal of buttressing of the arch.

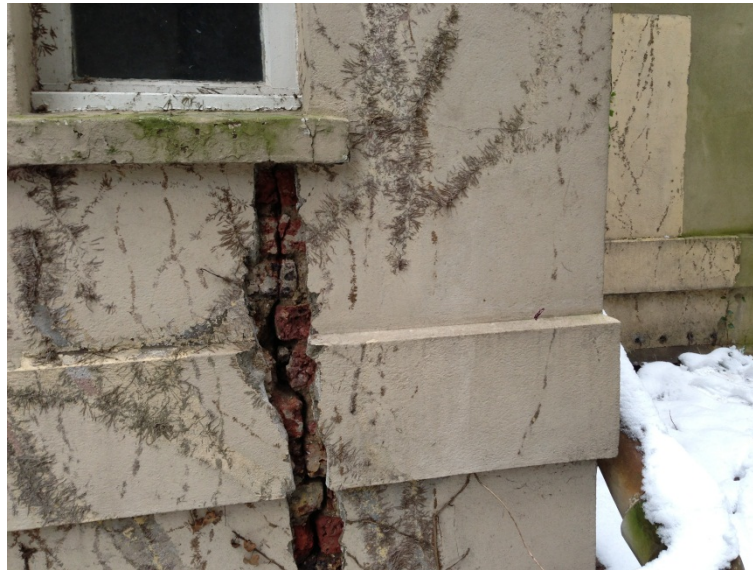
Figure 4 Cracking to Rear Side Corner

The rear elevation is finished with exposed brickwork above ground floor level with the ground and lower ground being finished in rendered brickwork. On the left side of the property there is a significant and major crack present, this runs from lower ground floor level up to the window sill level and further diagonal cracking has been noted above the WC window frame, this indicates that the rear left hand corner has dropped. The level of cracking is significant at around about 15mm.

To the rear left hand corner a SEVERE crack was noted.

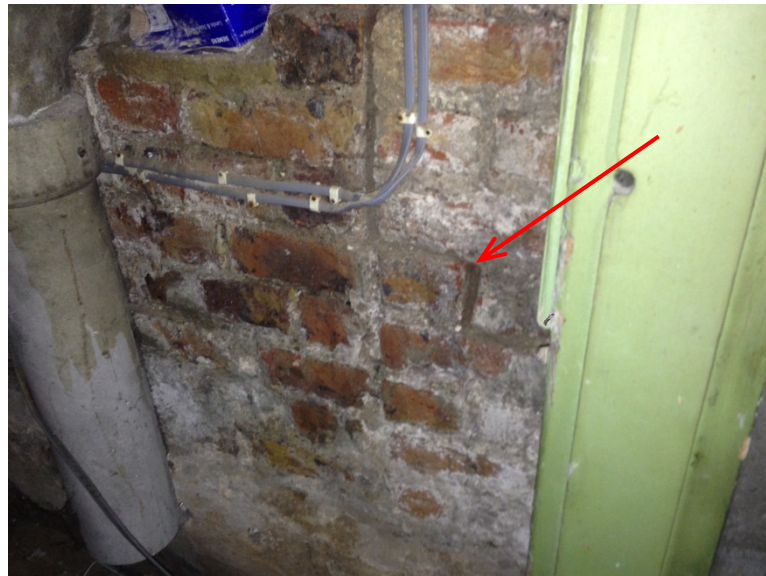
Figure 5 Cracked rear Wall

On the rear left hand side where the crack was noted externally, internally further cracking was noted of around about 15-20mm; this is a significant crack.

This cracking is to the rear wall towards the lime tree at the back of the property.
