97, Greencroft Gardens

**INSURANCE CLAIM**

**CONCERNING SUBSIDENCE DAMAGE**

## **ENGINEERING APPRAISAL REPORT**

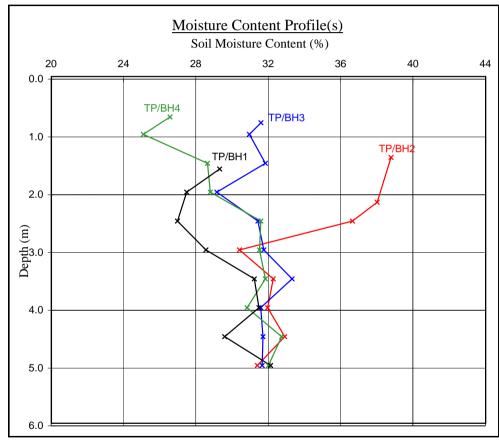
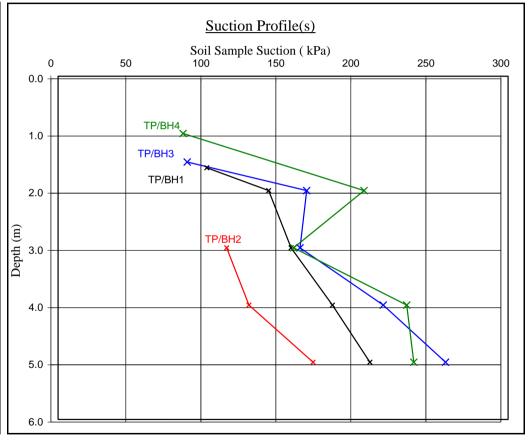
# Moisture Content and Suction Profiles

The site investigation results confirm that sub soil beneath the building foundations at the various locations around the property is desiccated due to the effects of the nearby trees.

We base this view on the fact that the foundations of the property in the area of damage have been built at a relatively shallow depth, bearing onto shrinkable clay subsoil. The soil is susceptible to movement as a result of changes in volume of the clay with variations in moisture content and analysis of the site investigation results indicates that the soil has been affected by shrinkage.

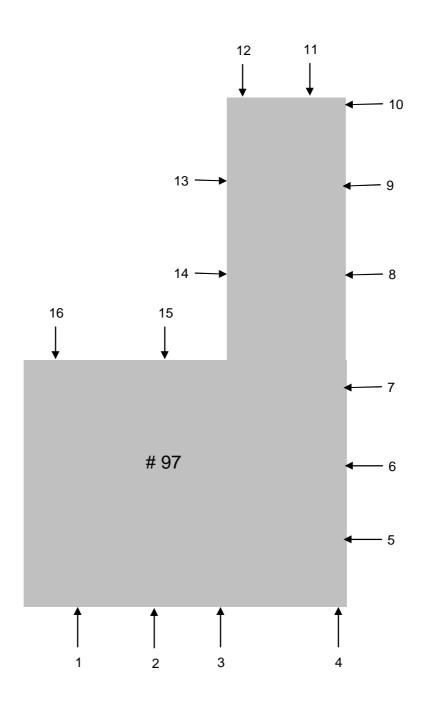
# **Level Monitoring - Site Sketch**

Using deep datum at front of property.
