**STRUCTURAL APPRAISAL OF THE EXISTING  
BUILDING INCORPORATED INTO THE  
REDEVELOPMENT AT  
43 BELSIZE LANE, LONDON, NW3 5AU**

Name of Client: PKS Architects

**Tel: 01892 521841**  
**Fax: 01892 533149**  
**E-mail: [tw@vkhp.co.uk](mailto:tw@vkhp.co.uk)**  
Date: 14 December 2012

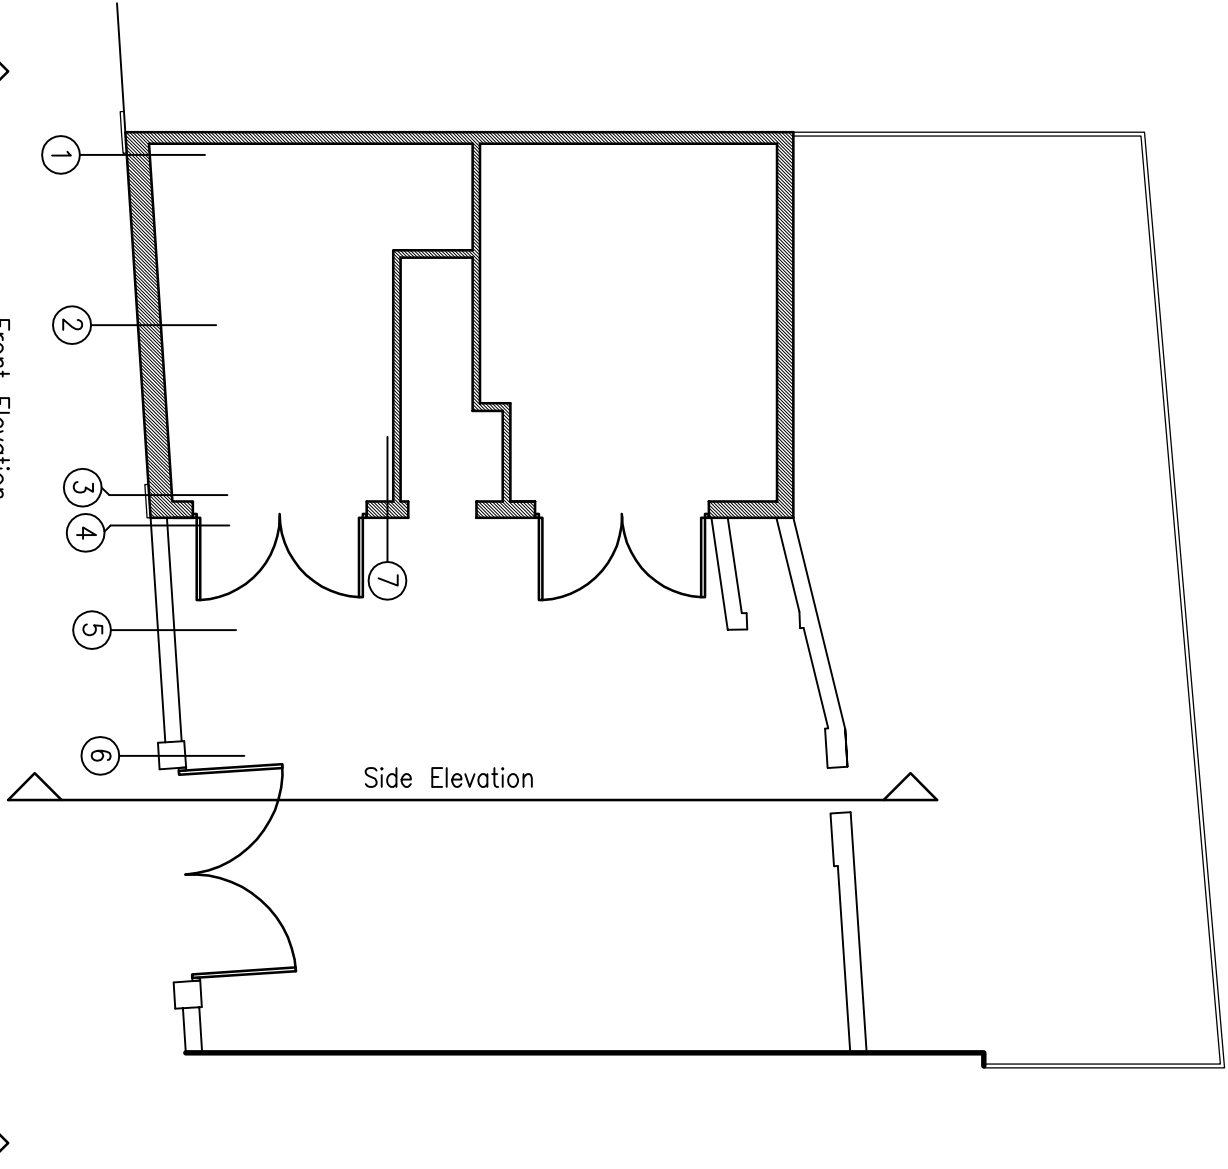
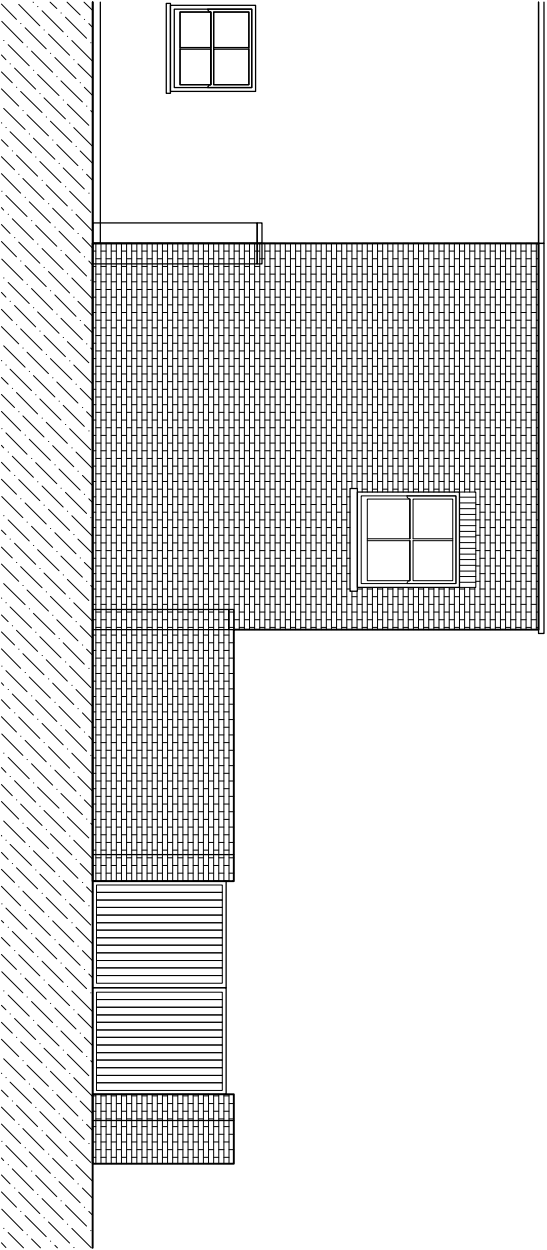
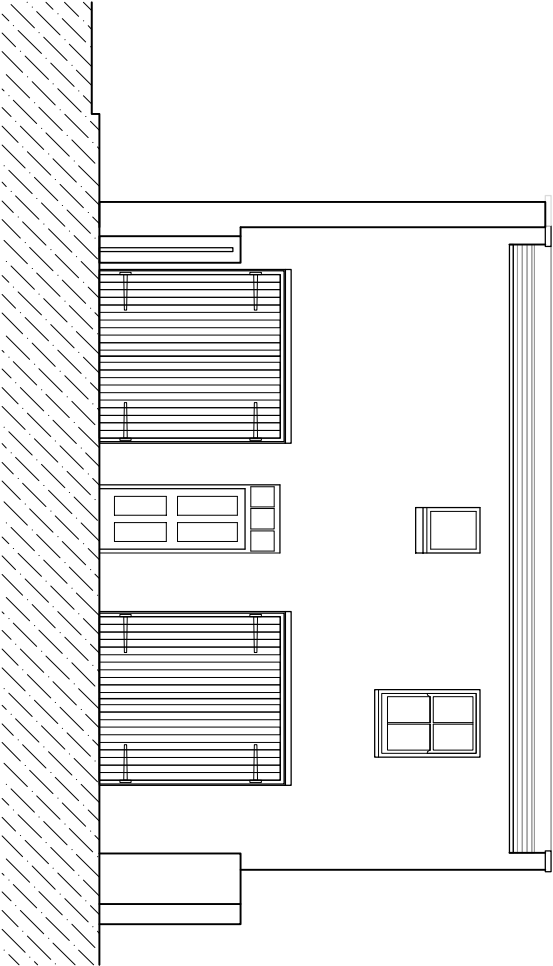
PROJECT  
**43 Belsize Lane**  
London NW3  
TITLE  
**Plumb Survey - Location Plan**

The upper portions of the first floor wall contains one first floor window and an upstand masonry parapet was seen to lean to varying degrees. This wall was checked for verticality and the results appear on 870612/001 and 002 in Appendix A.

- 4.5 From the plumb survey results, it is evident that the existing walls lean to varying degrees.

The degree of lean is such that without some form of supplementary support, the wall could be expected to fall over. The centre of gravity is in many places outside the middle third, thus generating tension which, in brickwork such as this, cannot be developed.

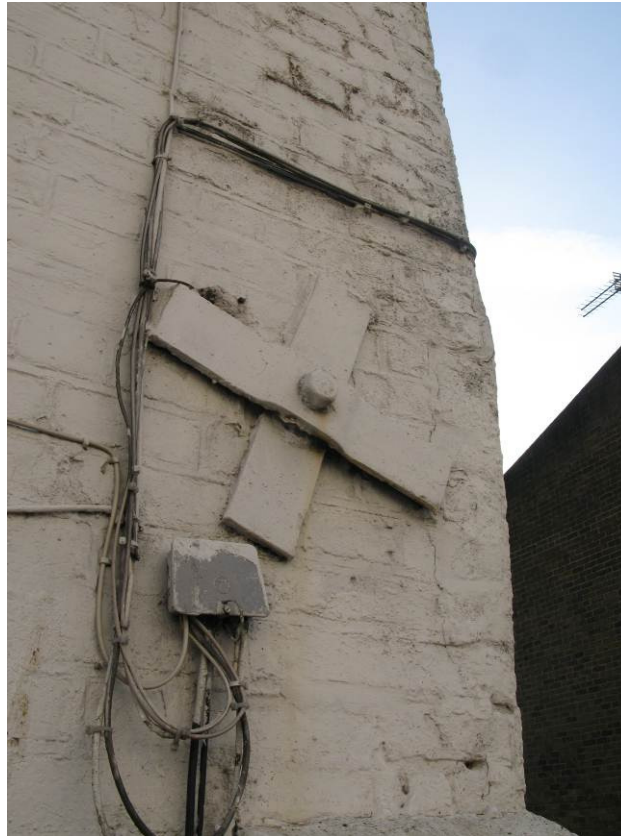
A historic tie bar end is located at the south west end of this elevation at first floor level. This bar was seen to be located immediately below the first floor and extended right through the property to a similar metal plate on the south east elevation. (See Photographs 1 and 2)

**PHOTOGRAPH 1**  
**Tie bar end, North West end**

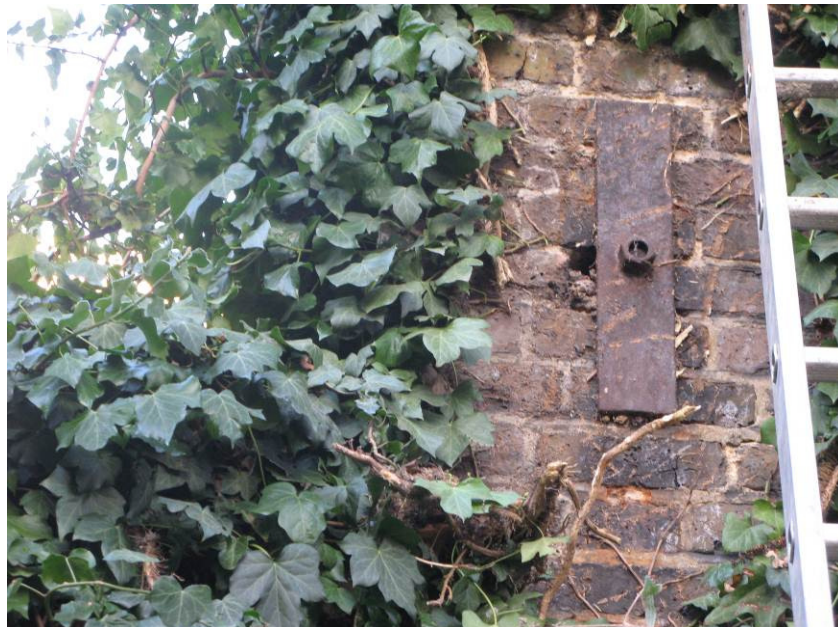
- 4.10 The presence of an existing tie bar end in the north west elevation indicates measures taken to address historic movement. It is therefore likely that measures taken to retain the existing masonry would need also to consider what effect partial removal of the existing structure would have on the effectiveness of this tie bar and the likelihood is that additional temporary works would be necessary to replicate the existing tying effect of the tie bar to ensure that any benefit currently being provided by the tie bar is maintained and the stability of the existing masonry is not compromised as a result of the partial demolition.

**PHOTOGRAPH 2**  
**Tie bar end, South East end**

- 5.4 The temporary works would also need to take into account existing loads from existing tie bars and ensure that sufficient temporary structure is introduced to replicate any loads prior to partial demolition of the existing structure.

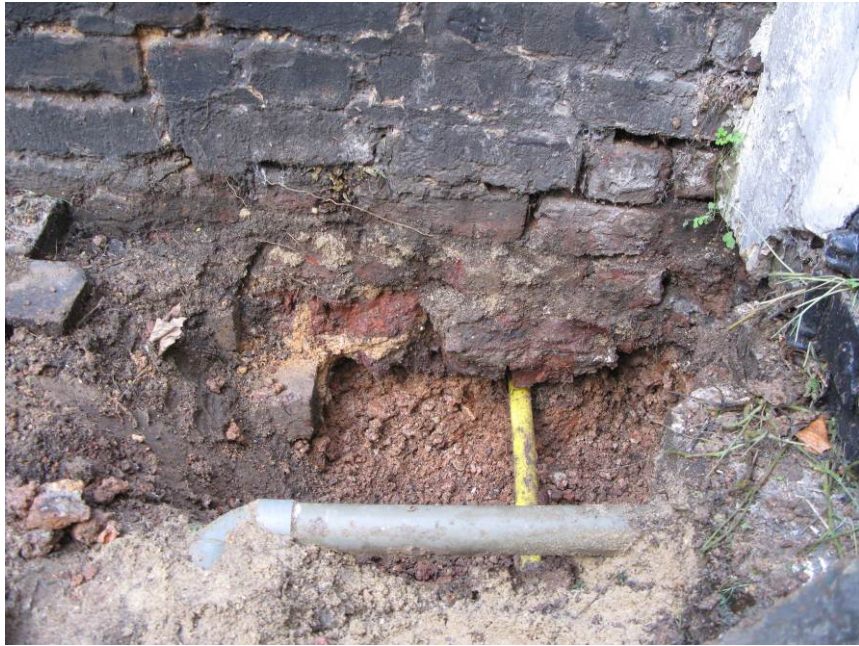
This wall was seen to be concave with the middle section having bulged towards the south east. This wall was checked for verticality and the results appear on 870612/001 and 002 in Appendix A.

The whole wall shows clear evidence of decay and deterioration of, not only the bricks but also the mortar. (See Photograph 3.)

**PHOTOGRAPH 3**  
**Dilapidated brickwork**

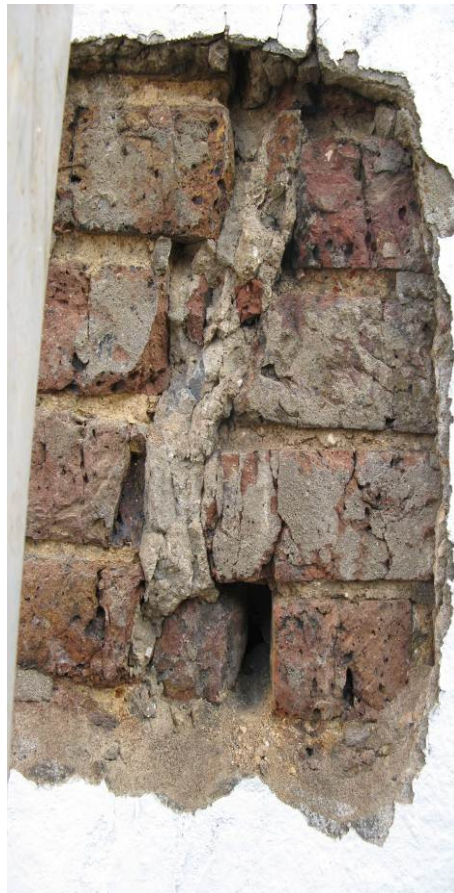
A part vertical, part inclined fracture was seen ascending from the top north west corner of the north west door opening which had evidence of former render repairs in its length.

A section of render was removed midway up this crack line. This revealed extensive cracking in the brickwork, measured as circa 50mm horizontal movement and circa 12mm vertical movement. (See Photograph 4).

- 4.7 Examination on site revealed brickwork which is in particularly poor condition. The wall above ground is fractured in numerous places. Removal of render revealed cracking 50mm wide with numerous repairs. The integrity of the wall in these areas is significantly reduced and, at worst, non-existent.

**PHOTOGRAPH 4**  
**Masonry fracturing**

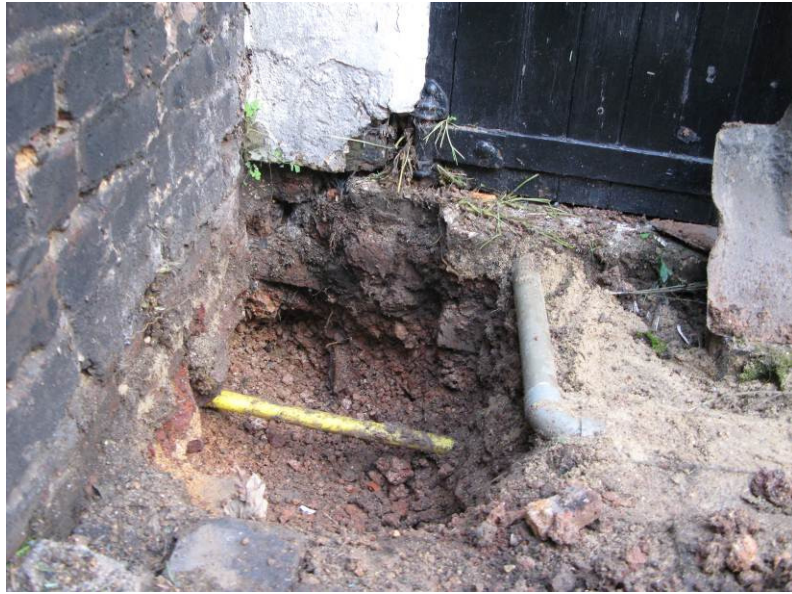
This trial pit revealed brickwork extending no more than 250mm below finished ground level, bearing on to a matrix of broken brick and lime mortar with no clearly identifiable interface to virgin ground. The below ground brickwork was significantly displaced in places. (See Photograph 3)

The brickwork below ground was similarly in a poor condition, having loose and missing bricks, substantially eroded joints and offering no evidence of a uniform horizontal line as a potential support line.

**PHOTOGRAPH 5**  
**Displaced dilapidated brickwork**
