43 BELSIZE LANE, LONDON NW3

ARCHITECTURAL REPORT

PKS Architects LLP

January 2013

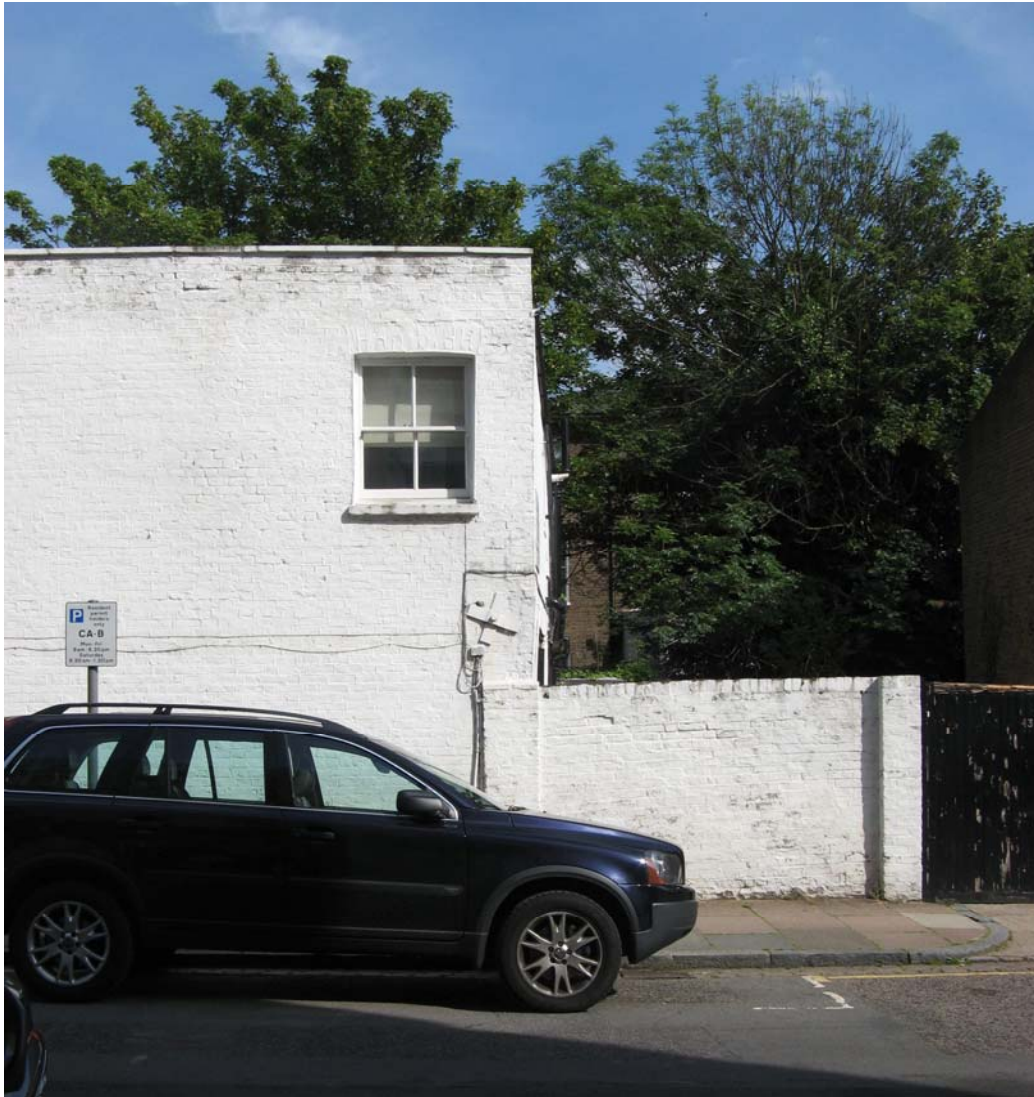
The street façade comprises whitewashed London stock bricks, now rather grubby. There is one first floor timber sash window offset to the right which balances a similar window in No.41 and this is the only feature, save for a brick pier at the start of the courtyard wall. The top of the wall has a thin, modern precast concrete coping, and there is a common brick area visible above the window.

Front Elevation to Belsize Lane

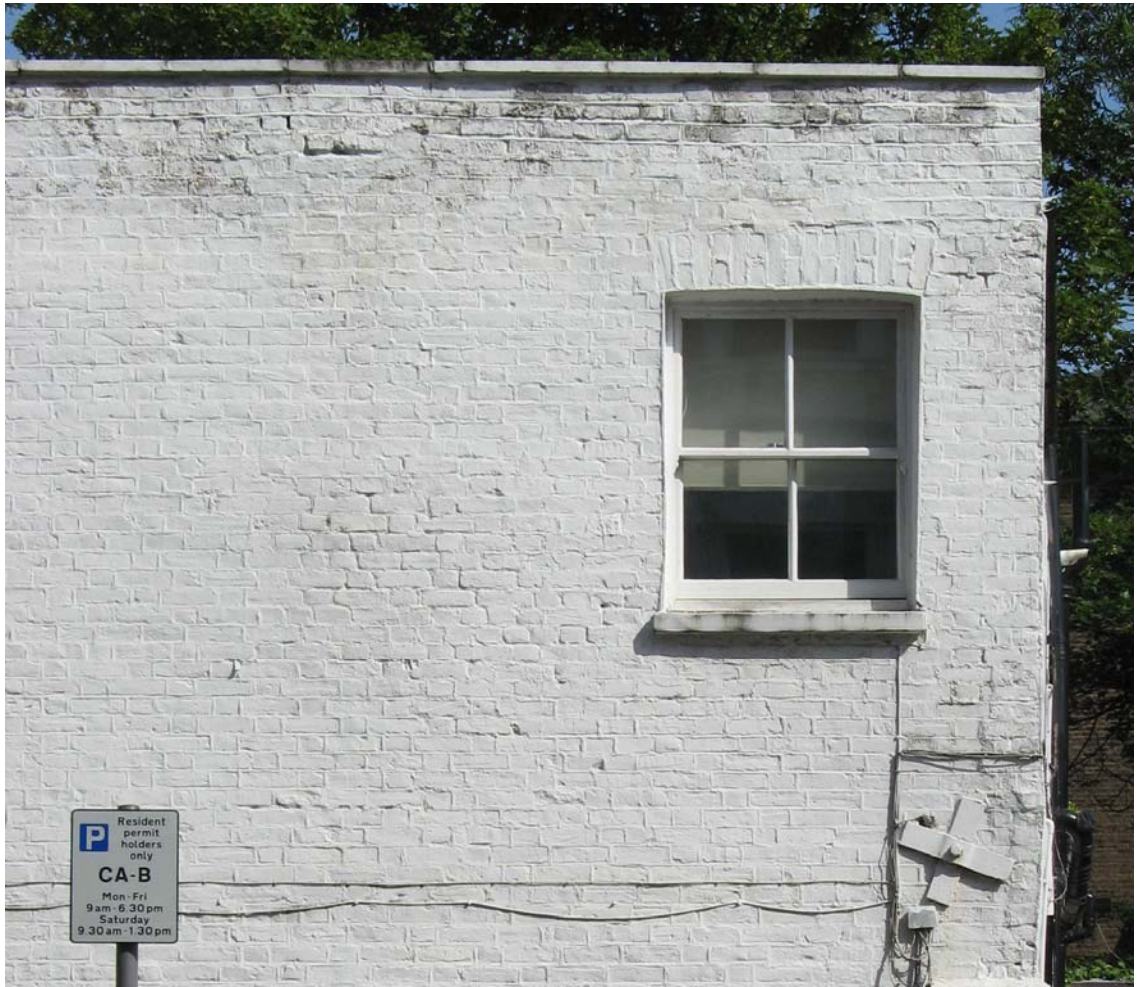
The brickwork is generally in poor condition with brick coursing of very poor quality workmanship in the top half metre of wall – refer to large scale photographs. There is a steel tie evident at first floor level, presumably to restrain the wall and limit further bulging and runs right through the building.

The top metre of the wall shows signs of water ingress with the lime mortar joints exhibiting efflorescence.

Detail of Front Elevation showing:

- damp ingress at top of wall
- poorly executed brickwork
- common brick arch
- steel tie at 1st floor

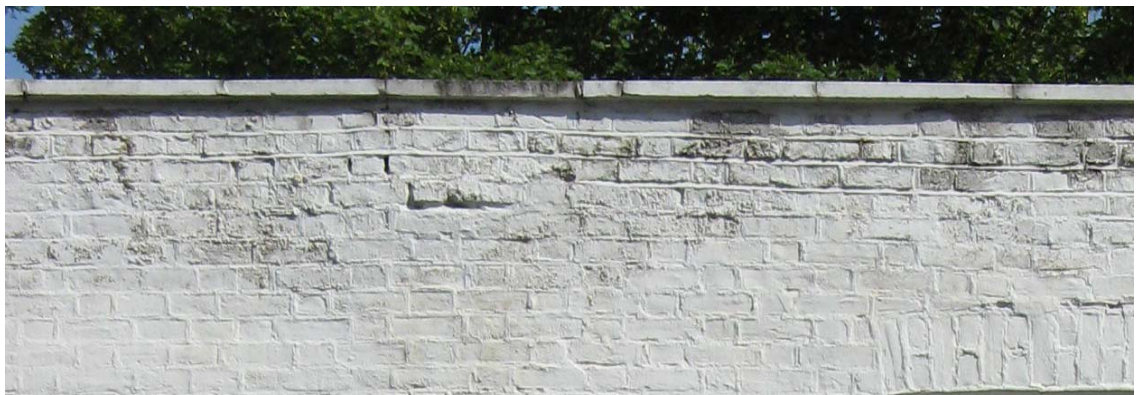
Modern precast concrete coping

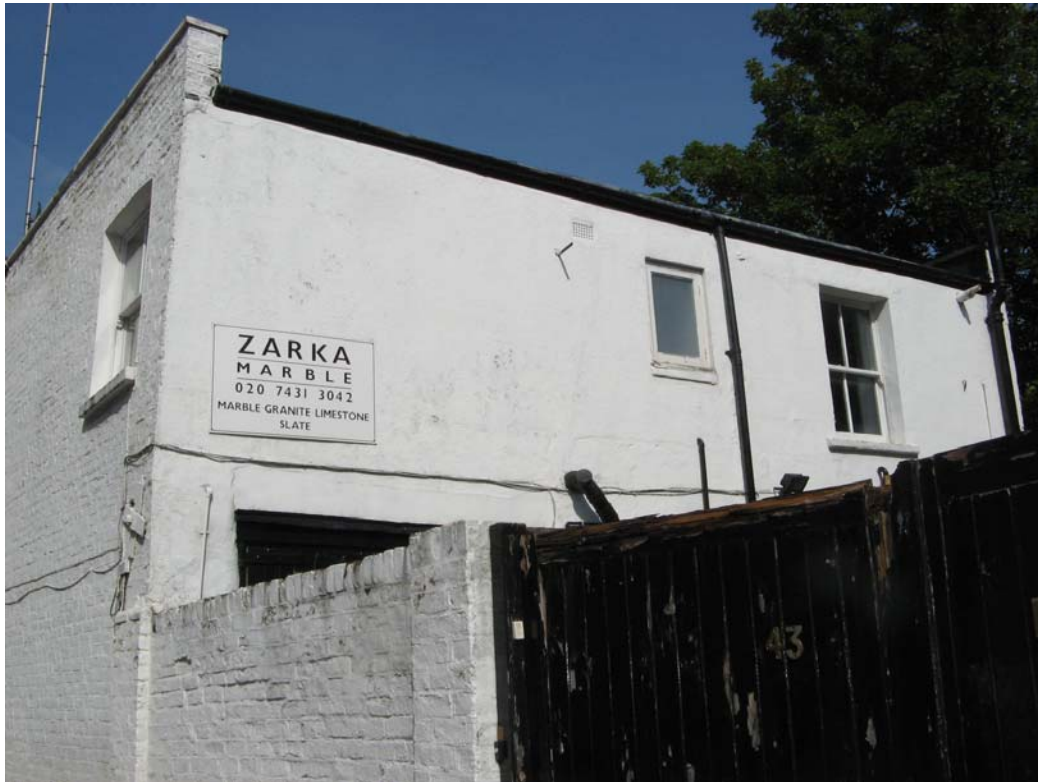
Courtyard Elevation above Courtyard wall and gate

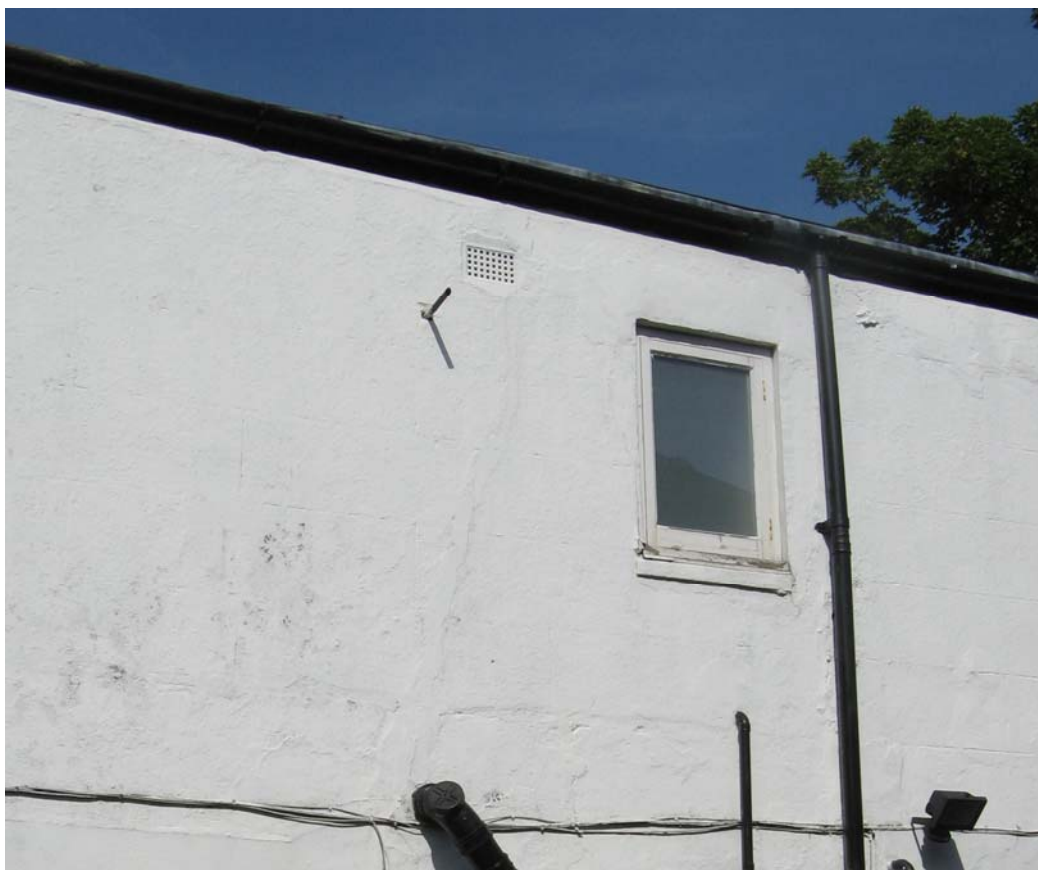
The courtyard elevation is part rendered and part painted London stock brickwork with lines indented in the render to mimic ashlar stonework. The render is patchy and very uneven and appears to be de-bonded in places from the brick substrate: it is now clear the rendering covers brickwork repairs. There is one sash and one timber casement window at first floor level. The casement appears to be a later insertion and is not in character with the building as a whole. At ground floor, there is a central personnel door to access the stairs to first floor, and two garage type doors to access the space at ground level.

Part Courtyard Elevation showing uneven render and window insertion

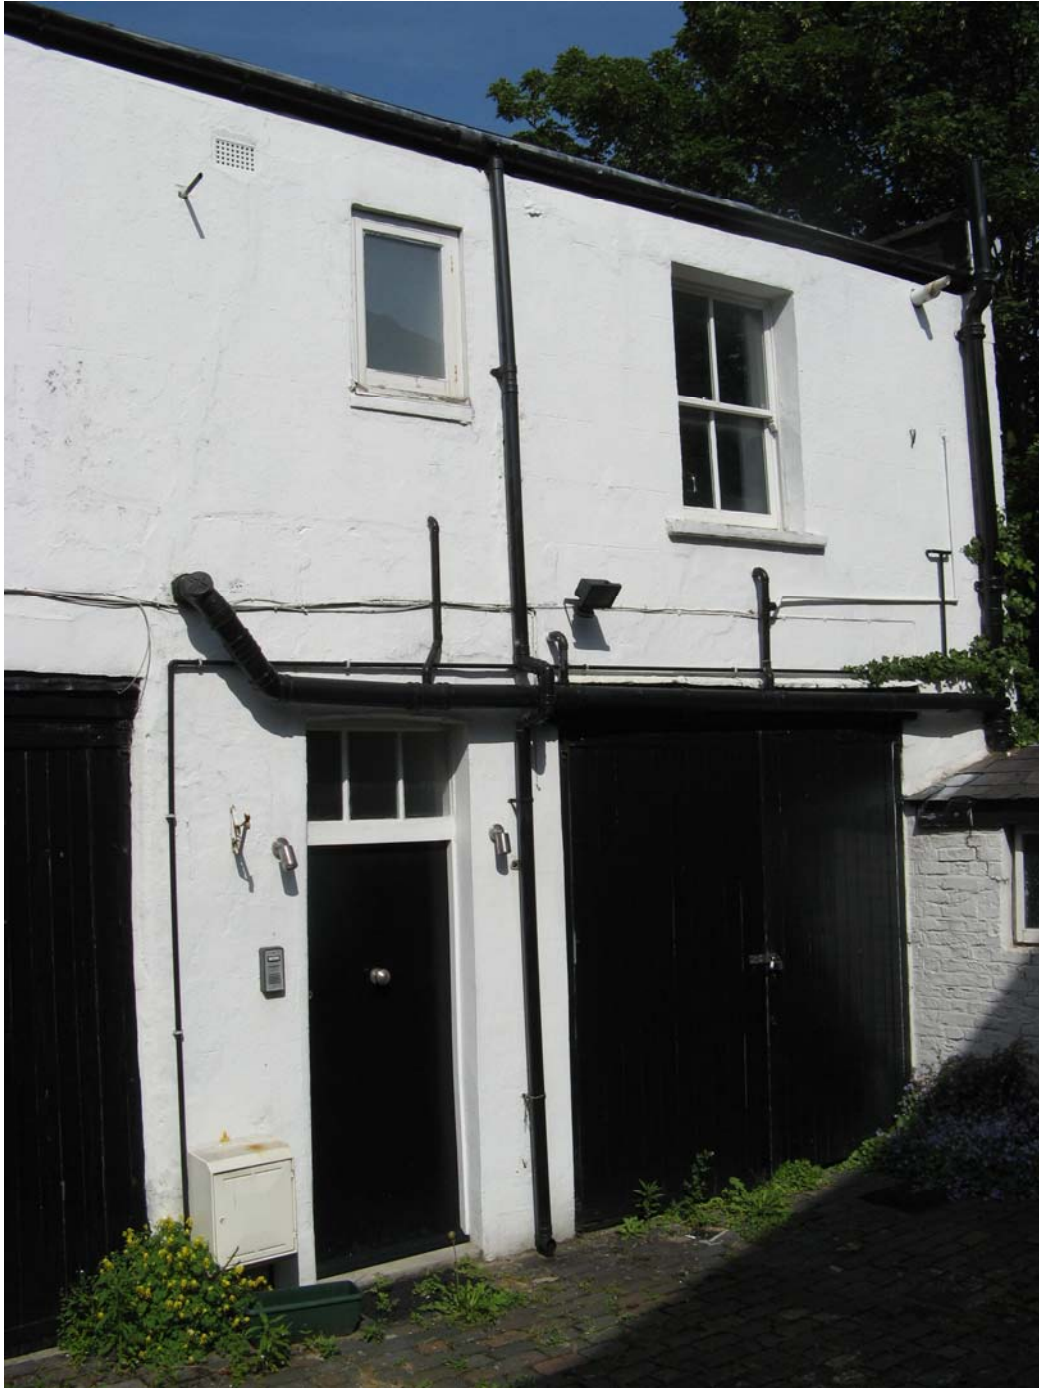
There is also on this elevation some ill-considered drainage pipework which detracts from the simplicity of the form and looks very ugly.

Part Courtyard Elevation showing services

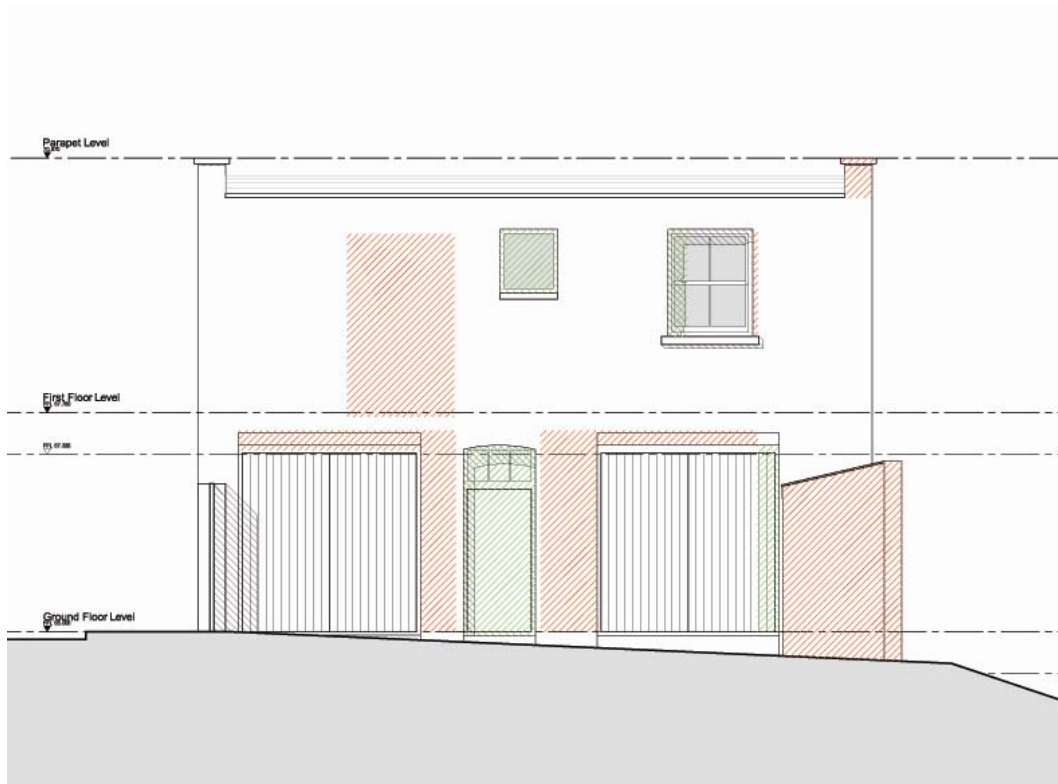
Elevation showing existing and consented openings in Existing Courtyard Elevation

The consented drawings show new, amended and re-sized openings in the existing courtyard elevation. A drawing showing the existing and consented openings is attached at appendix B. As can be seen from this drawing, none of the ground floor of the courtyard elevation remains, and it is doubtful if the first floor could stay in-situ without being re-built while the ground floor is being re-configured. With so little of the existing fabric being retained, it is unclear why this elevation merits retention.
