69 Highgate High Street
Surveyor's Report on Existing buildings

Estimate the cost of renovation,
Establish the Freehold Value,
Assess whether renovation is viable,

February 2009

Photographic Survey - No 69. Highgate High St.

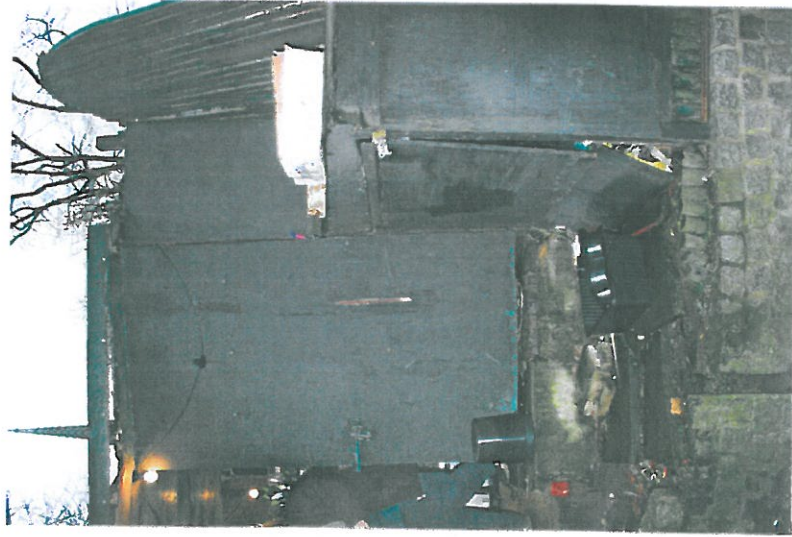
1. Flower Stall - ramshackle construction.

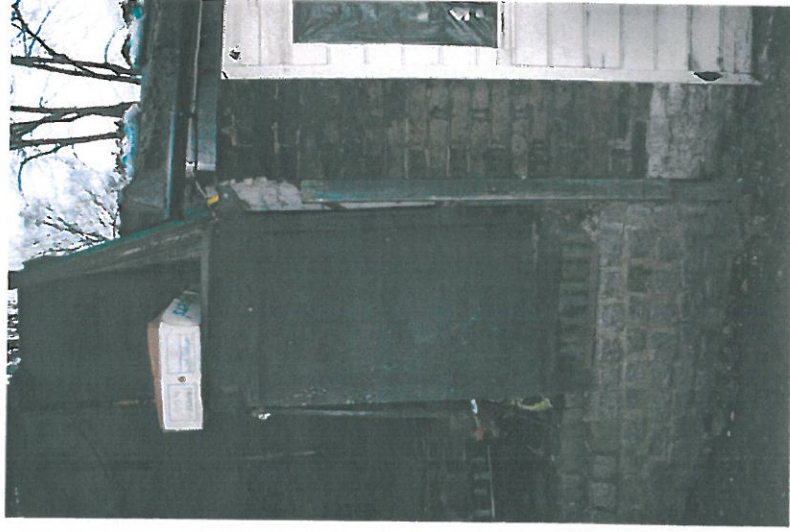
2. Studio - damp brickwork pier.

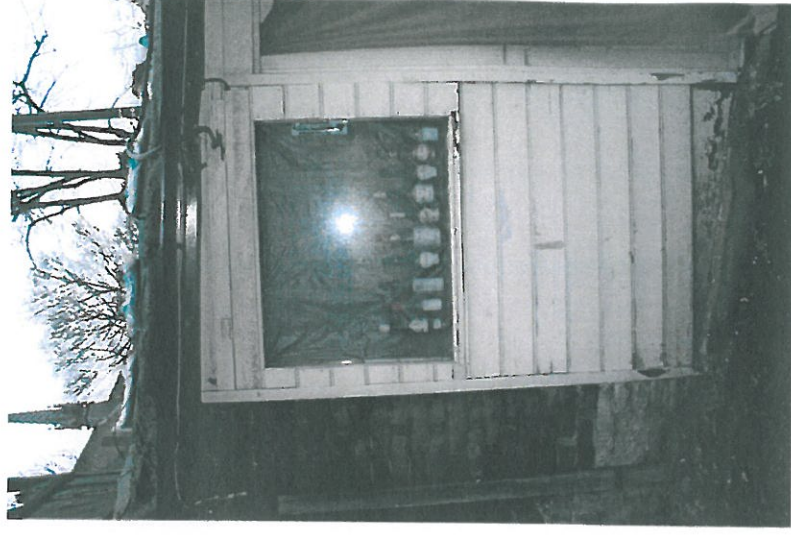
3. Studio - Poor condition timberwork.

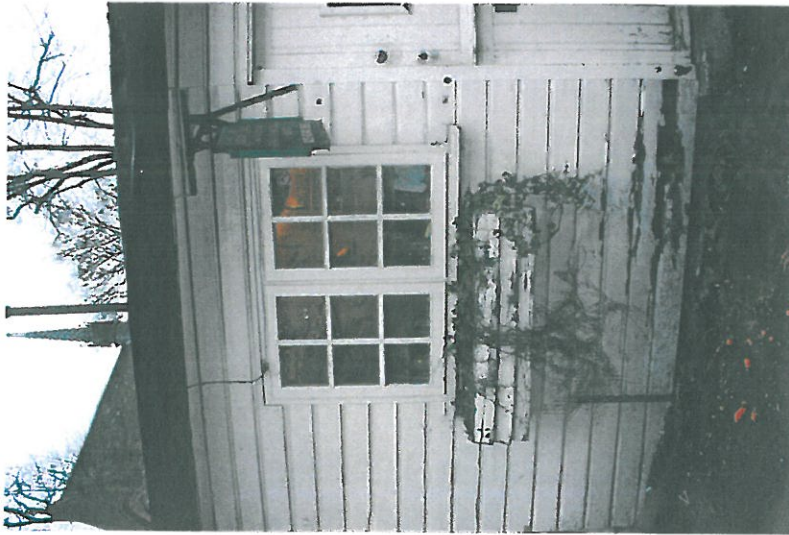
4. Clockmaker - Rotten weather boarding.

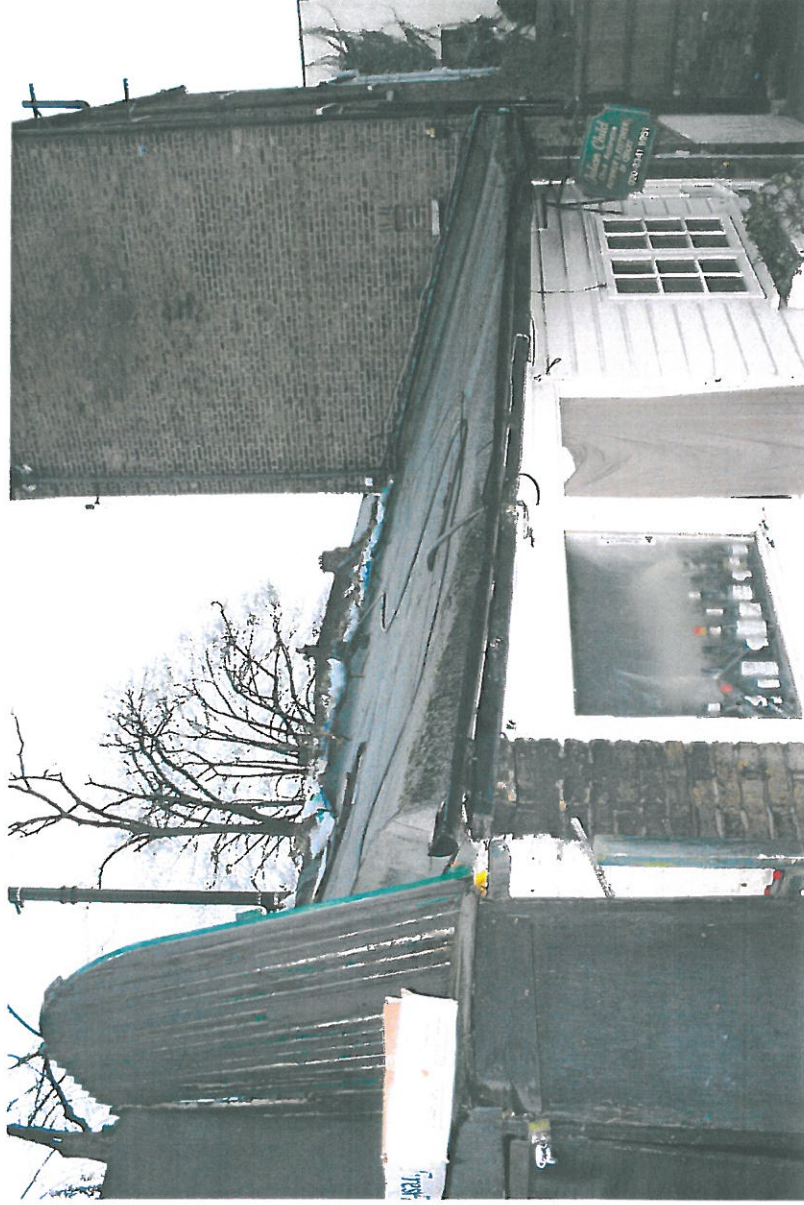
Area	Condition	Repairs/Remedial Work	Cost
Exterior			
Roof structure and covering	Pitched roof with felt covering and roof light in worn and poor condition with unsatisfactory detailing and evidence of leaking.	Strip and recover to include an allowance for timber repairs and renewals, new boarding and insulation and provision of ventilation.	£10,000.00
Rainwater fittings	Plastic gutters and downpipes deflected and in worn condition.	Requiring overhaul/renewal.	£750.00
Main walls	Solid brick with part rendered, timber boarding, rotted and decayed, pointing loose, uneven brickwork.	Re-pointing to brickwork required, renewal of sections of cills, renewal to weatherboarding, re-facing render finishes.	£5,000.00
External joinery	Timber doors, windows and fanlights (not including weatherboarding), and gutter boarding, Worn and in dilapidated condition, rotted sections and poorly fitted glazing.	Renewal works required, to include renewal of window planting box.	£5,000.00

7. Exterior felt roof - poor condition.

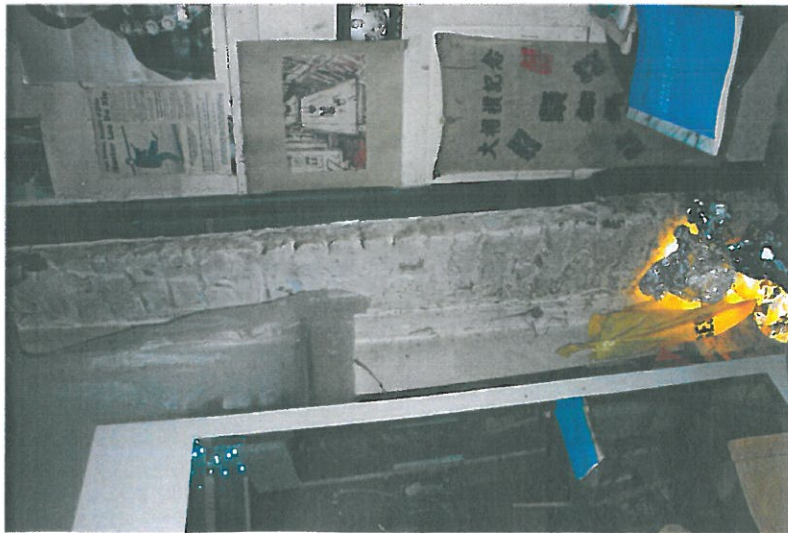
Area	Condition	Repairs/Remedial Work	Cost
Damp proof coursework	Evidence of high damp readings and damp penetration typical of a basement condition.	General damp proofing works required to prevent rising dampness to include tanking works. Allowance to be completed to take up solid floor complete and to reinstate to include tanking detail to be carried through to wall areas to achieve satisfactory damp proof seal. Further damp proofing works required to internal areas. Allow for preparation and full reinstatement.	£7,500.00
Timber defects	Areas generally concealed. Evidence of damp penetration as a result of leaks through the roof covering, rising and penetrating dampness through the walls and via services lead to the probability that there are concealed defective timbers.	Allow a provisional sum for repair and renewal works.	£2,000.00
Insulation	Minimal insulation provided by means of glass fibre insulation to the timber floor dividing the stores.	Further insulation works required to bring up to current standards. Allow for roof and wall insulation.	£3,000.00

8. Studio - rising damp.

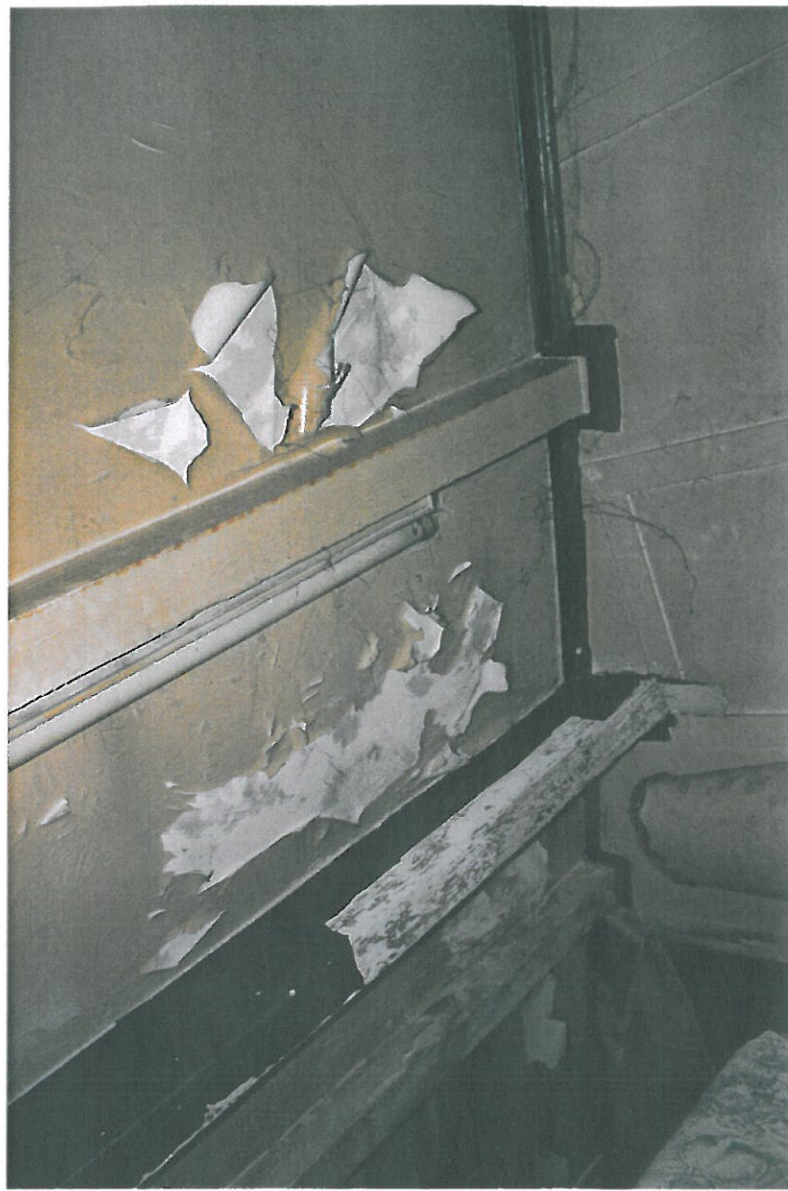
9. Studio - damp ceiling.

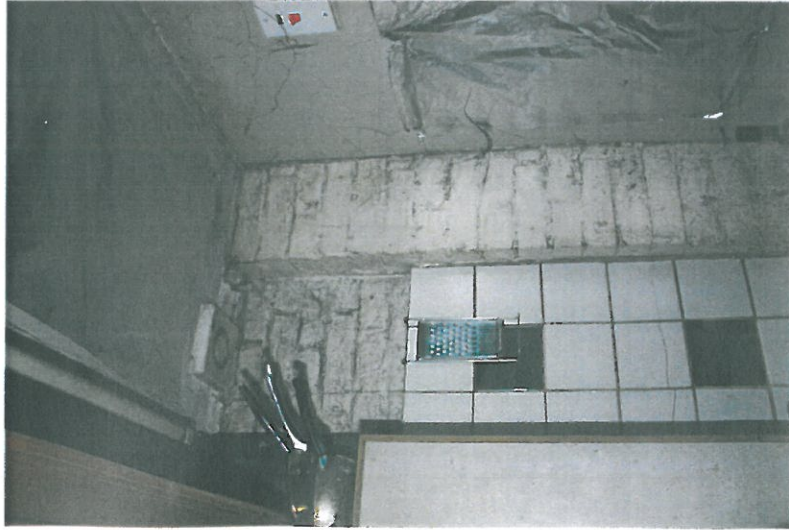
10. Studio - damp wall.

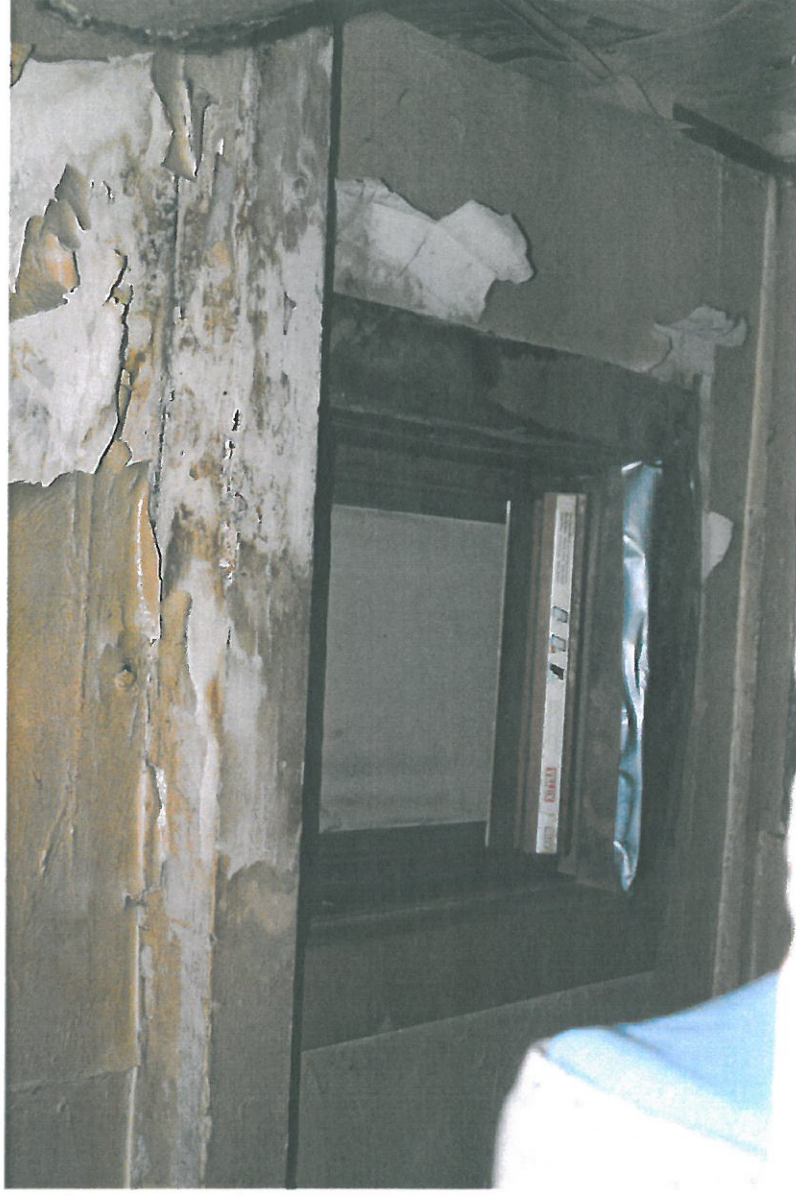
11. Studio - damp roof structure - velux roof light showing water penetration..

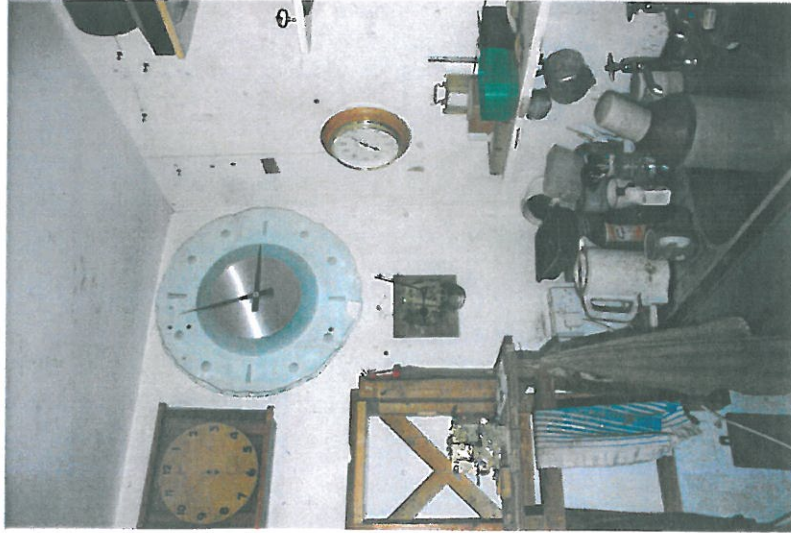
12. Clockmaker - damp walls.

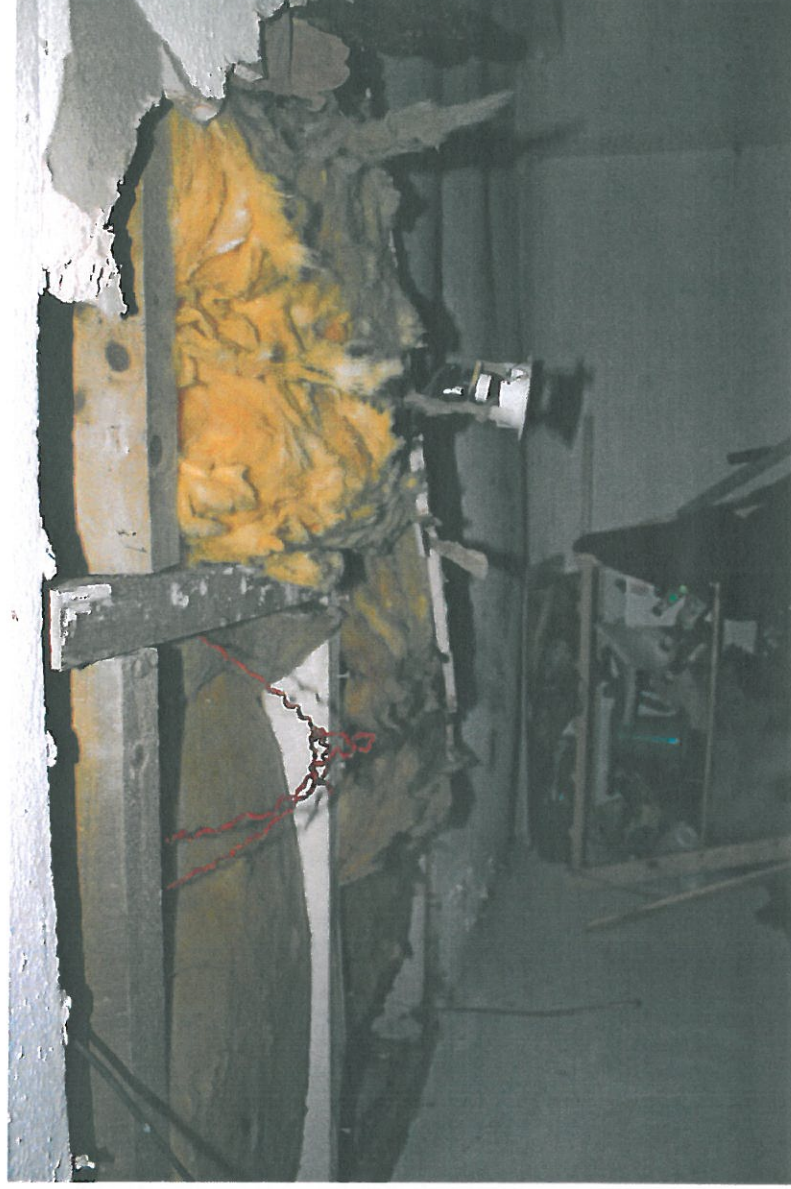
13. SnowHill Store - collapsed ceiling.

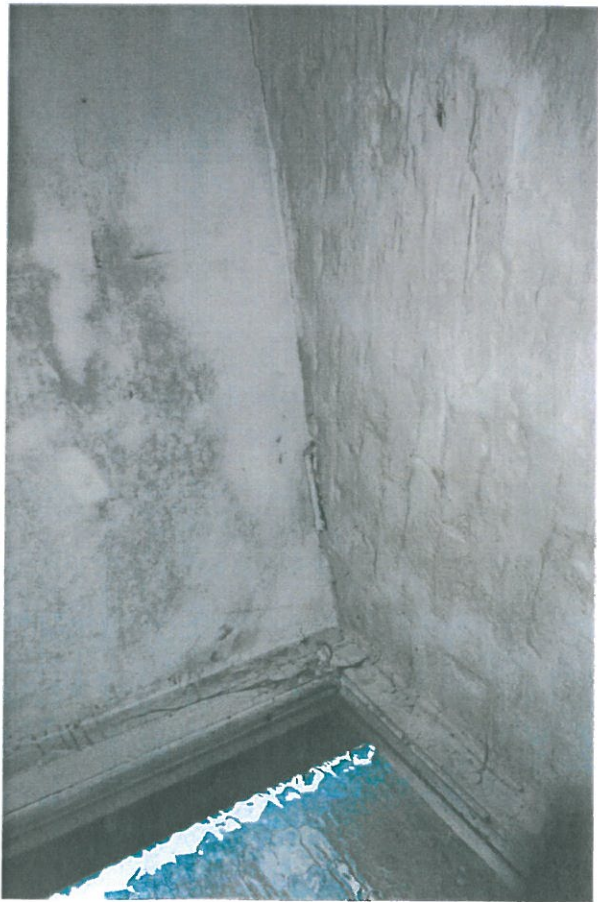
14. Snowhill Store - Damp penetration to wall + ceiling.

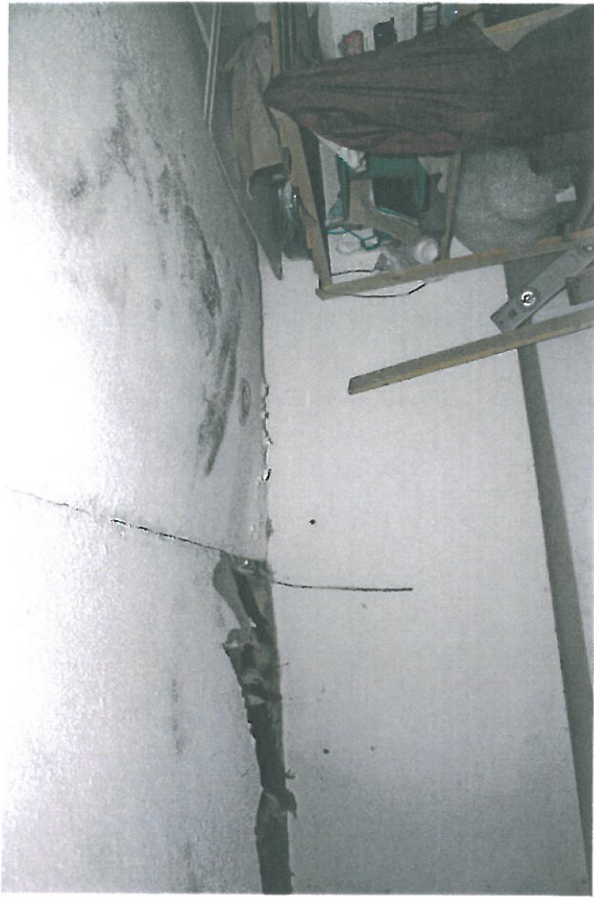
15. Snowhill Store - bowing damp ceiling.
