PARK VILLAGE EAST

EXISTING FRONT ELEVATION

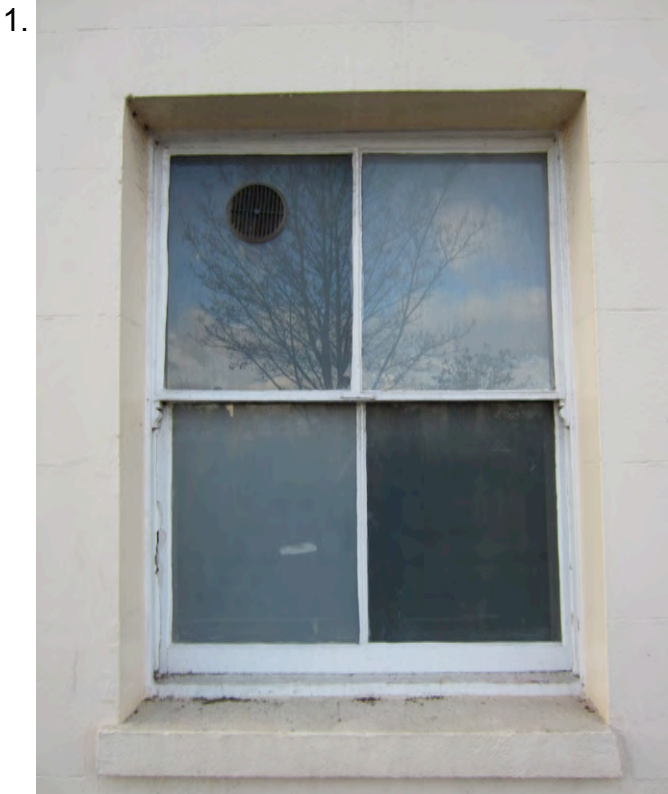
This original window opening has been repaired with replacement sashes fitted. The glazing bars are heavier in profile and do not align, the horns do not match the originals, obscure glass has been installed (including a bathroom extract fan). The windows in not in keeping with the original details.
Proposal to replace with new historic single glazed window to match original details.

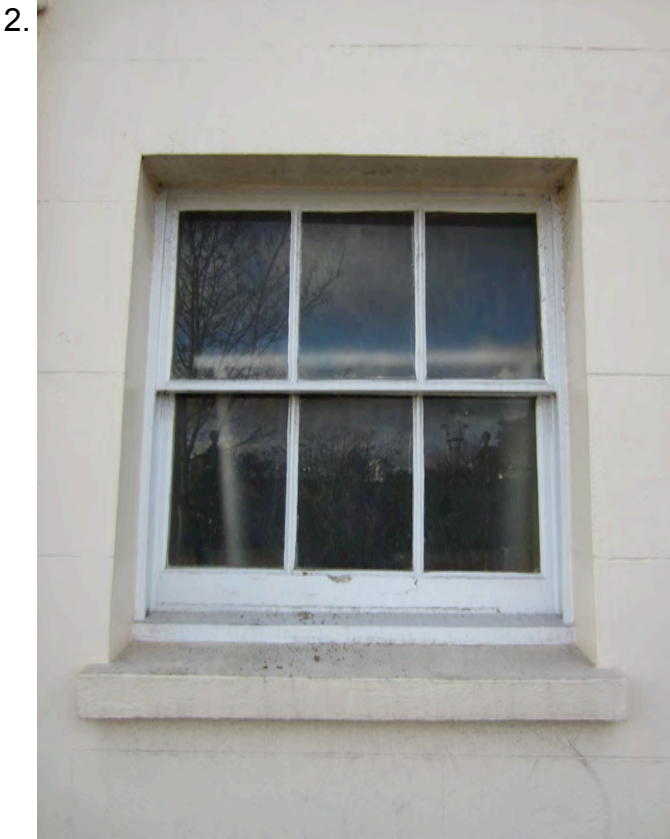
Non-original opening (post 1955). Window sashes and glazing bars are heavier, no horns and generally not in keeping with historic details.
Proposal is to replace with new historic single glazed window to match original details.

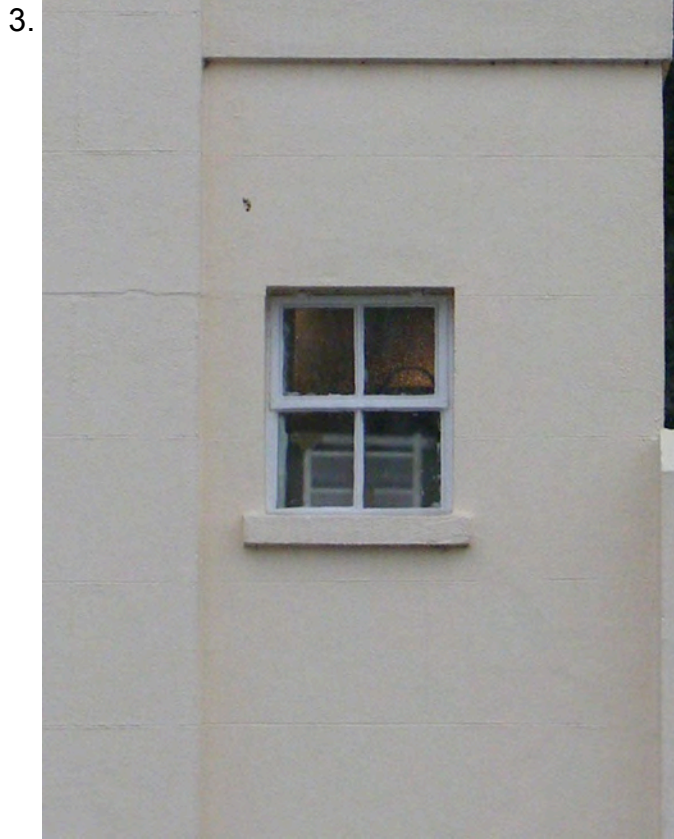
Non-original opening (post 1955). Window sashes and glazing bars are heavier, no horns and generally not in keeping with historic details.
This window is removed and infilled as previous approved application 2011/1435/L

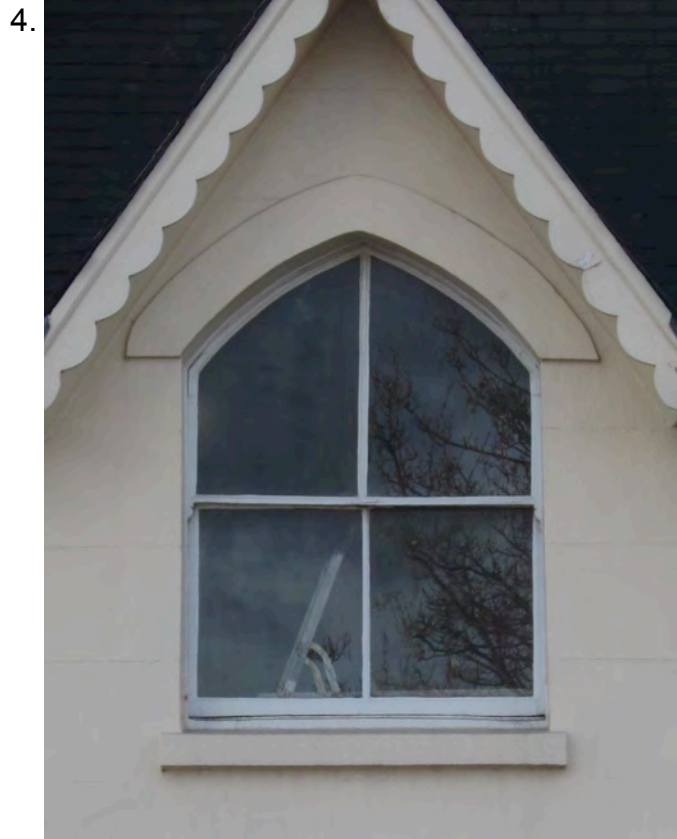
This original window has been repaired and partially replaced with non original sash fitted (circa 1955). The glazing bars no not align (see 4a detail photograph). The horns do not match on either side, and the window is generally in poor condition.
Proposal to replace with new historic single glazed window to match original details.

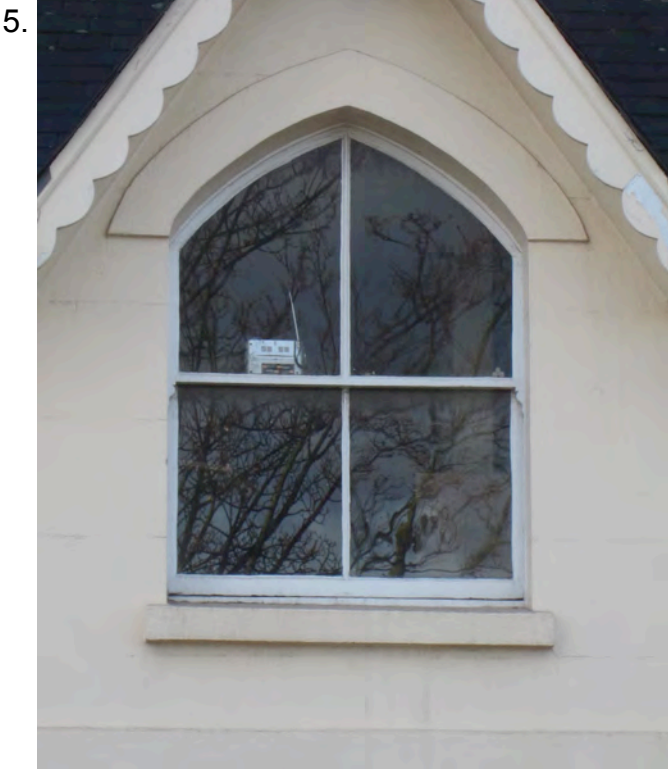
Original window has been repaired & partially replaced with non original sash. The window is generally in poor condition.
Proposal to replace with new single glazed window to match original details.

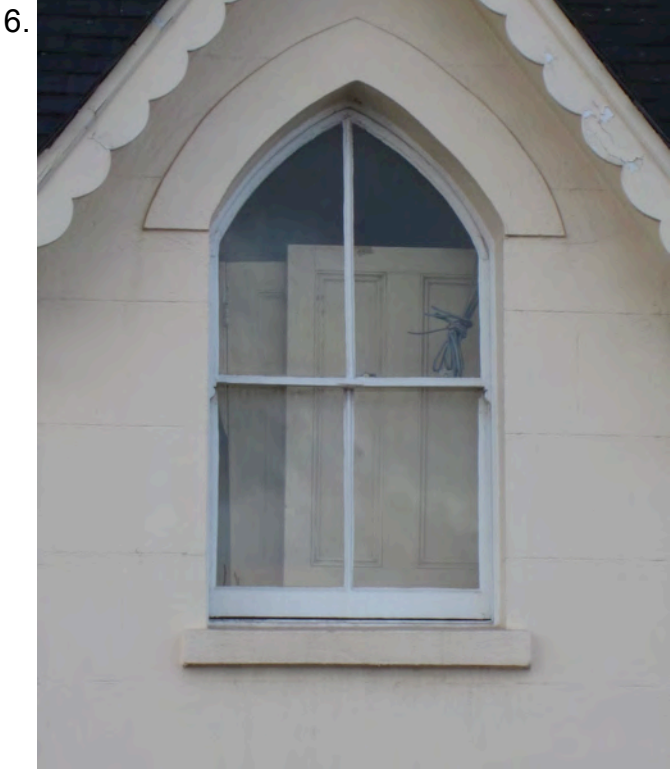
Original window has been repaired & partially replaced with non original sash and is generally in poor condition. Top sash has heavier glazing bar.
Proposal to replace with new single glazed window to match original details.

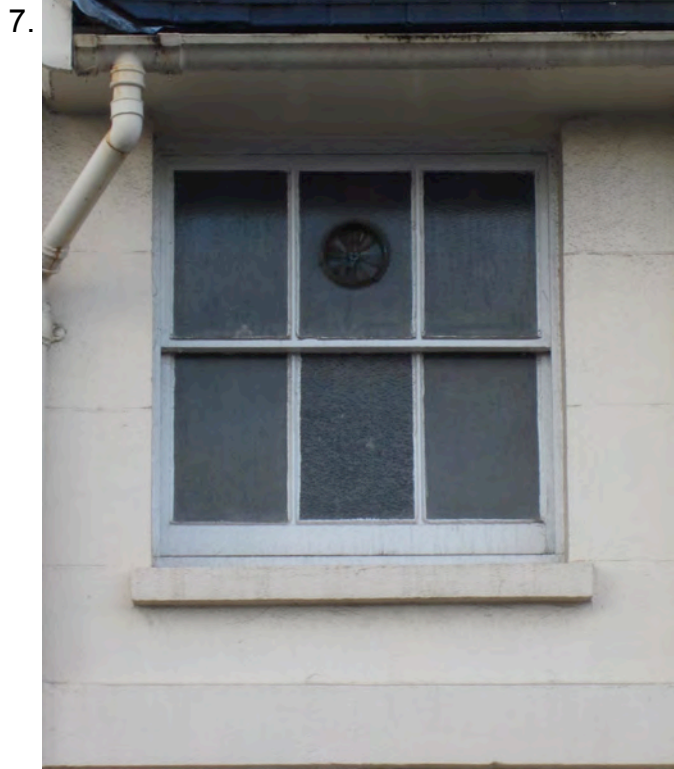
Non-original opening (post 1955). Window sashes and glazing bars are heavier, no horns, obscure glass has been installed (including a bathroom fan). Generally not in keeping with historic details.
Proposal is to replace with new single glazed window to match original details.

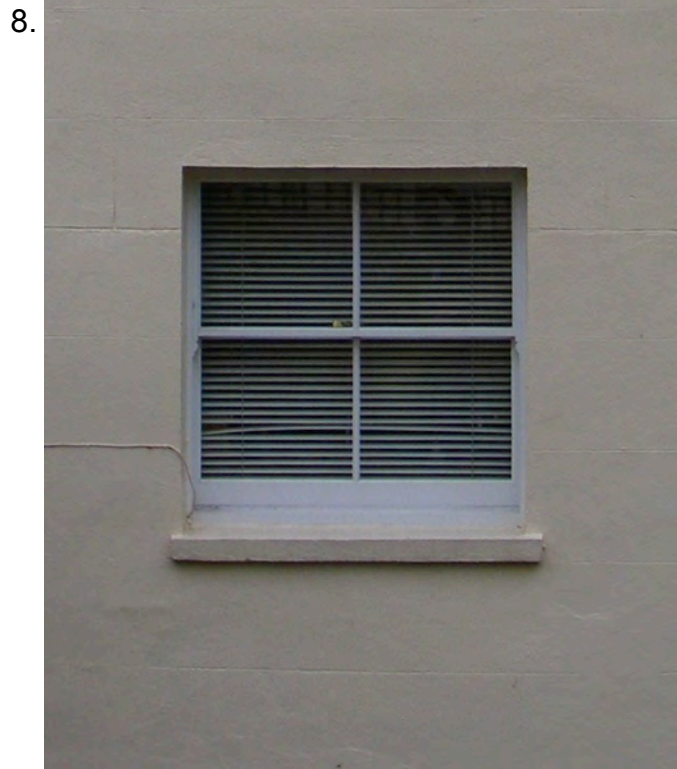
Non-original opening (post 1955).
This window is to be replaced with an arched door as previous approved application 2011/1435/L

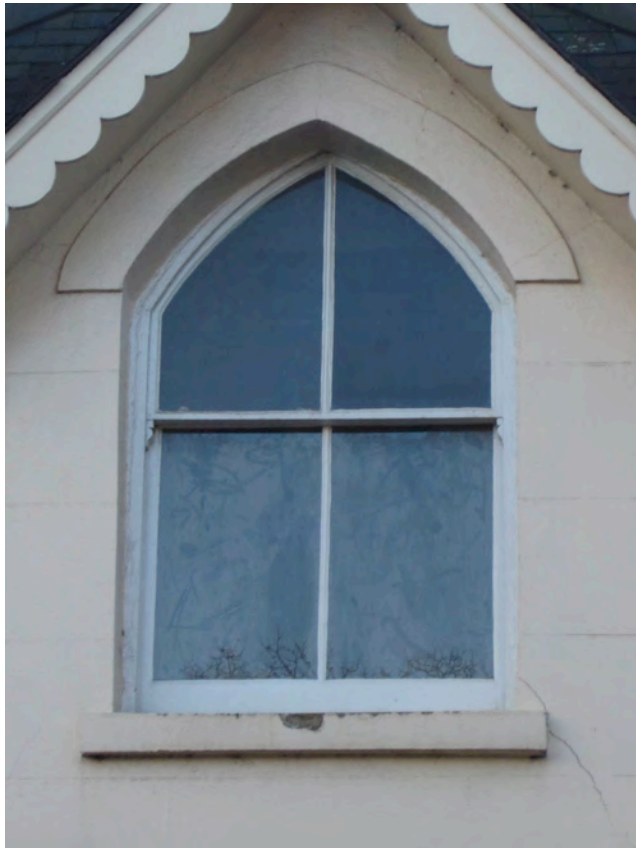
9.

Non-original opening (post 1955). Window sashes and glazing bars are heavier and generally not in keeping with historic details. Propose to replace with new single glazed sash window to match historic details.

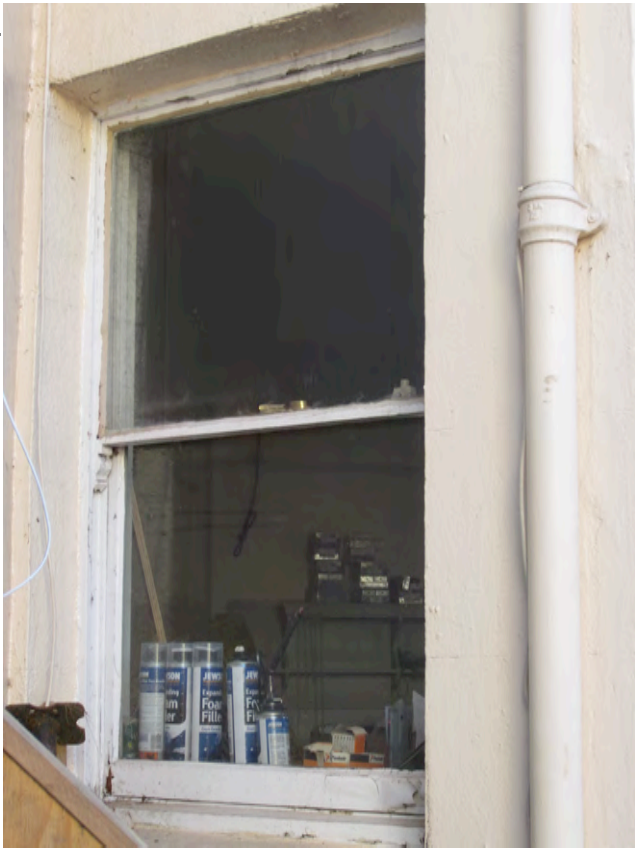
10.

Non-original window (post 1955). Most likely added when rear windows were fitted after 1955. No glazing bar, not in keeping with other windows. Proposal is to replace with new conservation double glazed sash window to traditional details.

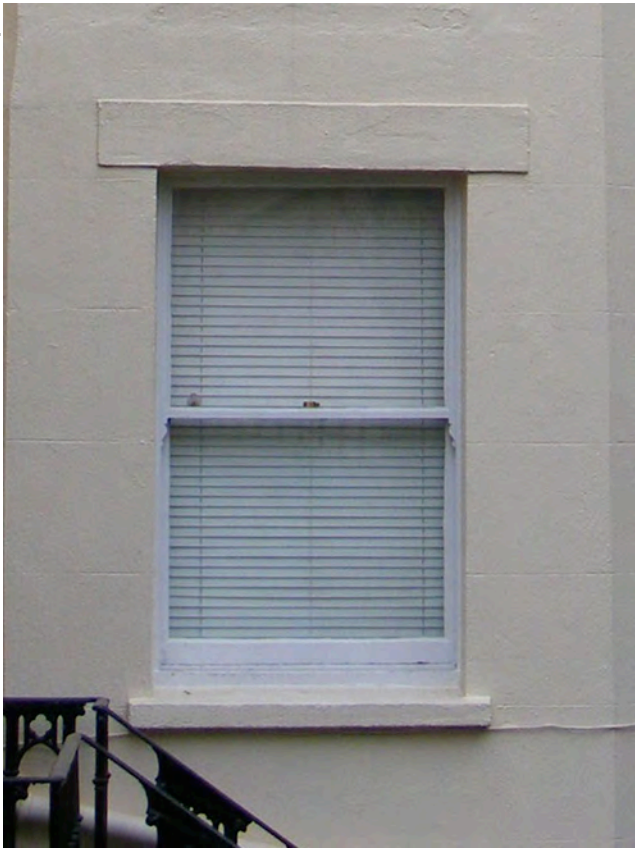
11.

Non-original window (post 1955). Most likely added when rear elevation windows were fitted after 1955. No glazing bar, not in keeping with other windows. Proposal is to replace with new conservation double glazed sash window to traditional details.

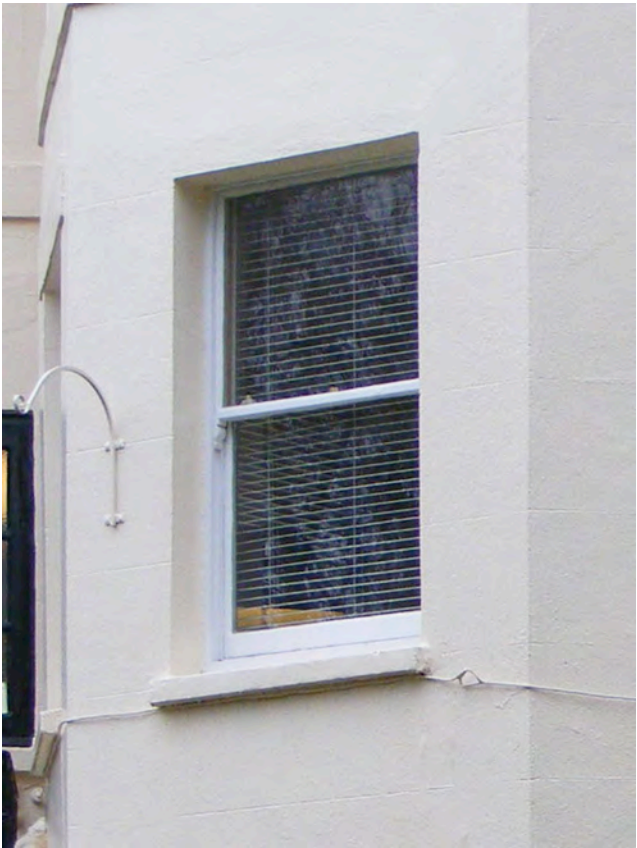
12.

Non-original window (post 1955). Most likely added when rear windows were fitted after 1955. No glazing bar, not in keeping with other windows. Proposal is to replace with new conservation double glazed sash window to traditional details.

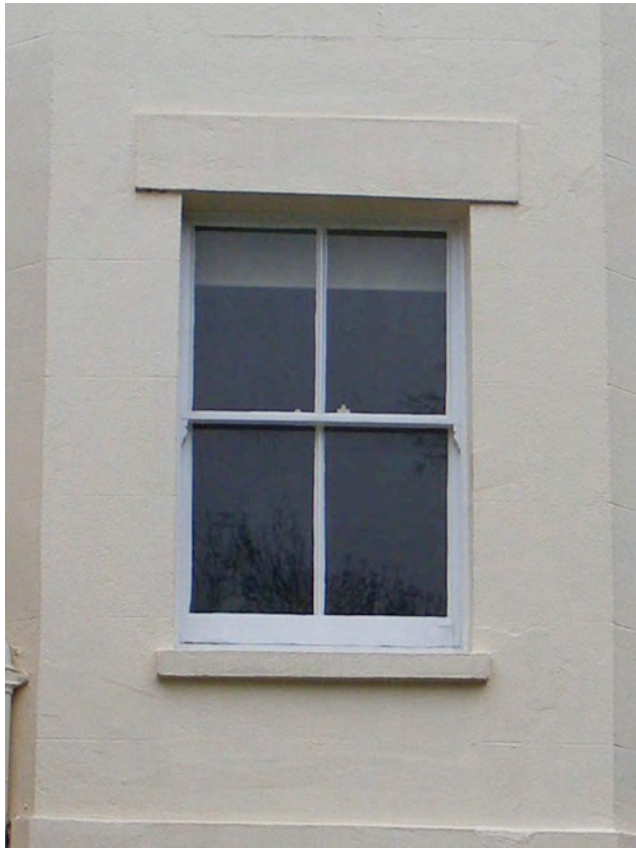
13.

Original window has been repaired and partially replaced over time. Both sashes have heavier glazing bars than the original windows. Proposal is to replace with new conservation double glazed sash window to traditional details.

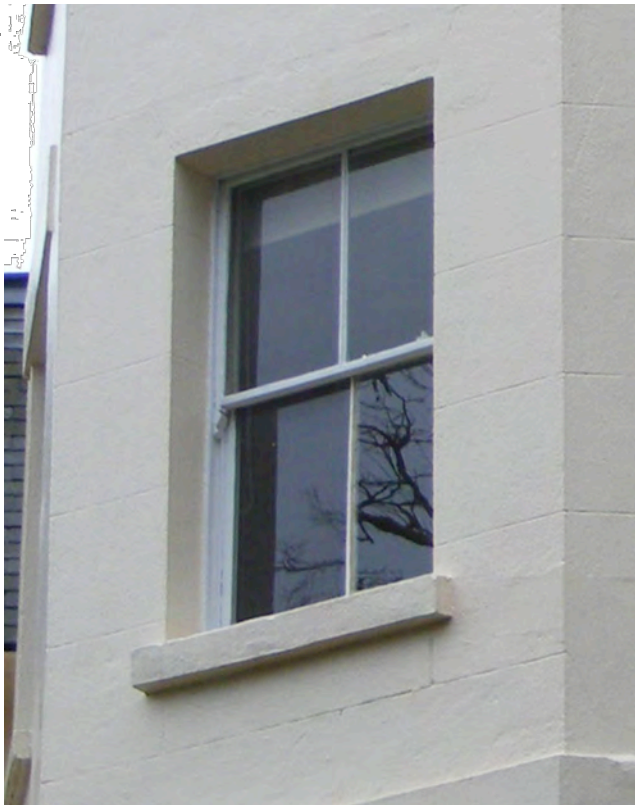
14.

Original window has been repaired and partially replaced over time. Bottom sash has heavier glazing bar & thicker window frame than the original windows (see detail 14a). There is also a large gap between sashes (similar to detail 16a). Proposal is to replace with new conservation double glazed sash window to traditional details.

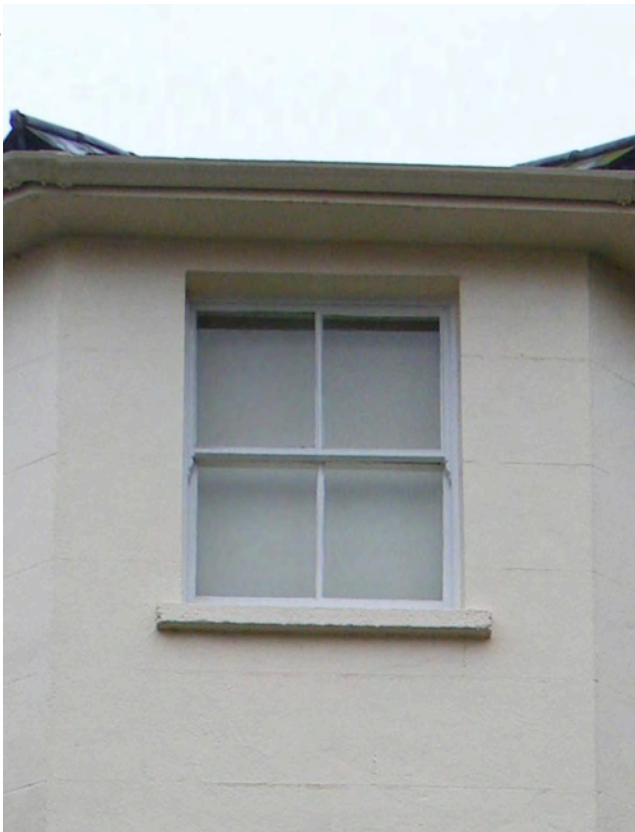
15.

Original window has been repaired and partially replaced over time. In poor condition, glazing bars don't line up & there is also a large gap between sashes. Proposal is to replace with new conservation double glazed sash window to traditional details.

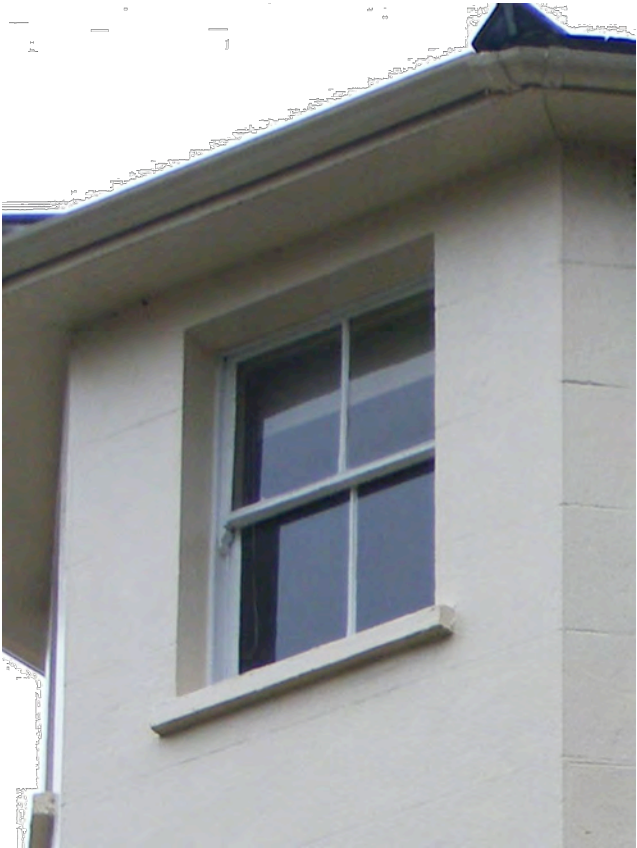
16.

Original window has been repaired and partially replaced over time. In poor condition & there is a large gap between sashes (see detail 16a). Proposal is to replace with new conservation double glazed sash window to traditional details.

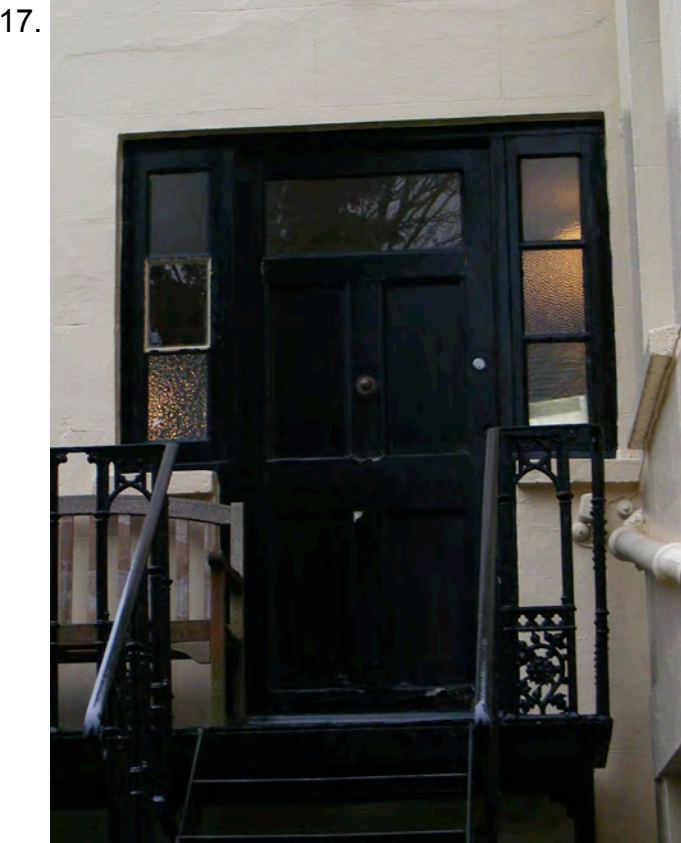
Existing door & side lights to be removed to be replaced by new sash window as per previous approved application 2011/1435/L. Proposal to replace with new conservation double glazed sash window to match all rear windows.

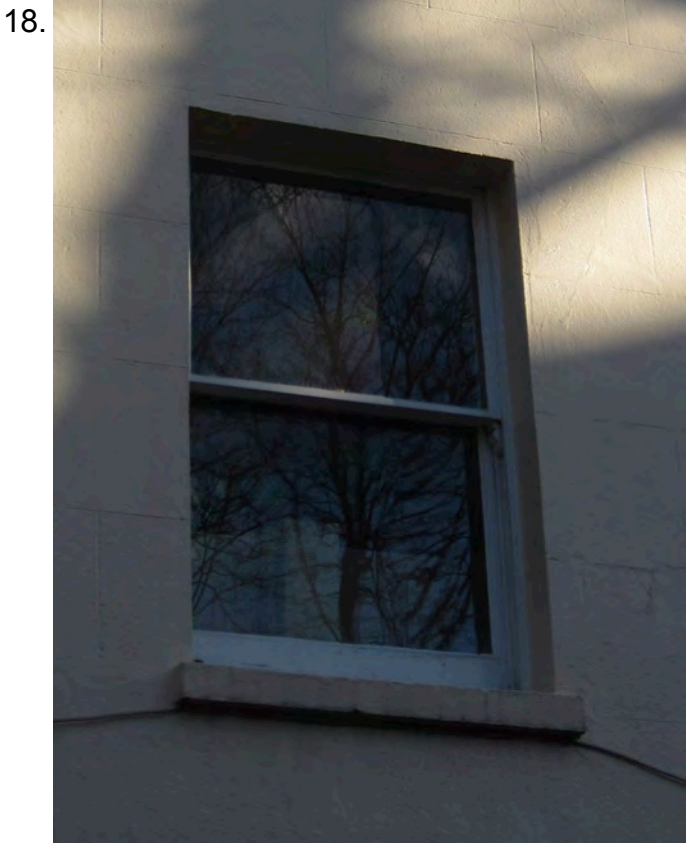
Non-original rear window (added post 1955). No glazing bar, not in keeping with other windows. This window is to be replaced with new glazed doors as per previous approved application 2011/1435/L.

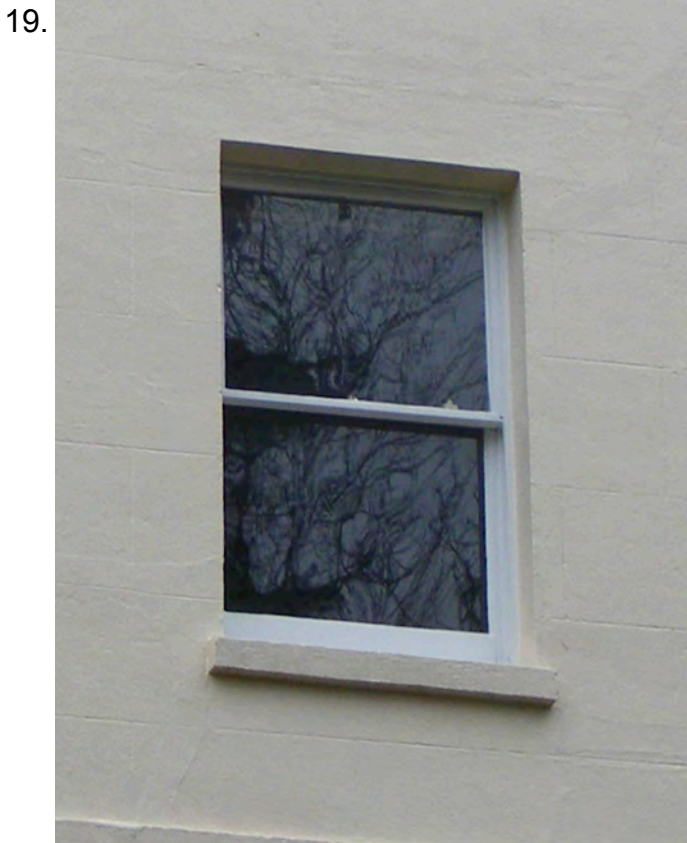
Non-original rear window (added post 1955). No glazing bar, not in keeping with other windows. New wider window to be added as per previous approved application 2011/1435/L. Proposal to replace with new conservation double glazed sash window to traditional details.

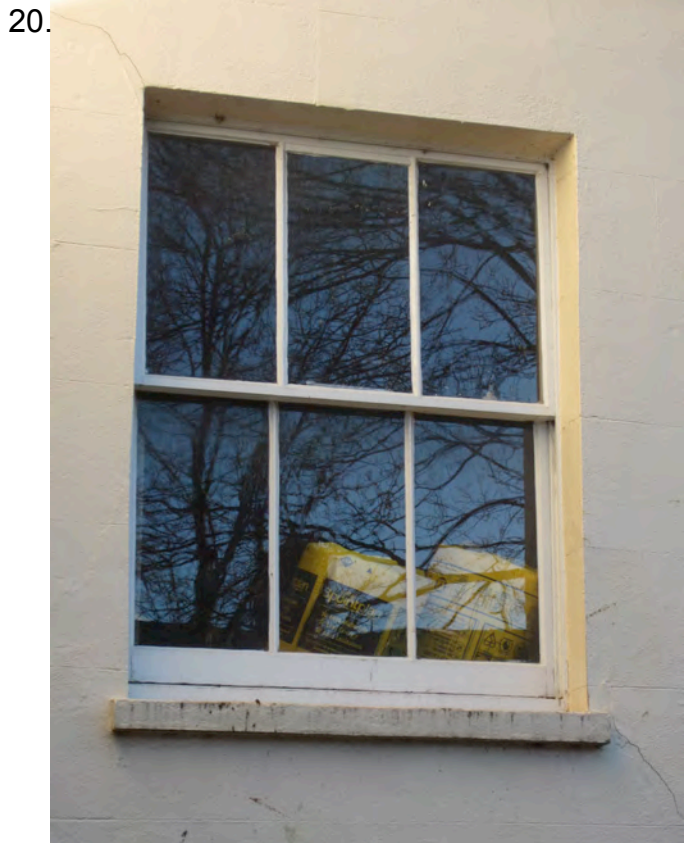
Non-original rear window (added post 1955). Proposal is to replace with new conservation double glazed sash window to traditional details.

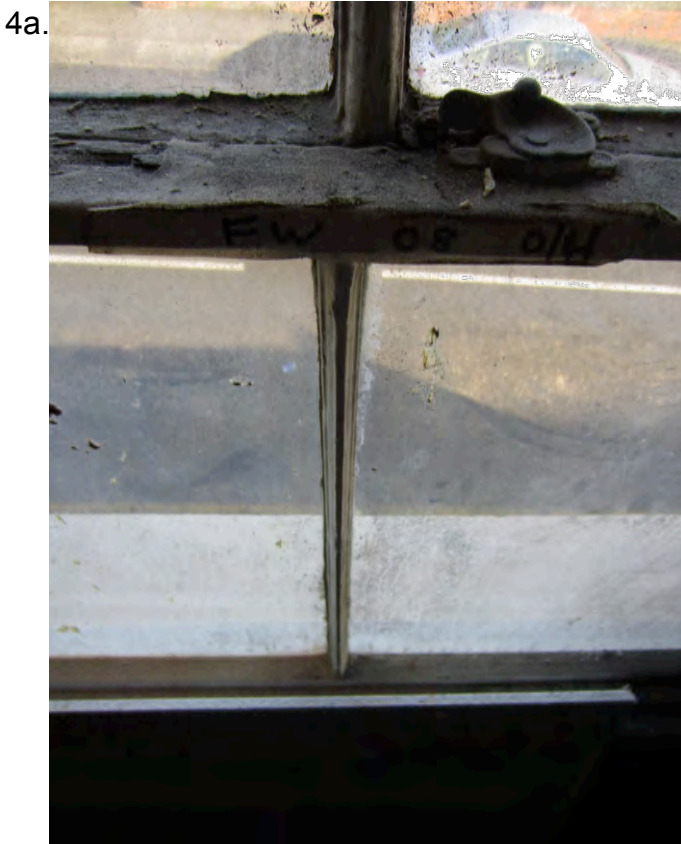
Internal detail of window 4. Note the glazing bars do not align. The bottom sash is original but in a poor state of repair this has an 18mm glazing bar, the upper sash is a replacement with heavier glazing bar at 23mm.

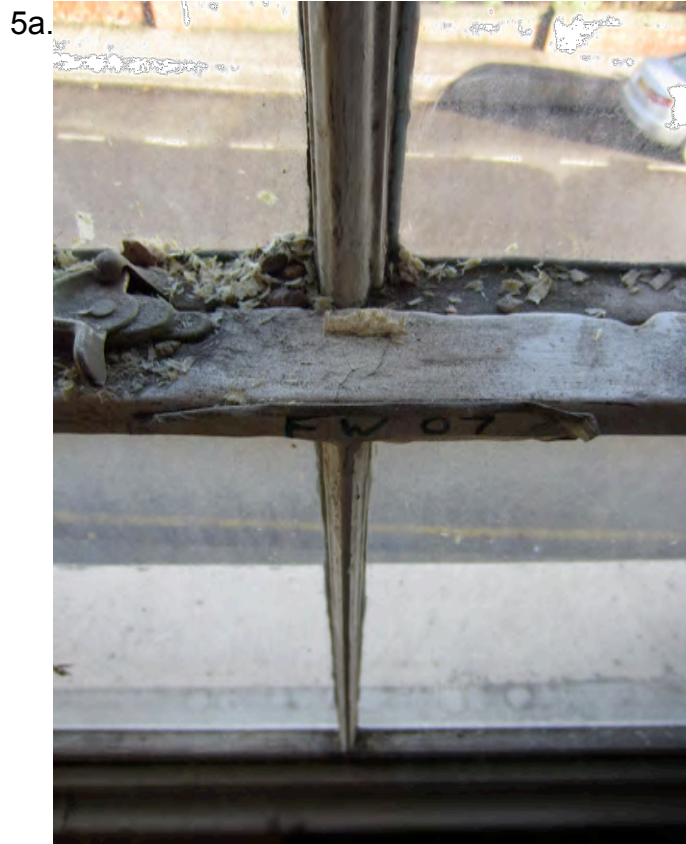
Internal detail of window 5 shows the window in a poor state of repair, with different glazing bar profiles for the top & bottom sashes again.

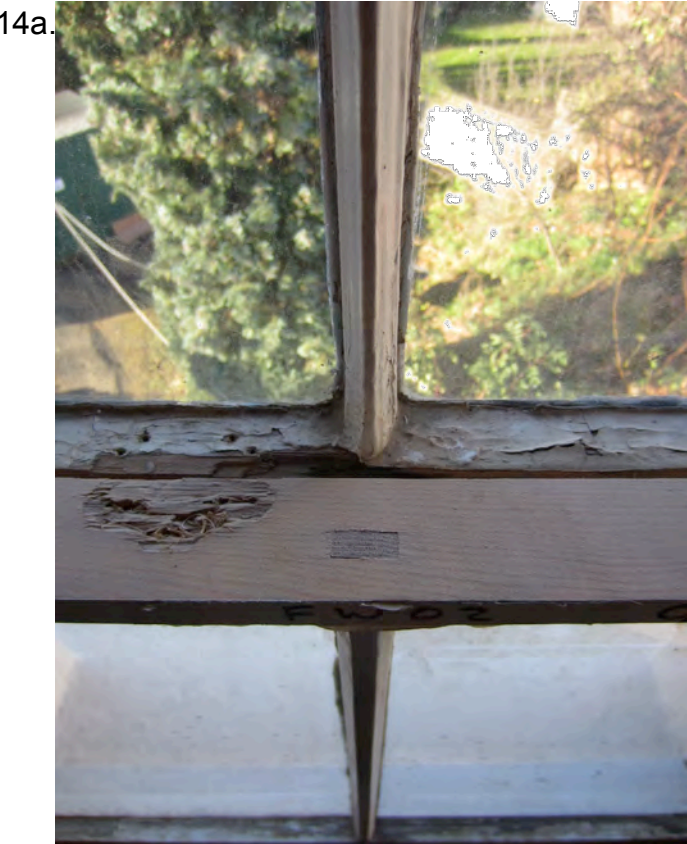
Internal detail of window 14 shows the window in a poor state of repair & different glazing bar details for the top & bottom sashes. Also the more recently installed bottom sash is deeper than the top sash.

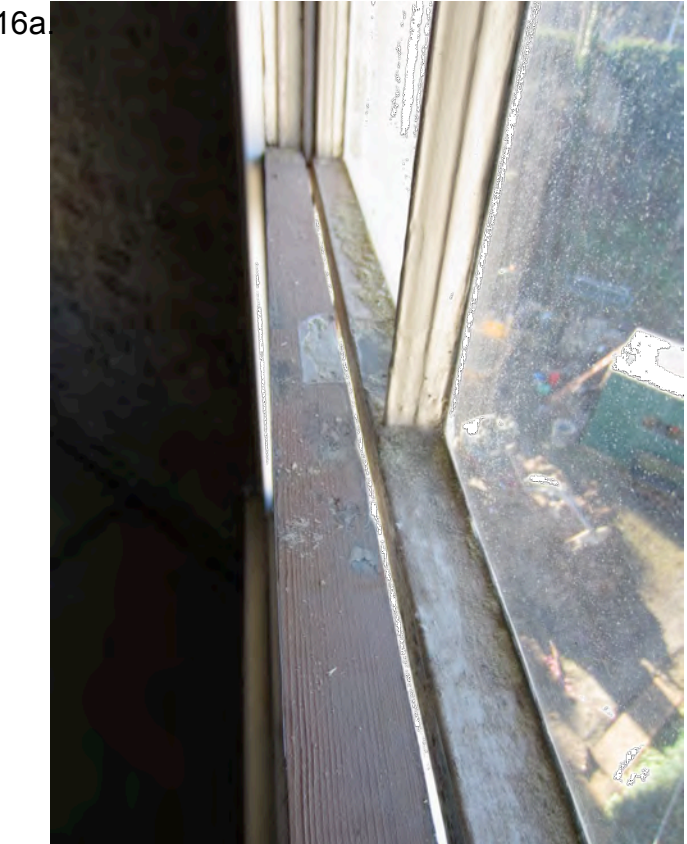
Internal detail of window 16 shows the window in a poor state of repair & the large gap between the two poorly constructed sashes.
