# BACTON LOW RISE REDEVELOPMENT

TREE SURVEY, IMPLICATIONS ASSESSMENT AND CONSTRAINTS

NOVEMBER 2012

### Bacton Low Rise, Tree Survey, Implications Assessment & Constraints Report

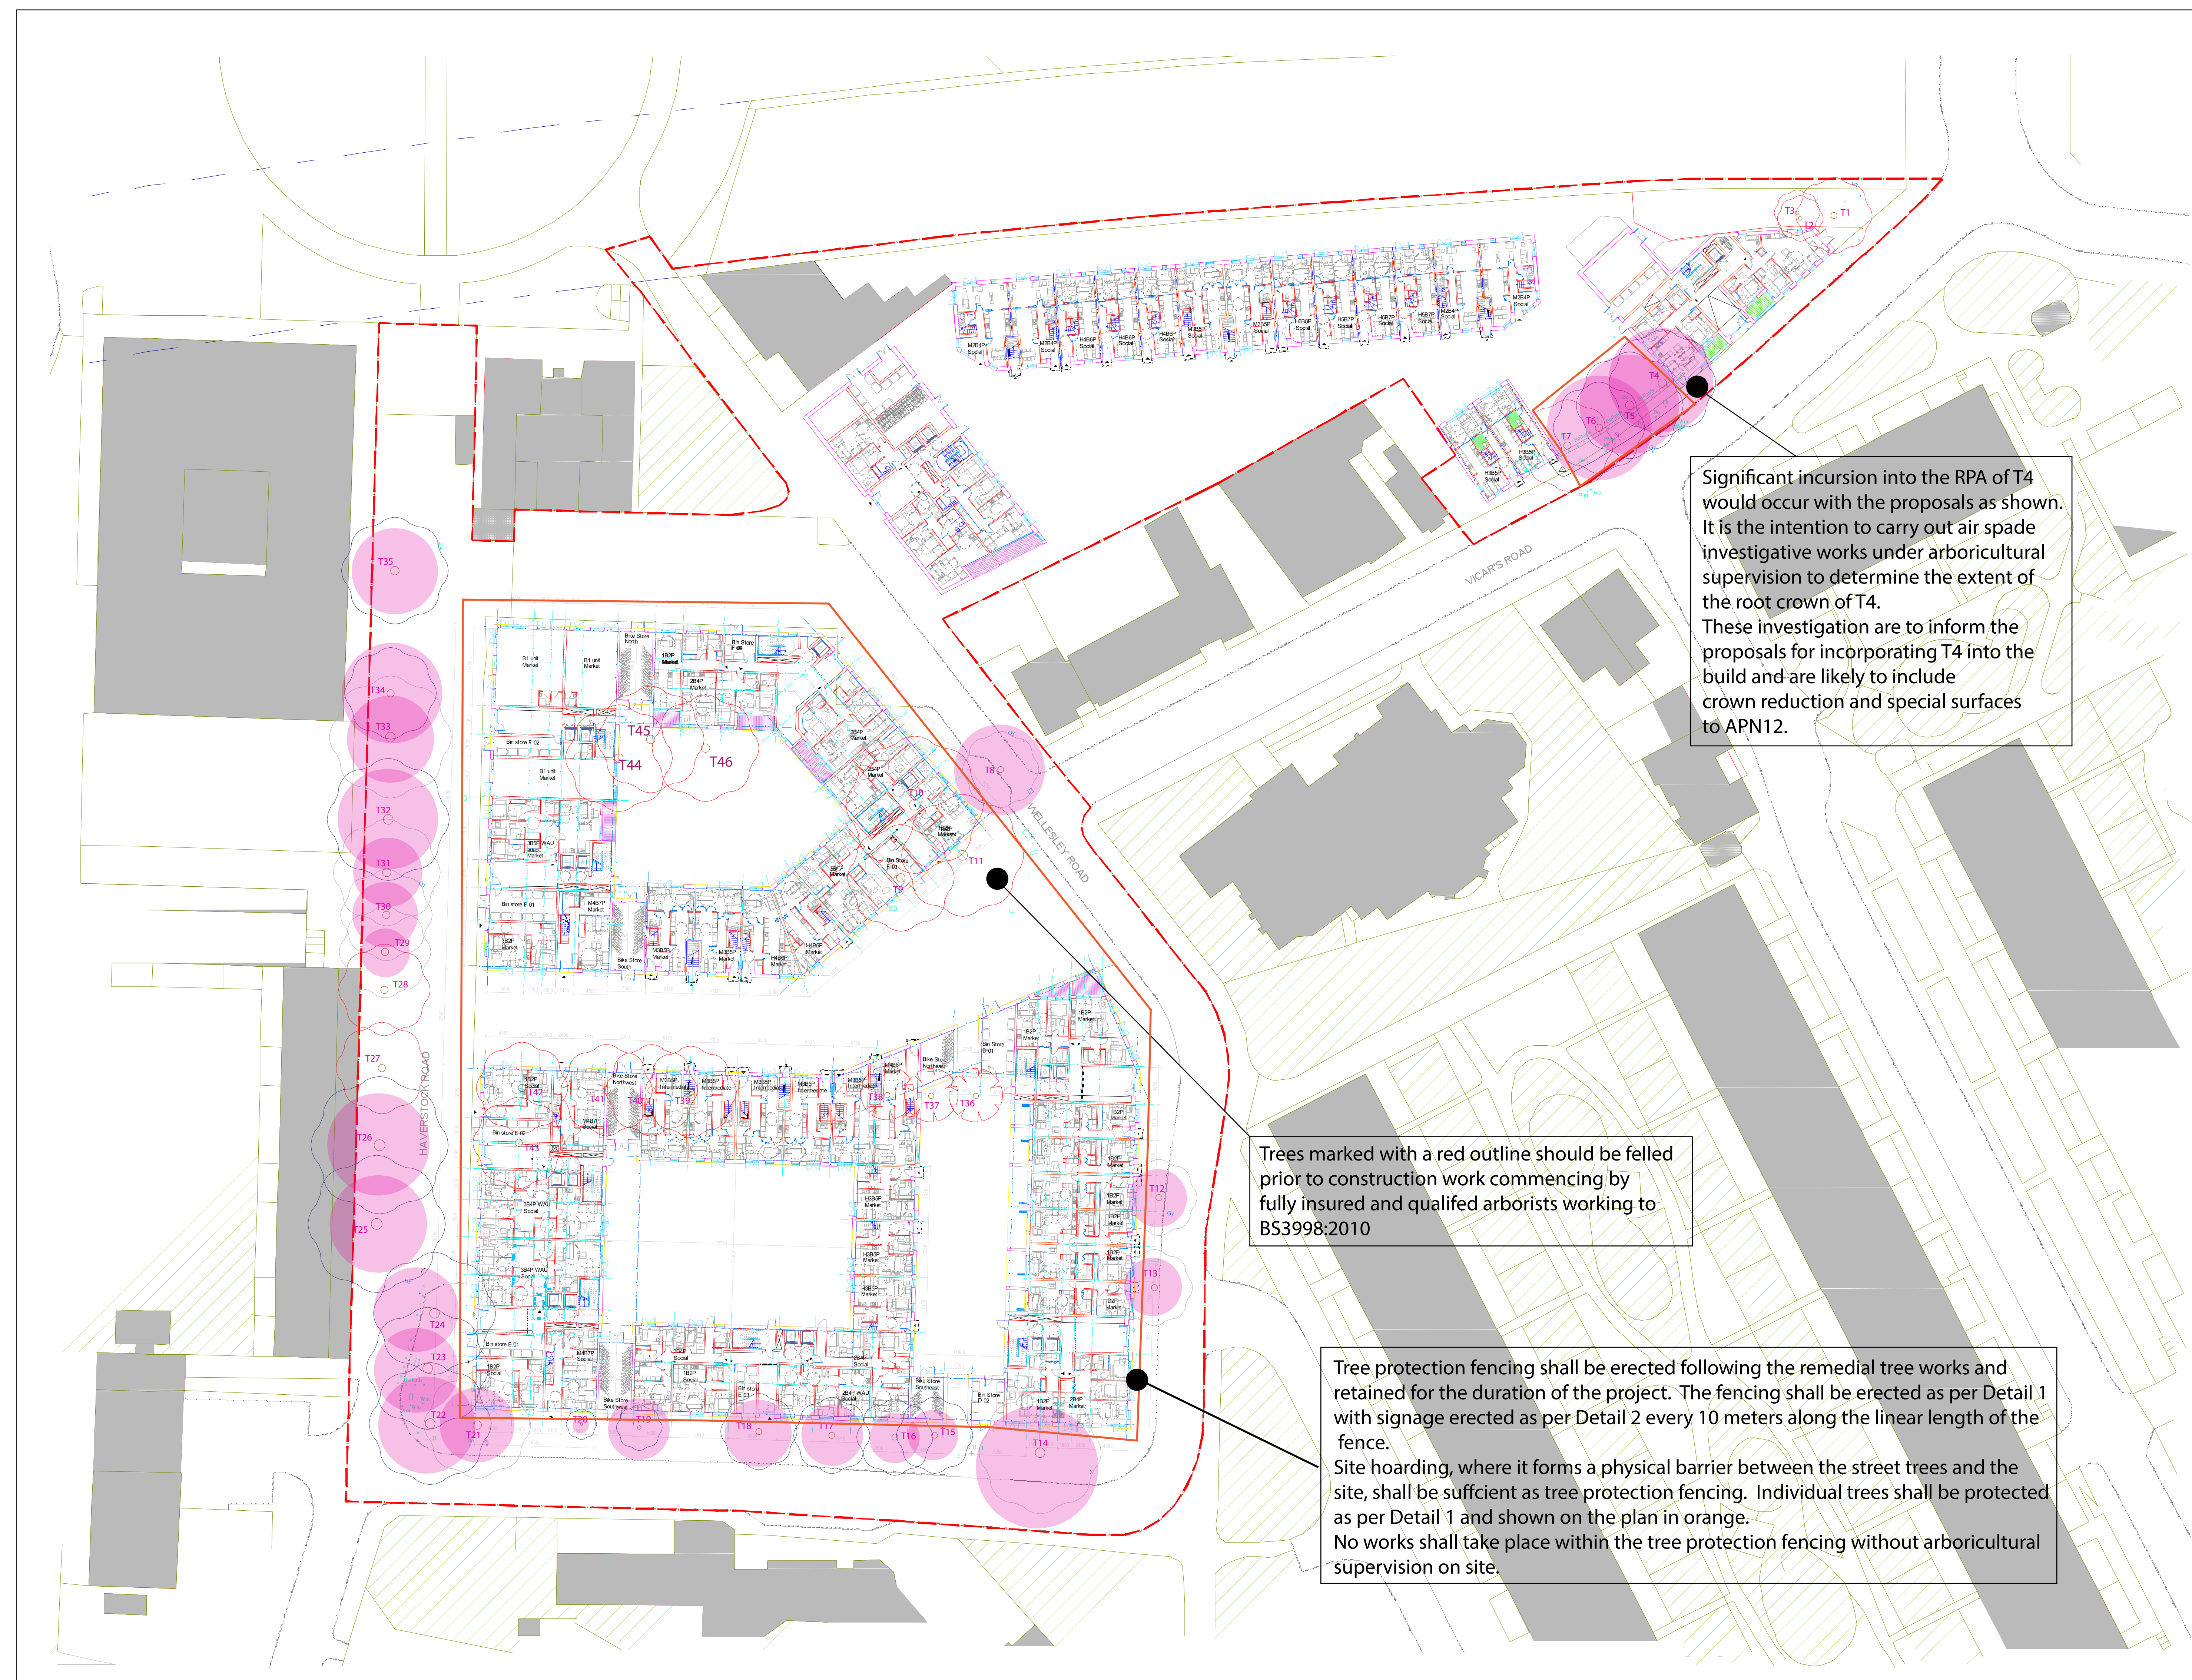
Significant incursion into the RPA of T4 would occur with the proposals as shown. It is the intention to carry out air spade investigative works under arboricultural supervision to determine the extent of the root crown of T4. These investigations are to inform the proposals for incorporating T4 into the build and are likely to include crown reduction and special surfaces to APN12.

Trees marked with a red outline should be felled prior to construction work commencing by fully insured and qualified arborists working to BS3998:2010

Tree protection fencing shall be erected following the remedial tree works and retained for the duration of the project. The fencing shall be erected as per Detail 1 with signage erected as per Detail 2 every 10 meters along the linear length of the fence. Site hoarding, where it forms a physical barrier between the street trees and the site, shall be sufficient as tree protection fencing. Individual trees shall be protected as per Detail 1 and shown on the plan in orange. No works shall take place within the tree protection fencing without arboricultural supervision on site.

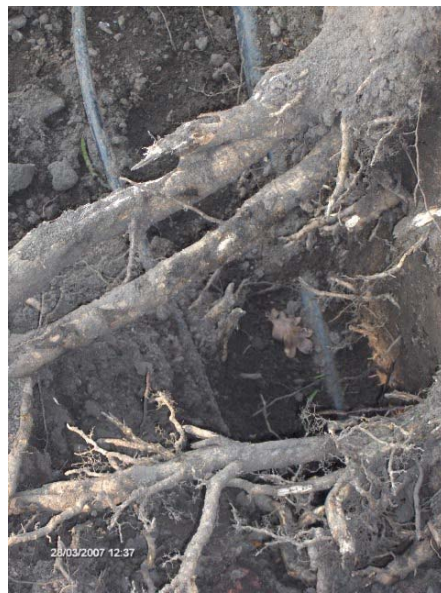
- the severance of a root, for example by trenching will destroy all parts of the root beyond that point. Even roots less than 10mm in diameter may be serving the fine roots over a wide area. The larger the root severed, the greater the impact on the tree.

**Typical root damage caused by excavation works**

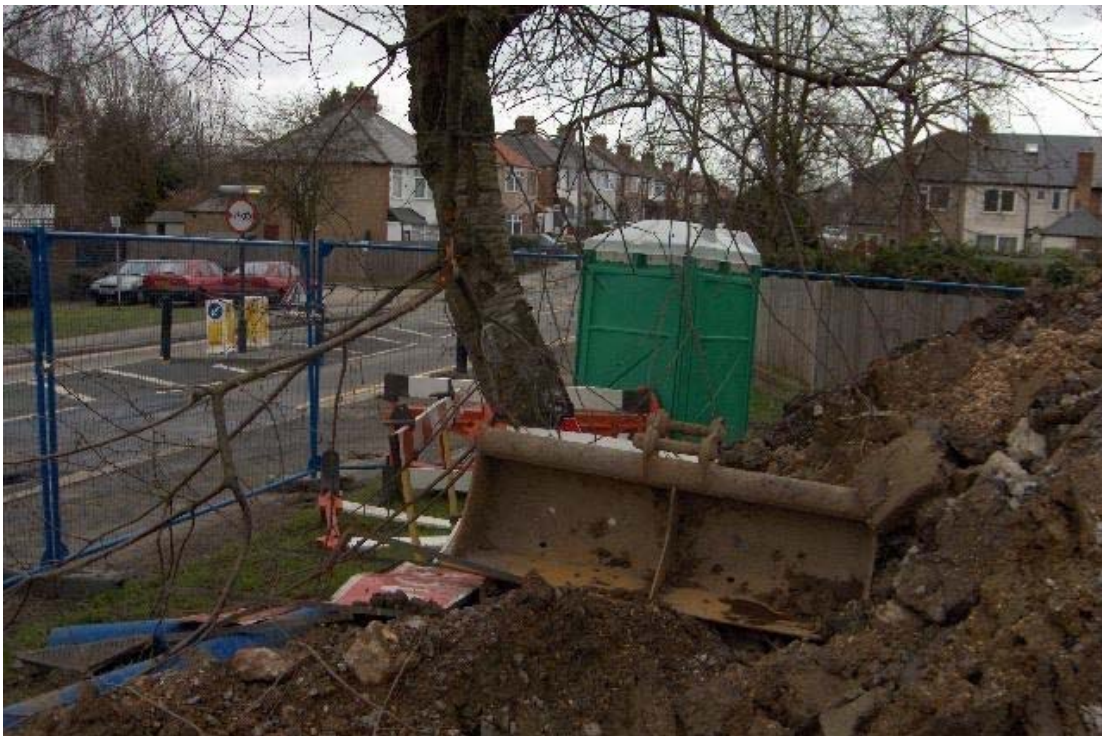
- compaction of the soil. Incidental compaction may occur from storage of materials and / or the passing of heavy equipment over the roots. This can restrict or even prevent gaseous diffusion through the soil, and thereby asphyxiate the roots. The roots must have oxygen for survival, growth and effective functioning.

### Poor site management within the Precautionary Zone
