# Arboricultural Appraisal Report

## Subsidence Damage Investigation at:

55 Shirlock Road  
London  
NW3 2HR

CLIENT:	Crawford & Company
CLIENT REF:	SU1203736
POLICYHOLDER:	Mr Martin Jourdan
MWA REF:	NW140912.01DW
MWA CONSULTANT:	David Williams (N.D.Arb MArborA)
REPORT DATE:	01 October 2012

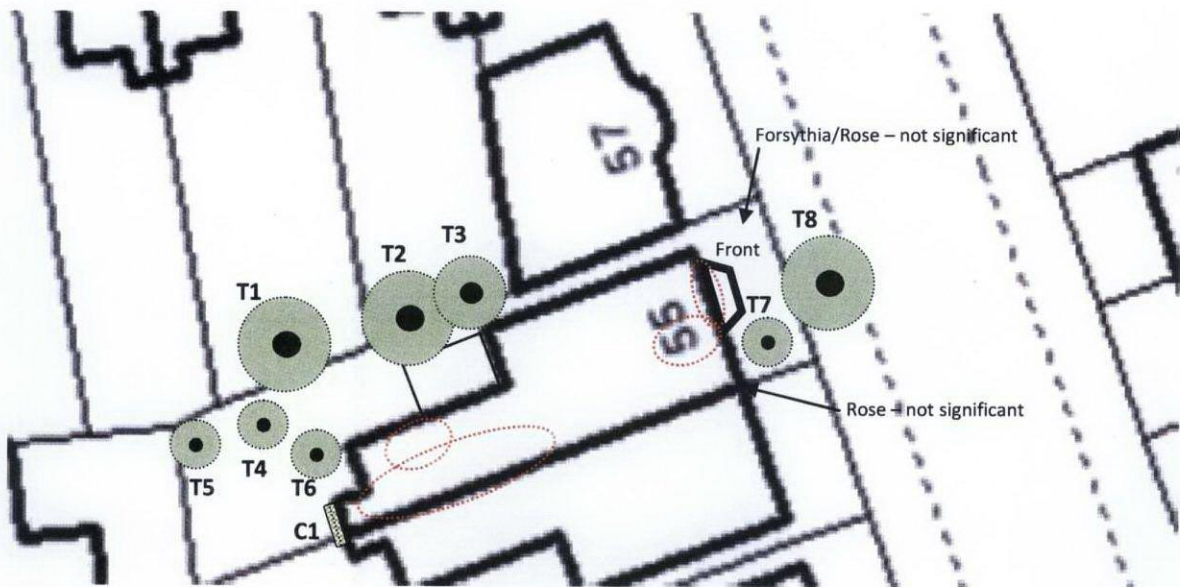
## SITE PLAN

Approximate areas of damage

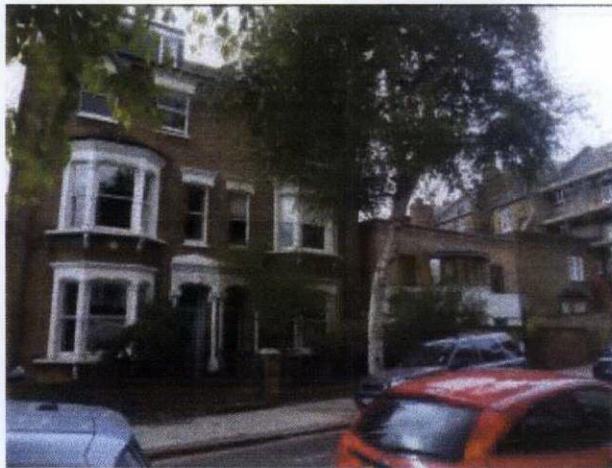
The movement affecting the front of the property is to the two storey bay and possibly movement of the front elevation as indicated by internal cracking to the spine wall between the hallway and front reception room which suggests that a larger tree is involved with a wider and deeper soil drying influence.

In our opinion, the local authority owned Birch tree, T8, is likely to be the dominant cause of the current damage at the front. However, we cannot rule out some secondary drying influence from the policyholders Magnolia, T7, based on its size and proximity to the bay window and front elevation.

View of front elevation and T8

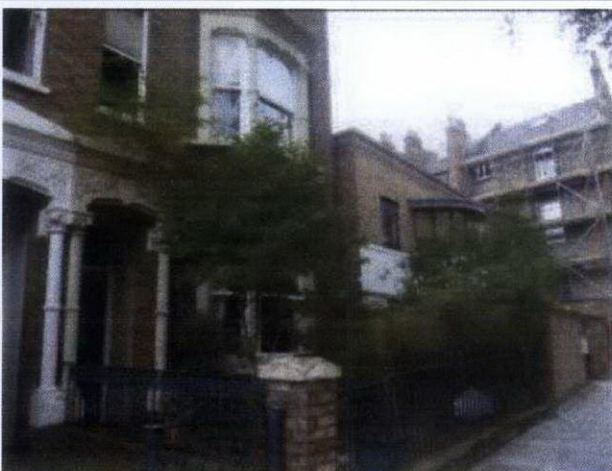
View of front garden

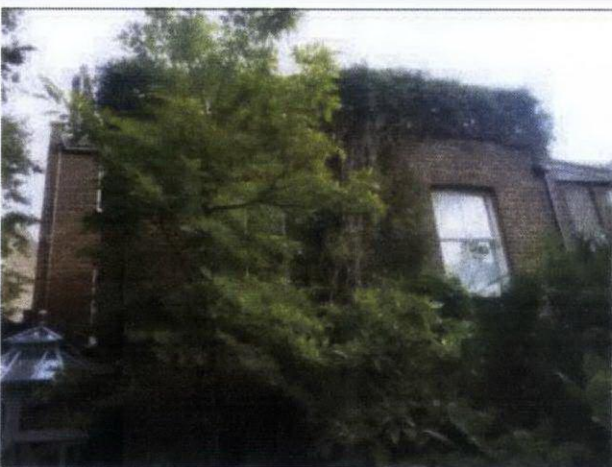
With reference to the movement at the rear, it is our opinion that the drying influence of third party owned trees, T1-T3 inclusive is likely to be the dominant cause of the current damage based on their size and proximity to the focal area of building movement. The influence of the policyholders Magnolia, T6, is considered to be very much secondary to that of the Lime trees.

View of rear elevation and T6 and C1
