# **TECHNICAL REPORT ON A SUBSIDENCE CLAIM**

**Crawford Reference: SU1203736**

**Mr Martin Jourdan  
55 Shirlock Road  
London  
NW3 2HR**

**SUBSIDENCE CLAIM**

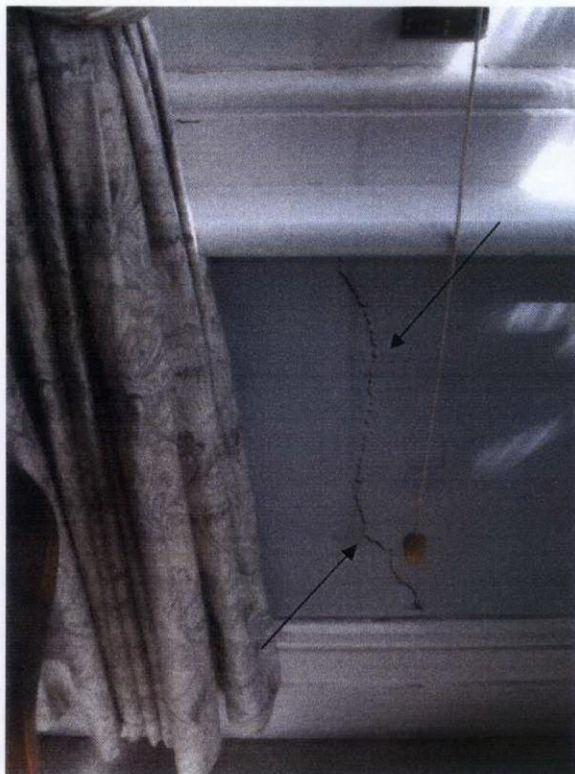
2mm Vertical/Diagonal cracking below bay window at ground floor level.

2mm Vertical/Diagonal cracking below bay window.

The pattern and nature of the cracks is indicative of an episode of subsidence. The cause of movement appears to be clay shrinkage.

The timing of the event, the presence of shrinkable clay beneath the foundations and the proximity of vegetation where there is damage indicates the shrinkage to be root induced. This is a commonly encountered problem and probably accounts for around 70% of subsidence claims notified to insurers.

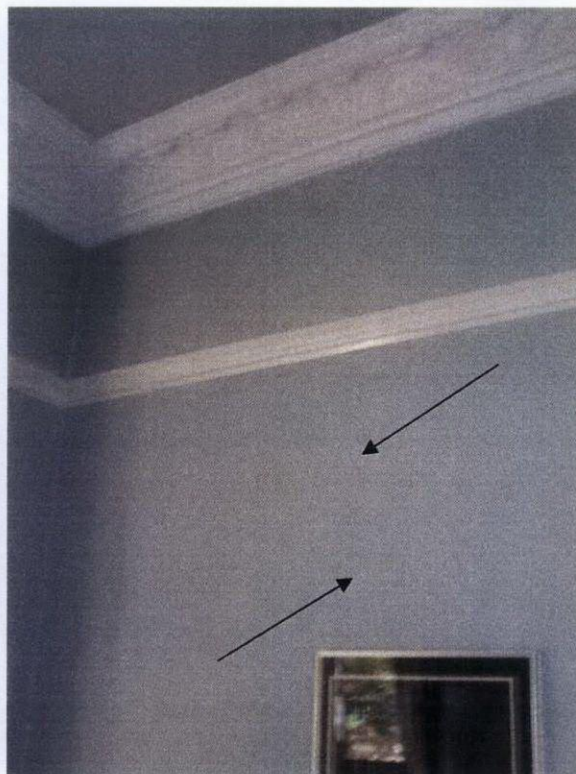
1mm Diagonal/Vertical crack to the left hand wall (spine wall) at ground floor level.

1mm Diagonal/Vertical crack to the left hand wall.

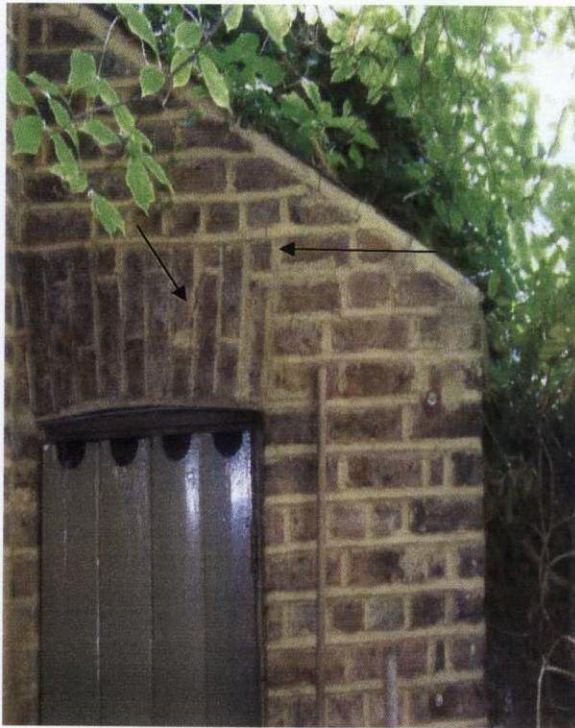
3mm Stepped cracking in brickwork above the door.

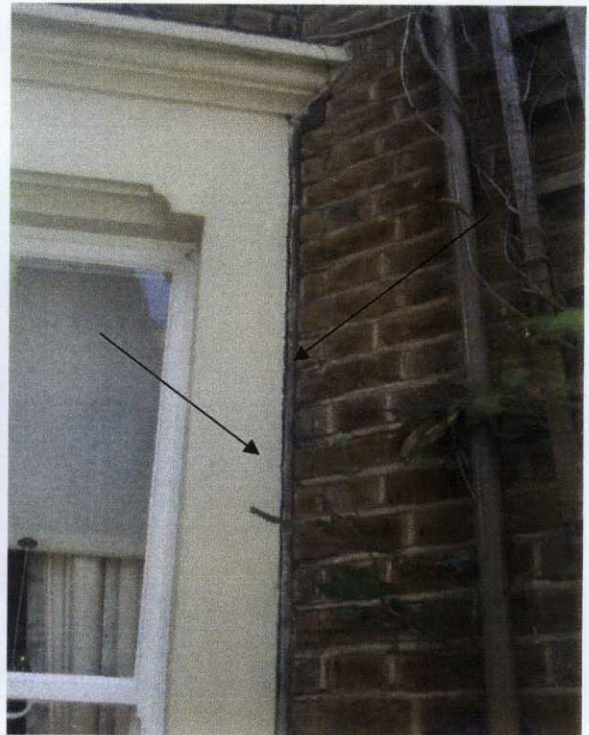
2mm separation at junction of bay and front elevation.

2-4mm vertical cracking either side of the bay below the bay window.  
2mm separation at junction of bay and front elevation.
