FACTUAL REPORT

INVESTIGATION

AT:- 55 Shirlock Road, London

REF:- SU1203736-Mr Martin Jourdan

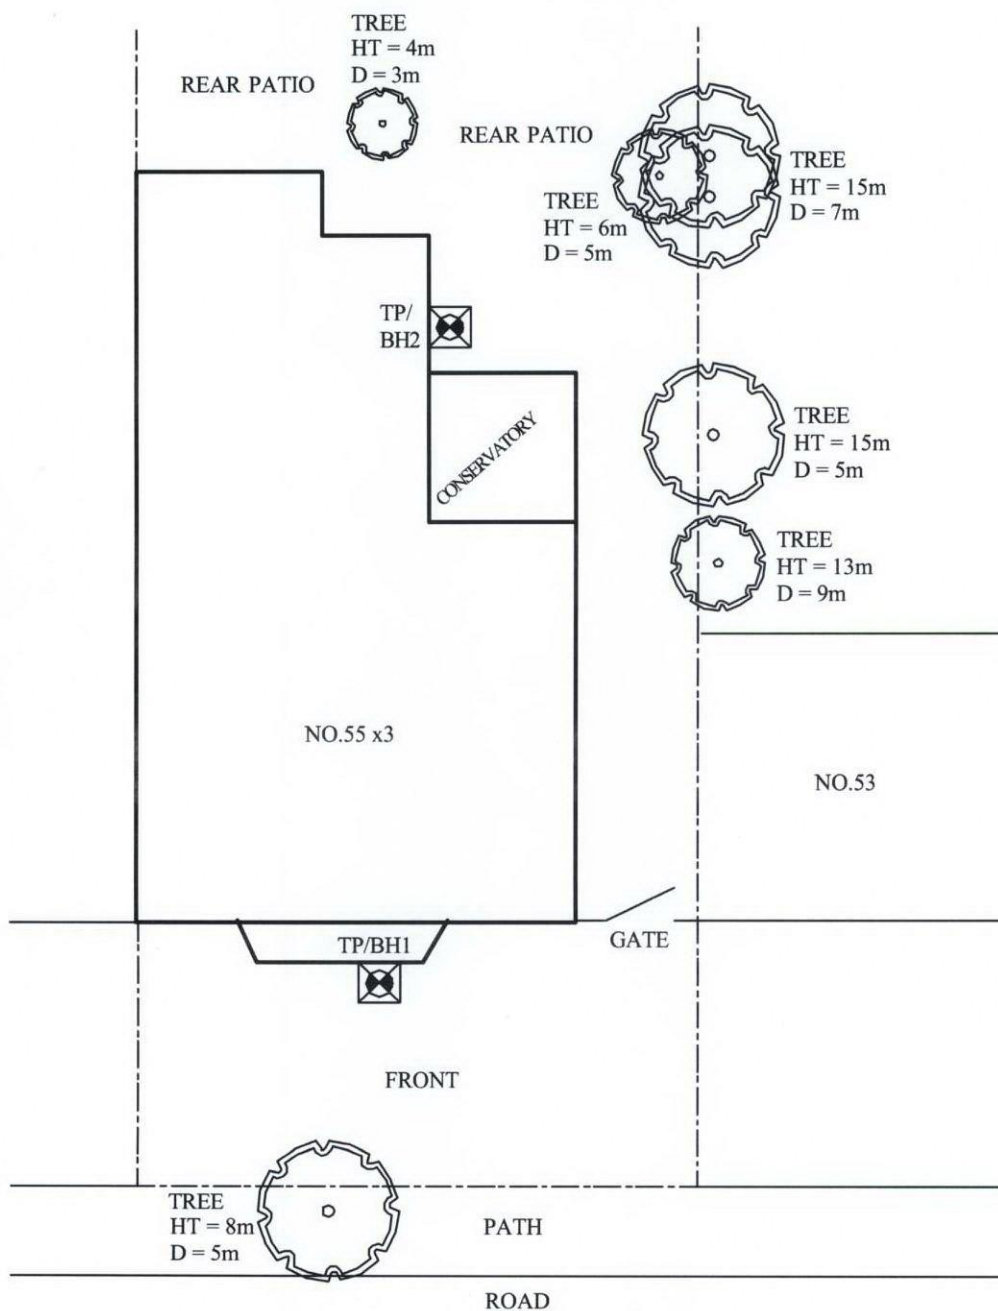
Investigation Layout Plan

Remarks:
Trial pit/borehole 2 relocated as agreed with engineer.

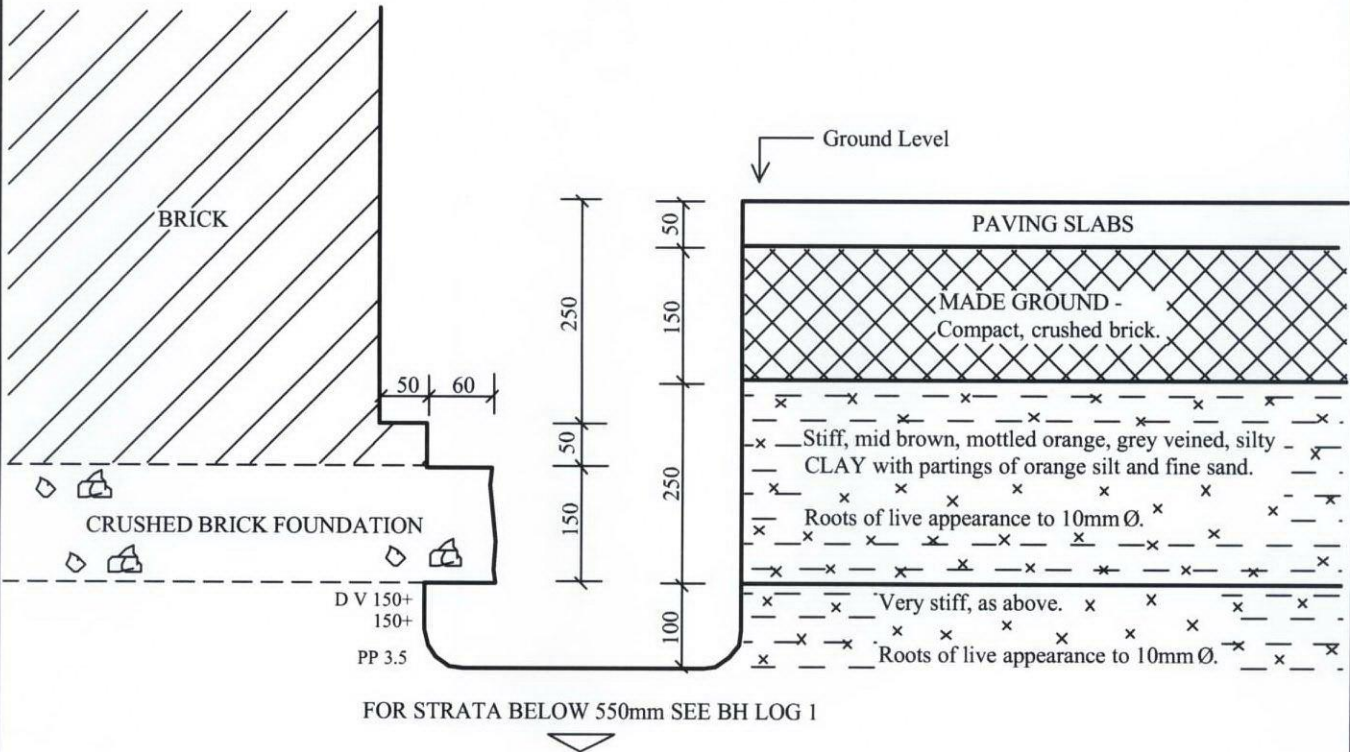
Trial Pit No: 2

<u>Trial pit/ Borehole number</u>	<u>Root diameter (mm)</u>	<u>Tree, shrub or climber from which root originates</u>	<u>Result of starch test#</u>
TP1 (underside)	thread-like	too immature to analyse (3 roots)	—
TP2 (underside)	10.0	<u>Tilia</u> (lime) (4 roots)	positive
BH2 (depth: 1.5m)	<0.5	<u>Tilia</u> (lime) (2 roots)	positive

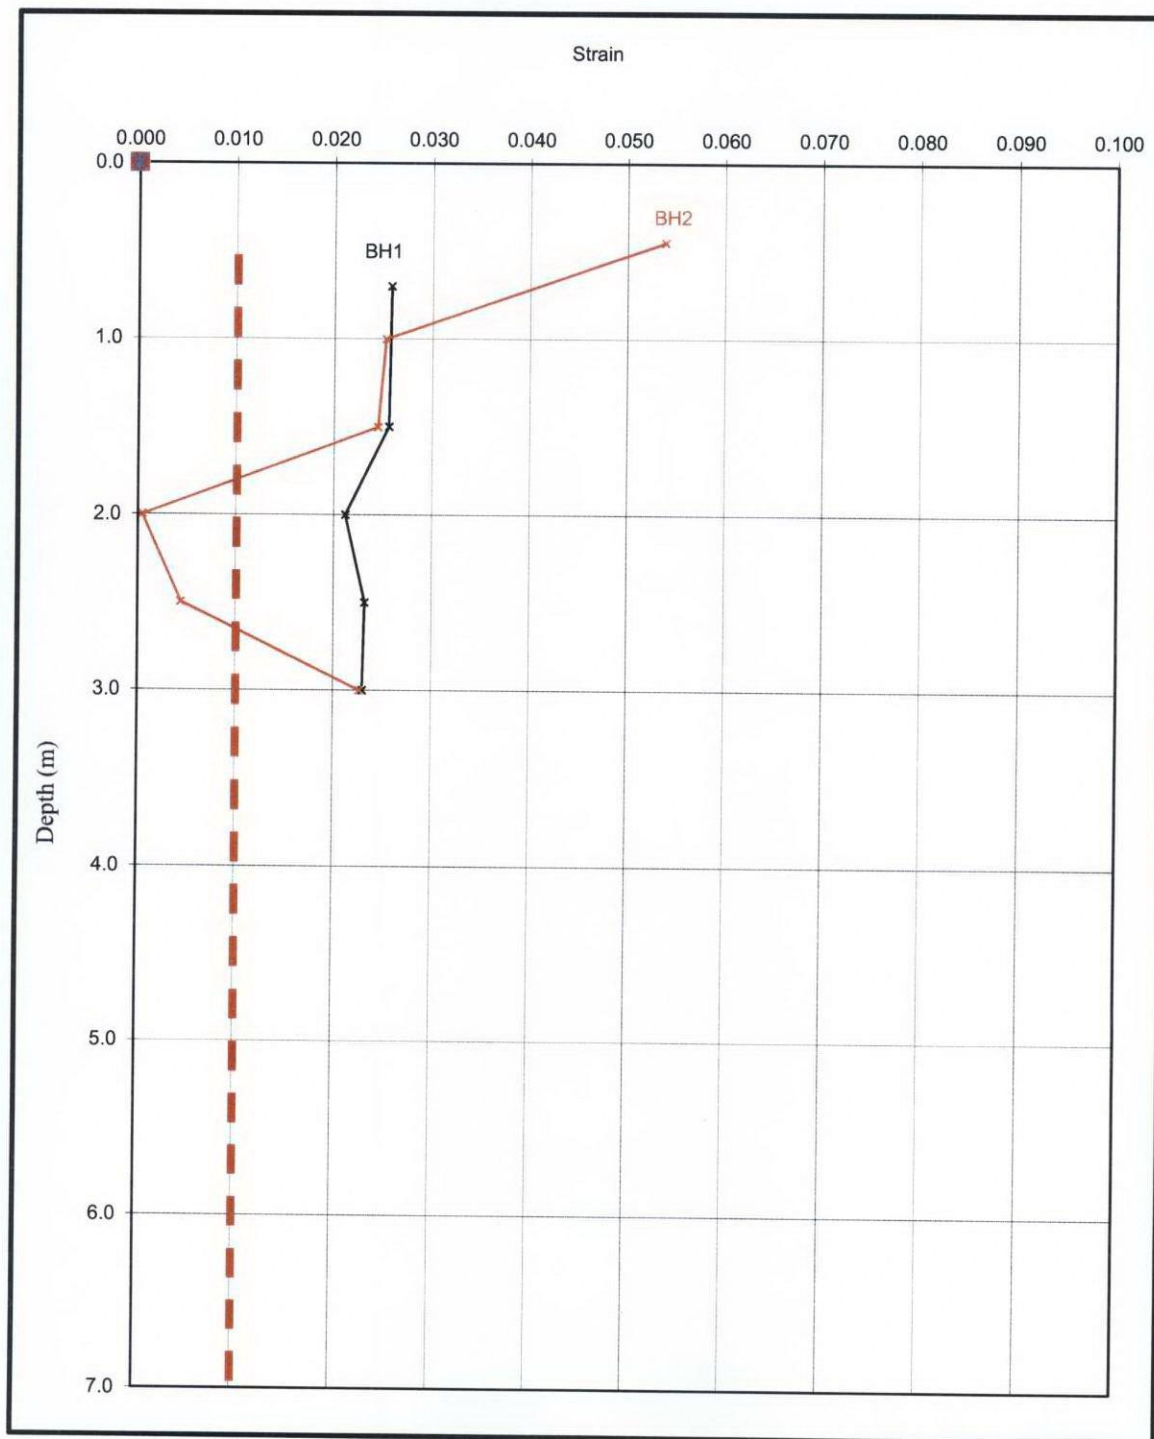
Oedometer Strain Profiles

1. Soil Bulk Density (moist unit weight) is equal to 2039kg/m³
2. The water table is assumed as 1.0m below ground level.
3. Shrinkage Factor (sf) of 2 has been applied to the predicted heave, where applicable
4. Any possible surcharge stresses due to construction are not considered
