TECHNICAL REPORT ON A SUBSIDENCE CLAIM

Crawford Reference: SU1200782

**Rowrange Properties Ltd
105 Bartholomew Road
London
NW5 2AR**

SUBSIDENCE CLAIM

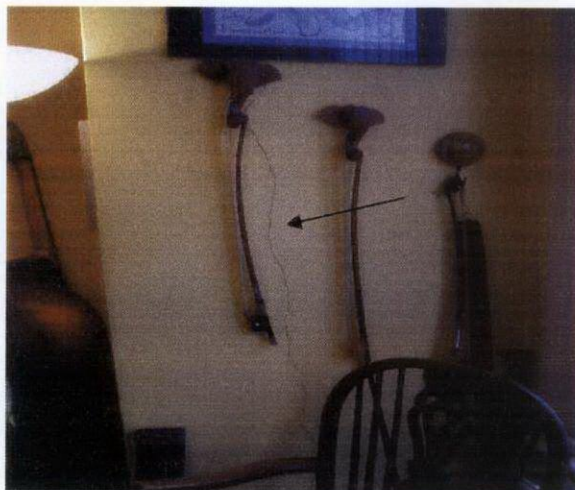
Cracking to right hand side of bay in ground floor flat music room

Ground Floor Flat - Music Room - 2mm vertical crack to right hand side of bay, 1mm vertical crack to left hand side of bay, 2mm vertical crack to bay behind radiator, wall / ceiling junction cracking along front wall and left hand party wall, hairline diagonal crack to left hand party wall, hairline vertical crack to left hand party wall, rucking to wallpaper in rear right hand corner, damp in bay at low level and to skirting along left hand party wall - not related to movement.

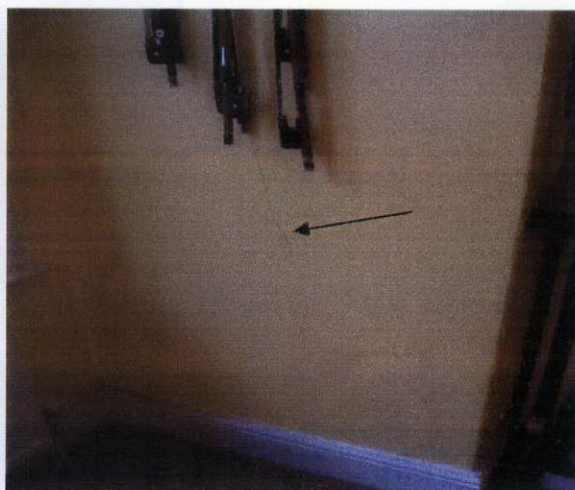
Cracking to left hand side of bay in ground floor flat music room

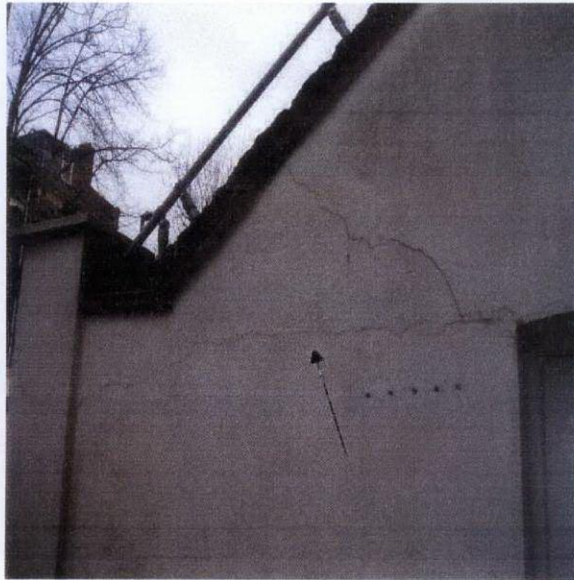
Cracking to steps wall

Front - 1mm horizontal / diagonal cracking to right hand flank of front steps, gap between step asphalt and right hand step wall on top step area.

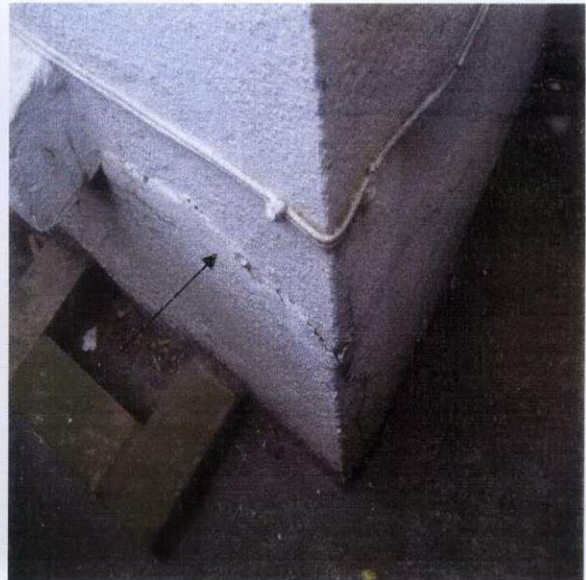
Cracking to bay

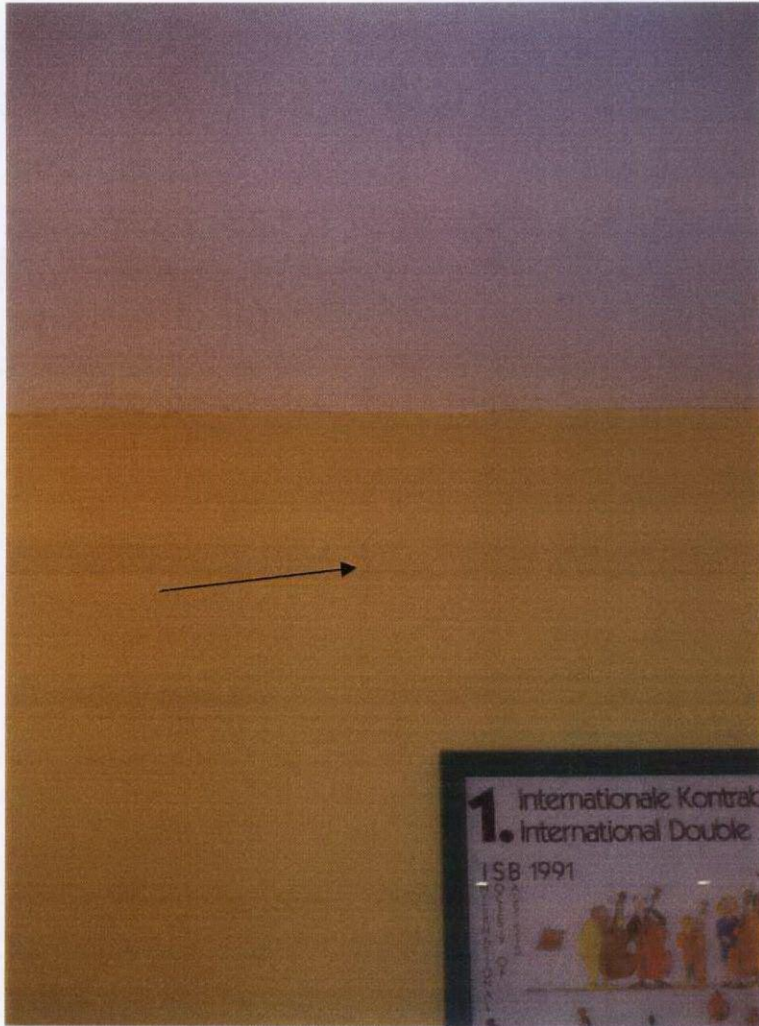
Cracking to left hand party wall in ground floor flat music room

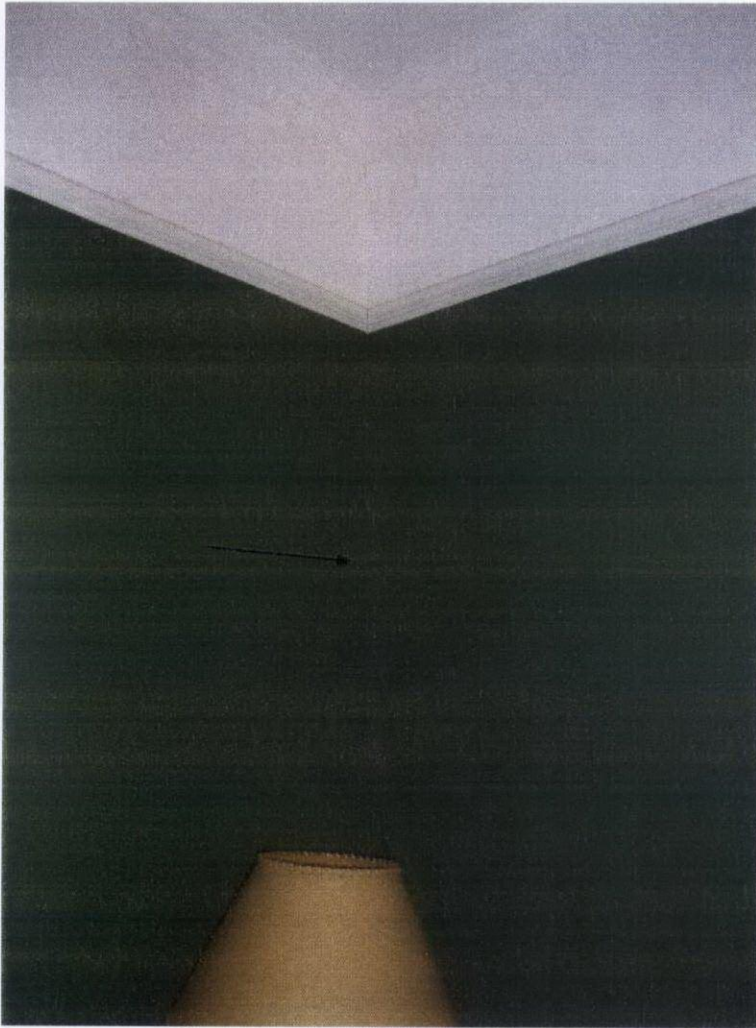
Lounge - Rucking to wallpaper in rear right hand corner and right hand side of bay.

Rucking to wallpaper in ground floor flat lounge

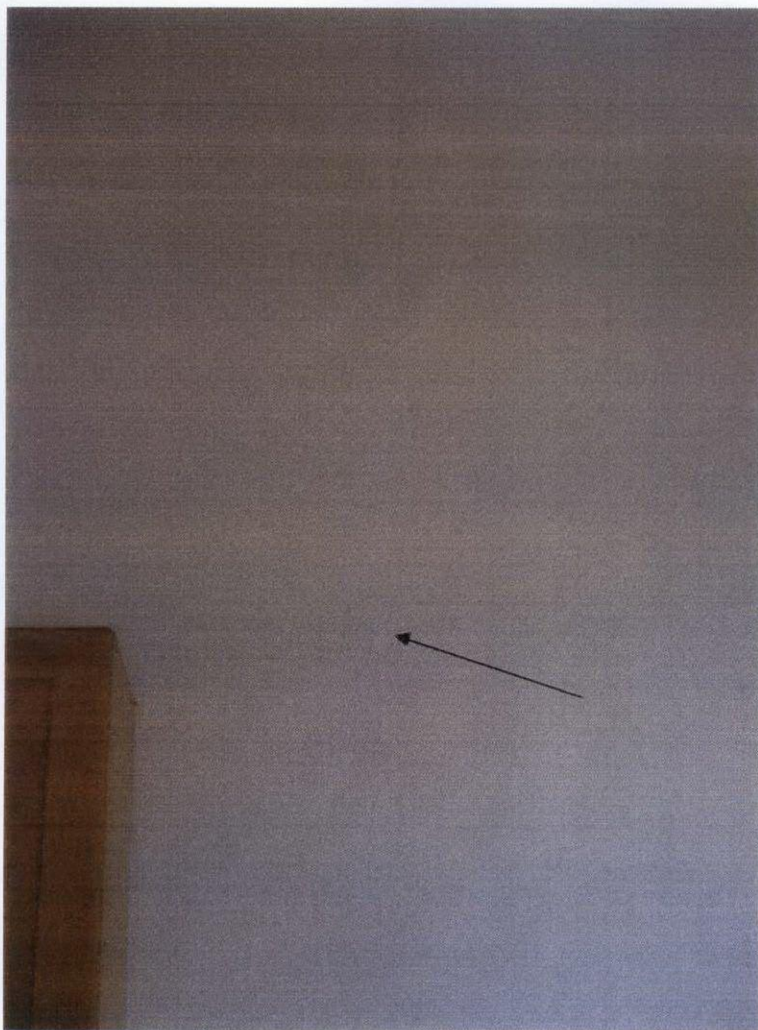
First Floor Flat - Lounge / Kitchenette - Hairline diagonal cracking to right hand party wall, wall / ceiling junction cracking along front wall, cracking to ceiling parallel to left hand party wall.

Cracking to right hand party wall in 1st floor flat lounge / kitchen

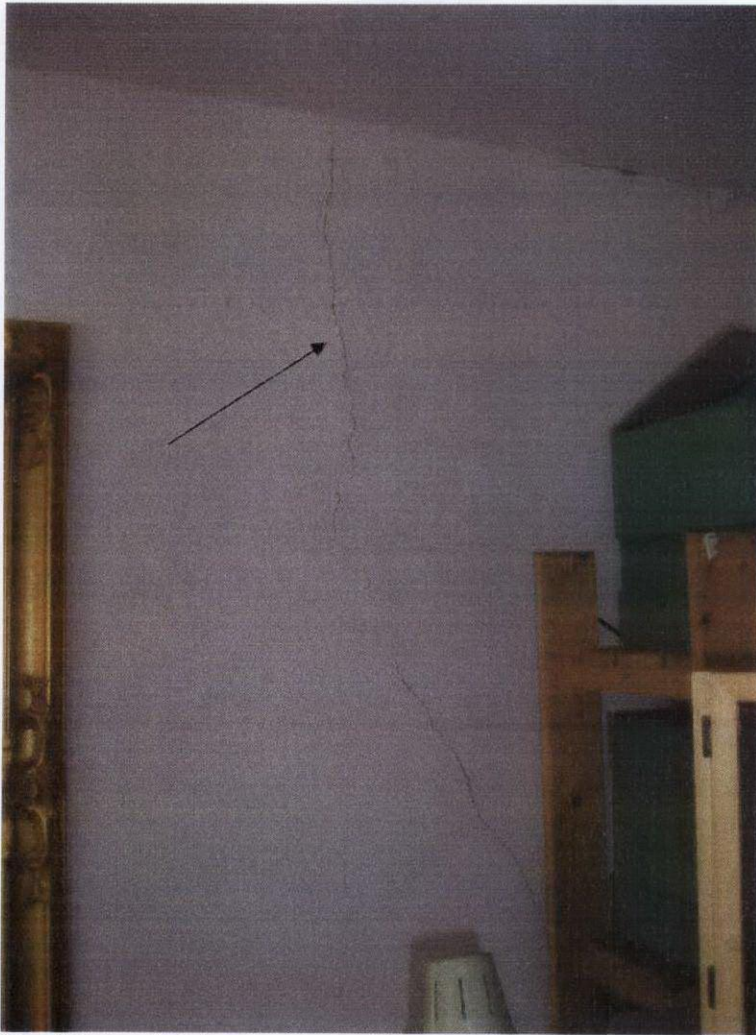
Second Floor Flat - Lounge / Kitchenette - 1mm diagonal crack to left hand party wall, wall / ceiling junction cracking to left hand party wall and front wall, 1mm vertical crack to right hand party wall, cracking to ceiling.

Cracking to left hand party wall in 2nd floor flat lounge / kitchen

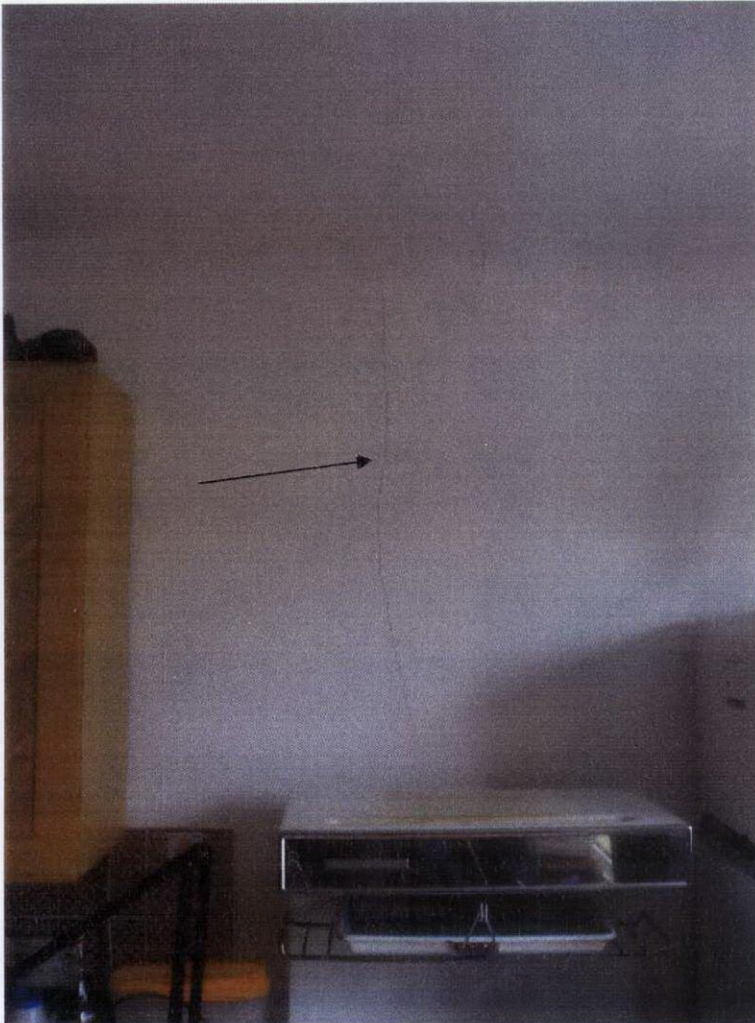
Cracking to right hand party wall in 2nd floor flat lounge / kitchen

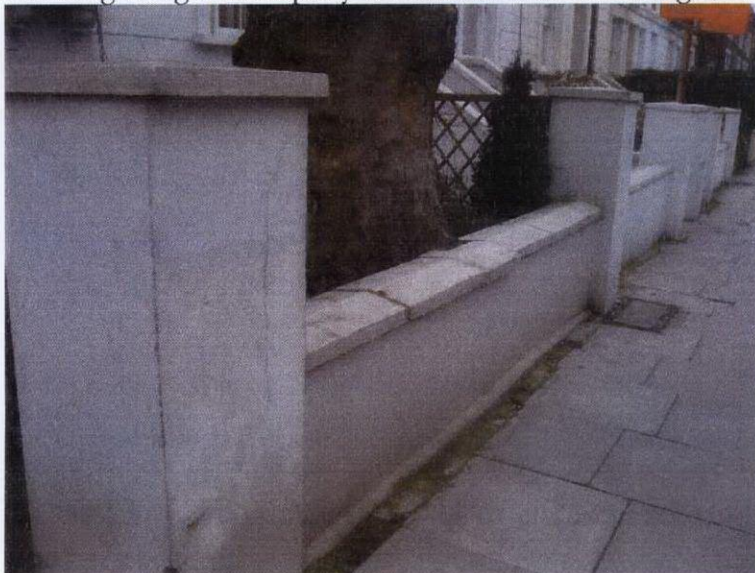
Boundary, Retaining Walls and Understeps Storage - The front boundary wall has been pushed outwards by the action of the tree growing against it, the lower brick retaining wall and the understeps storage area walls are bowing significantly towards the front bay due to the build up of lateral earth pressure and physical tree root presence behind it. These items of damage are not due to foundation movement.

The front boundary wall has been pushed outwards by the action of the Plane tree growing against it and the lower brick retaining wall is bowing significantly towards the front bay due to the build up of lateral earth pressure and physical tree root presence behind it. Similar bowing was also noted to the flank walls within the understeps storage area. Dampness was also noted within the music room in the ground floor flat. These items of damage are not due to foundation movement and therefore the cost of their repair will fall outside the scope of this claim

View of tree growing against and pushing front boundary wall

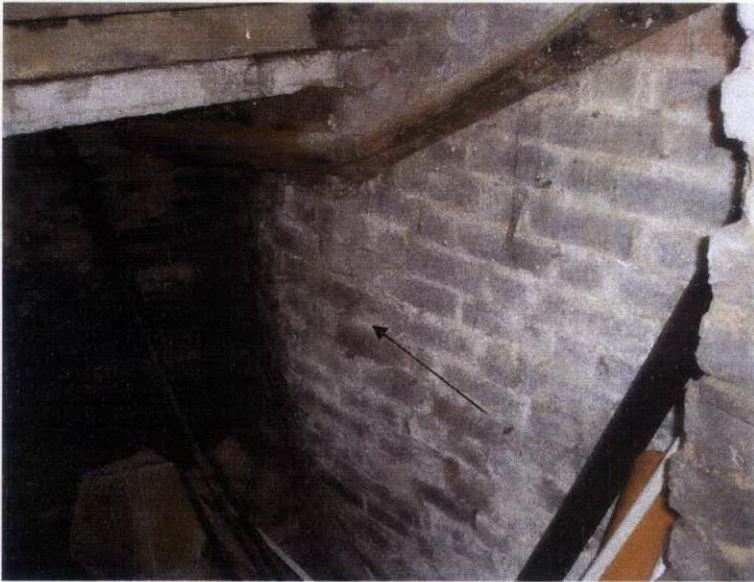
View of bulging wall in understeps storage area

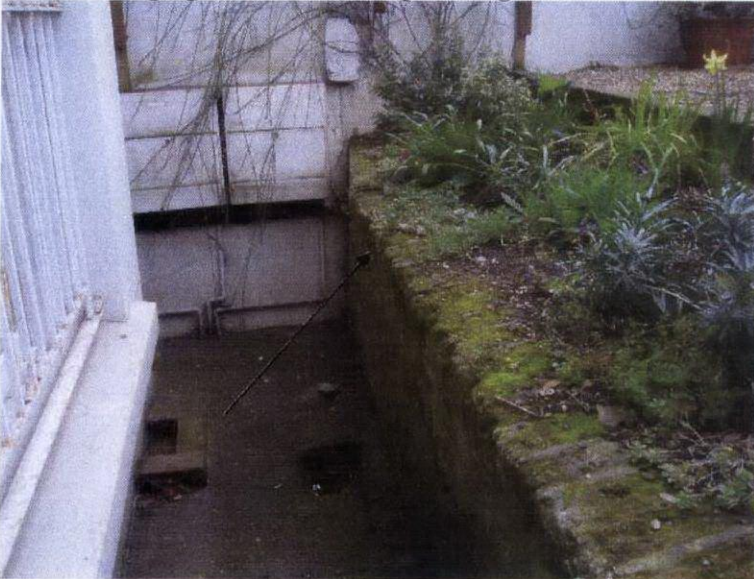
View of movement to front retaining wall
