# ADDENDUM TECHNICAL REPORT ON A SUBSIDENCE CLAIM

**105 Bartholomew Road  
London  
NW5 2AR**

**Claim Reference 11T601238**

**DATE 10 October 2012**

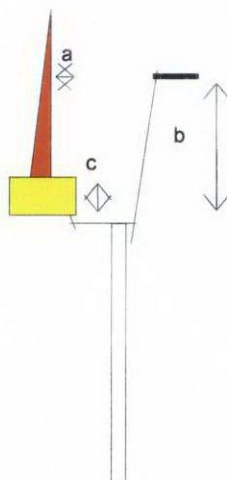
Foundation Details

A trial hole was excavated to expose the foundations - see site plan for location and the diagram below for details. Trial Hole 1 revealed a brick and clinker footing founded at a depth of 0.48m below ground level which bears onto firm brown CLAY.

Root activity of live appearance was noted to the underside of the foundations.

No.	Borehole Depth	Footing (a)	Underside (b)	Thickness (c)
TH1	3.00 m.	100 mm.	480 mm.	260 mm.
