## LABORATORY REPORT

**Address:** 105 Bartholomew Road,  
London,  
NW5 2AR

# Arboricultural Consultancy for Aviva

## LEVEL MONITORING - RELATIVE SURVEY READINGS

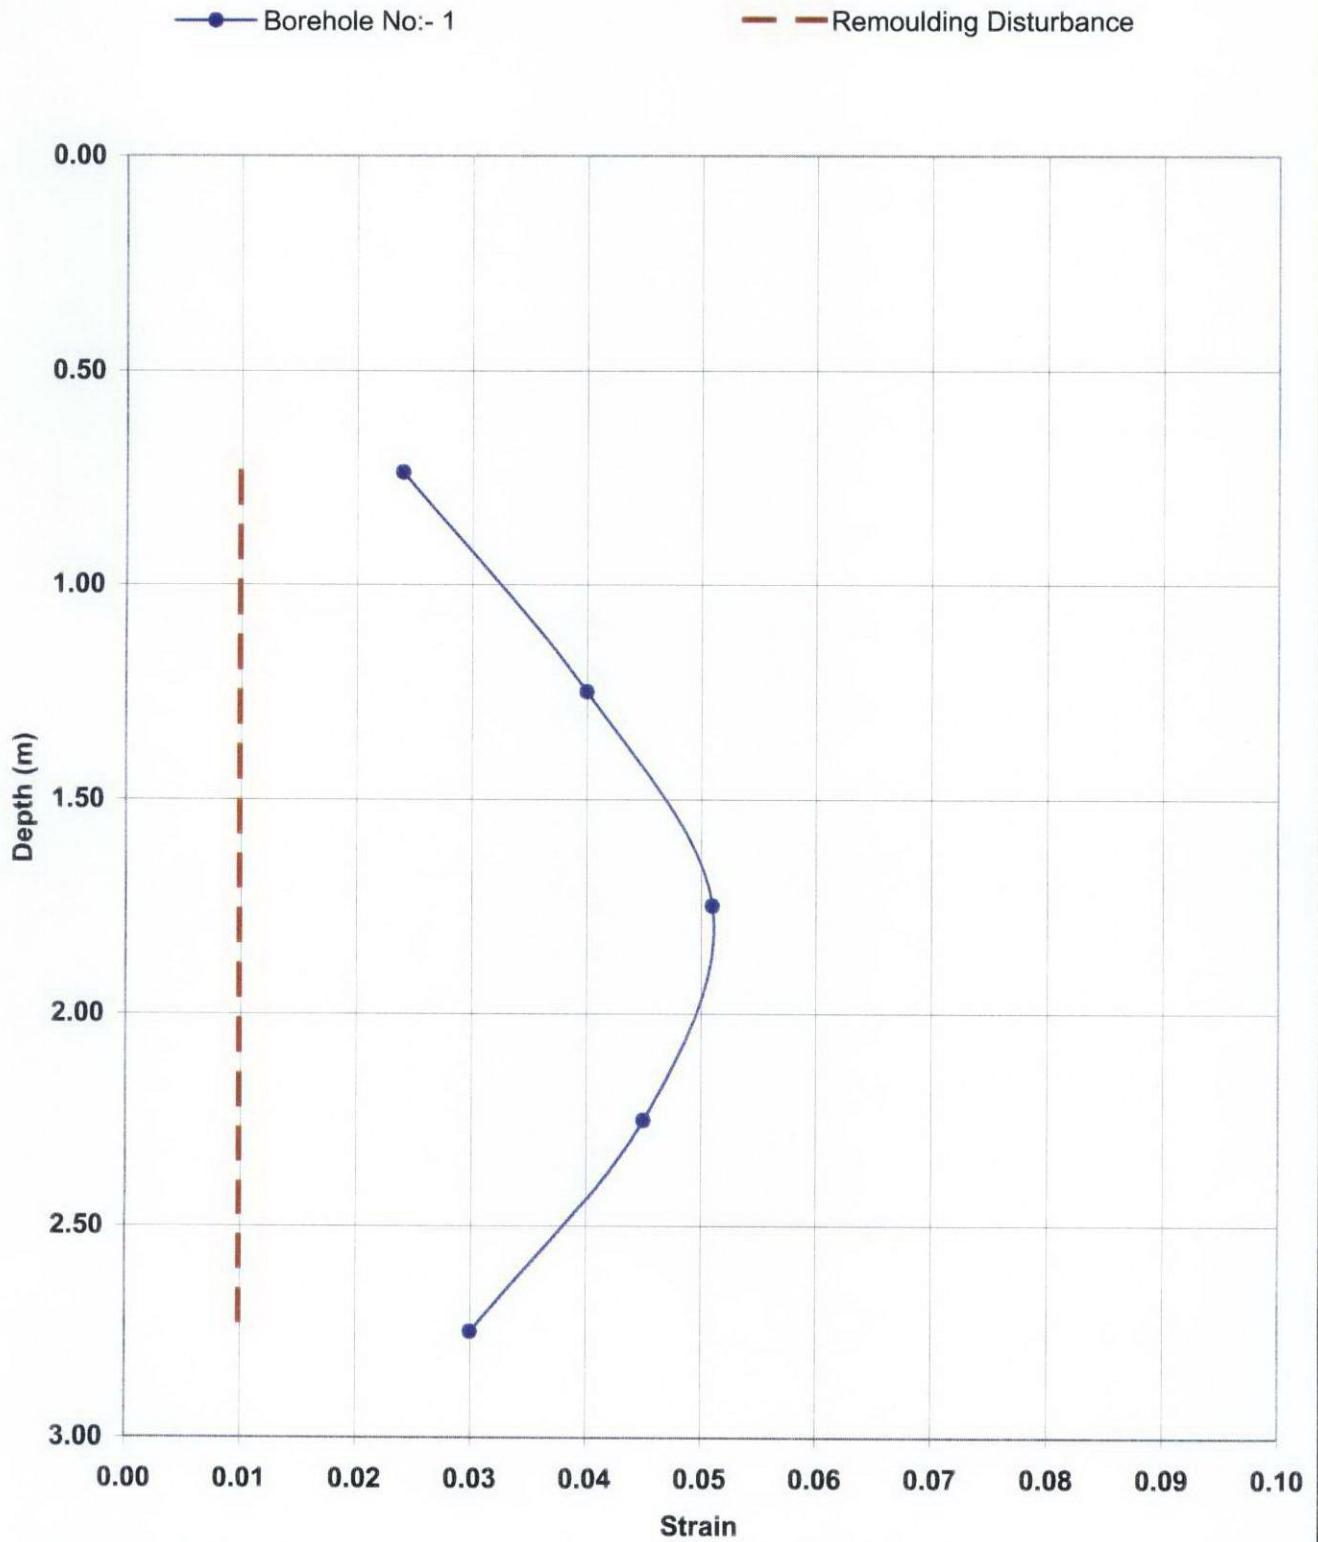
Oedometer Strains

An approximated value of 0.010 strain is deducted from the measured oedometer strain to account for remoulding of the sample. Therefore strain in excess of Remoulding Disturbance Line (see Results Chart) is extrapolated for calculation of Predicted Heave per incremental layer displayed in the following table(s), in column labelled "Dd mm". A Shrinkage factor (Sf) of 2 is also applied to each heave value. Heave values per layer are summed as a total for each Borehole (in mm), and then displayed as a range in (in cm).

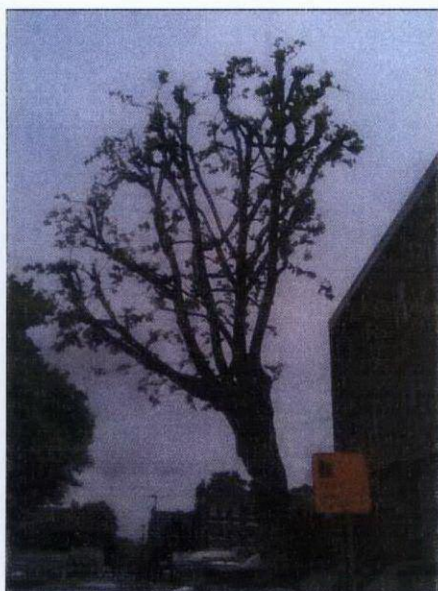
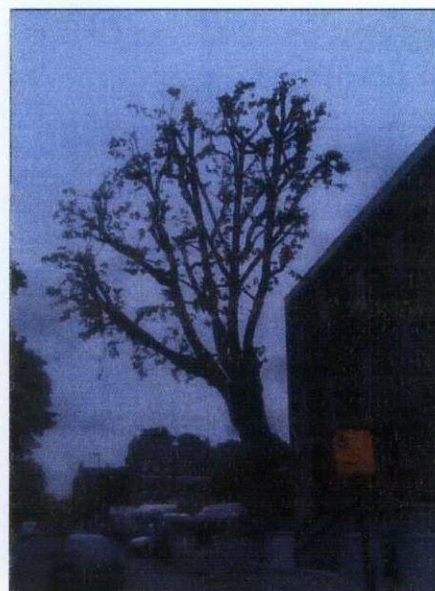
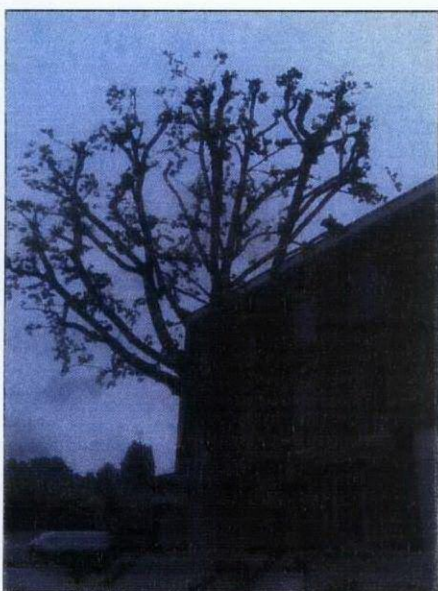
Based on our site investigations, and taking account of vegetation location, relative to the focal area of movement / damage, it is our opinion that T1 (Plane (London)) will be exerting a significant vegetative influence.

Although T1 (Plane (London)) has been reduced, known practice and established research (Hortlink 212) suggest that pruning is a largely ineffective means of controlling water uptake; for this reason removal is recommended.

T1 - Plane (London)

Tree No.	Species	Age Cat	Approx. Height (m)	Distance to Building (m)	Ownership	Action	Requirement
T1	Plane (London)	1	18	3	C - Insured	Remove	Remove and treat stump to inhibit regrowth.
Age Cat: 1 = Younger than property; 2 = Similar age to the property; 3 = Significantly older than property

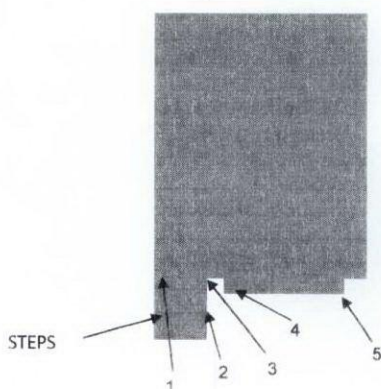
The rear of the building was not measured. The plan is just for illustrative purposes only.

- 04/10/2012  
The Occupier was not unduly worried
- Stations haveNOT been installed within the same brick course. There fore initial readings care Relative
- Readings have been made relative to rim of cover to front . It has an assumed value of 10.0000m. If this is not appropriate, please advise if a deep datum is required?
- No further visits planned.

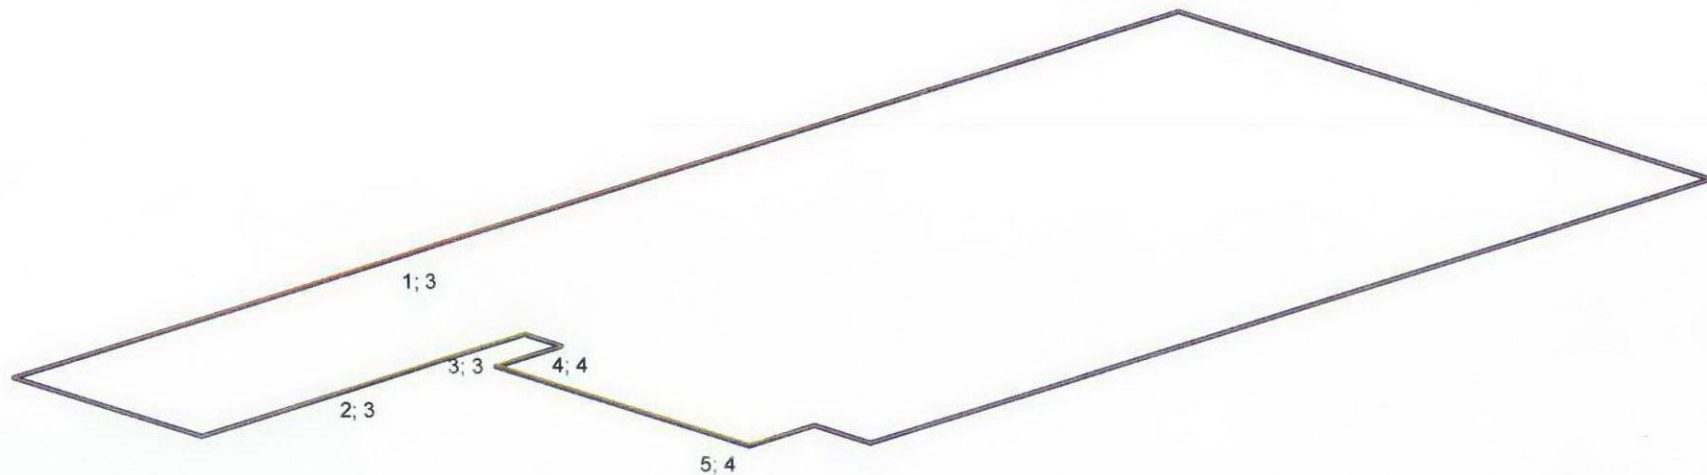
# LEVEL MONITORING - RELATIVE MOVEMENT SKETCH

Point labels give level difference of last reading from original datum in mm.
