**69 CHARLOTTE STREET
LONDON W1T 4RW**

Condition Survey Report

May 2012

JF/21277A

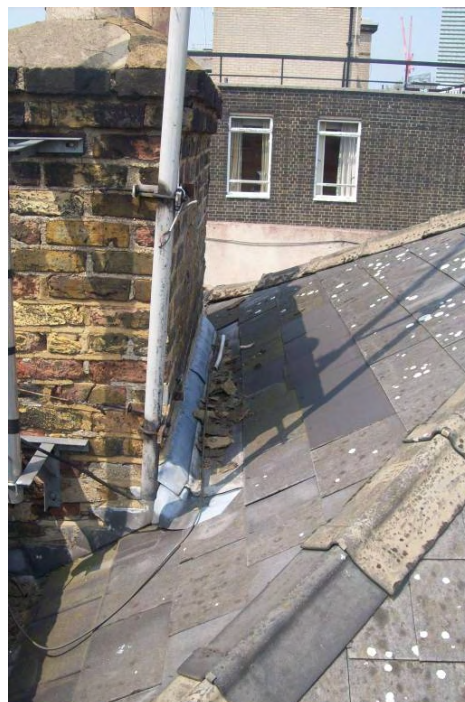
- 3.1.2 Both hipped slopes are pitched at approximately 30° and clad with artificial cement based slates with ridges and hips in a similar material; presumably a replacement for the original natural slate covering. The slates are laid on timber boards supported by a simple cut and pitch softwood roof structure. 2

*Photo 2 – Section of roof on west side
(3.1.2)*

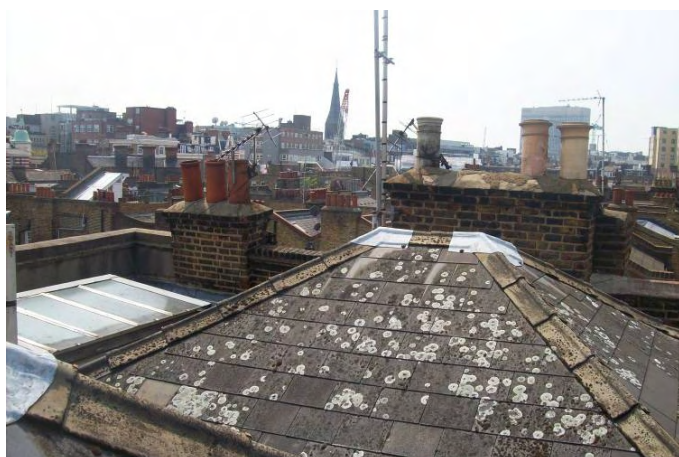
- 3.1.3 The replacements themselves are of some age, and although generally sound are beginning to show signs of surface lamination and loose fixings. Some sections of the roof on the north side are moss grown. 3

*Photo 3 – Pitched roofs showing replacement artificial
Slates and repairs (3.1.3)*

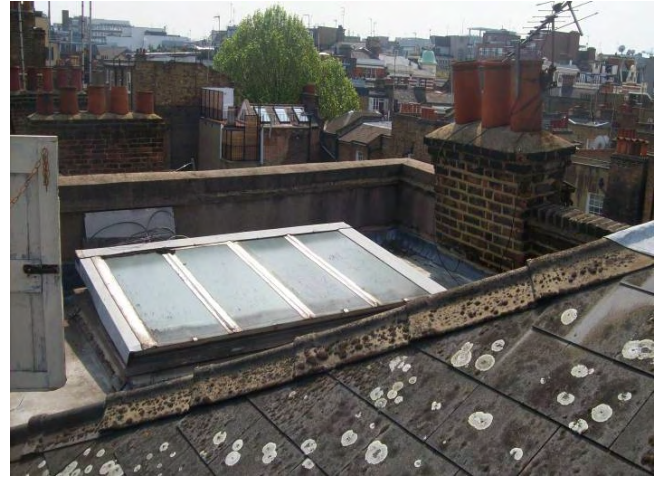
Repairs have been carried out, however the laylight remains in a very poor condition, with water penetration continuing to the upper communal landing and bathroom of the flat below (see later item 3.9.8).

Photo 6 – Defective laylight (3.1.10)

The laylight requires total renewal; the replacement structure will need to be upgraded to provide both double glazing and ventilation.

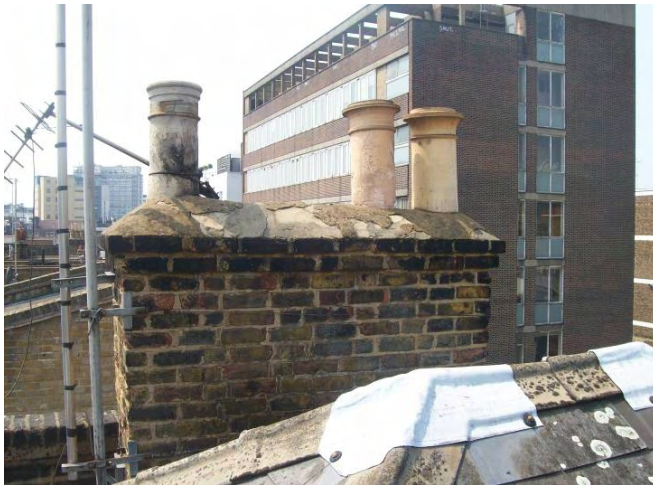
- 3.1.13 The largest brick stack on the west elevation is constructed on the party wall and contains four flues. One of the four original clay pots is missing; the remaining three are in fair condition. A TV aerial is fixed to this stack. The stack shows no sign of structural movement and remains vertically aligned. 7

The brick joints have been pointed with cementitious mortar which is cracking and missing in places. The face of the stack facing outwards could not be inspected; however, it should be assumed that all faces of the stack need repointing. Repointing the outward face will present problems gaining access.

Photo 7 – Brick stack on west elevation (3.1.13)

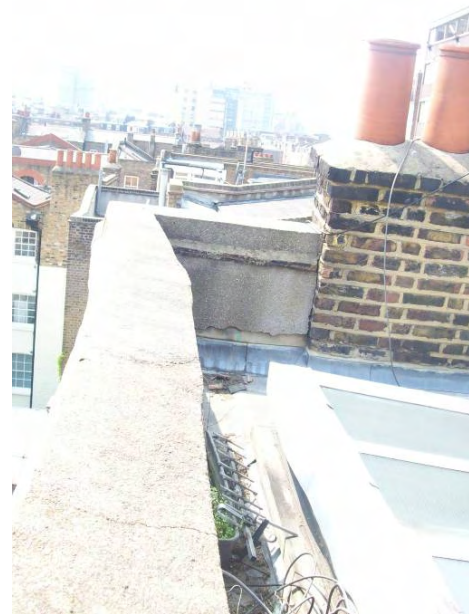
Photo 8 – Leaning brick stack and deflecting parapet on south west corner (3.1.14)

Further structural advice will be needed to establish the cause of the movement; however the upper will need to be taken down and capped or rebuilt. The complication is that the stacks serve the adjacent property, and a Party Wall Agreement is likely to be required, whatever course of action is agreed upon.

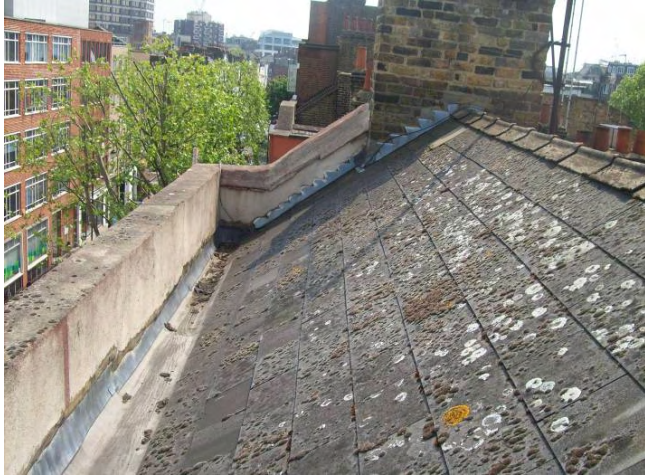
structure is in reasonable condition, but is open jointed on the south and west facing sides. These faces require repointing, and the lead flashings at the abutment with the roof refixing.

Photo 9 – Stack on south gable (3.1.15)

There are four clay pots; the western pot is badly cracked and should be replaced.

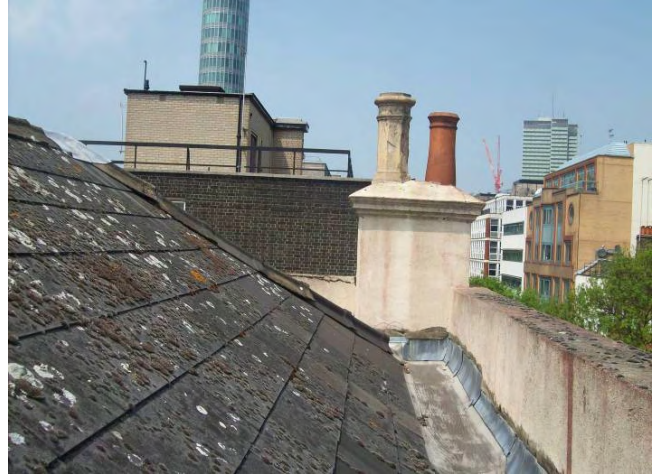
- 3.1.16 The fourth and final stack is located on the parapet wall in the north east corner. The stack was built to serve two flues and has been rendered to match the adjacent external walls. The rendering is in good condition, and the two clay pots are intact. **10**

Photo 10 – Corner stack (3.1.16)

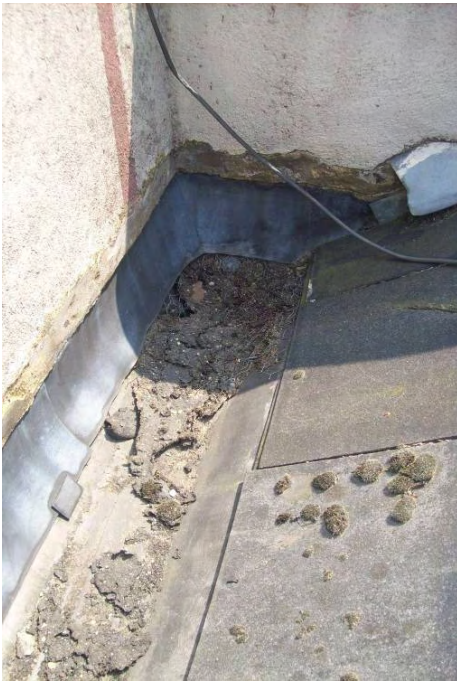
- 3.2.2 The roof outlets are small and prone to blocking; leading to a build up of water and the risk of local damp penetration to the parapet and upper walling. The asphalt and lead sleeves leading to the rainwater heads are also cracked in places. **11**

Photo 11 – Roof outlets prone to blocking (3.2.2)

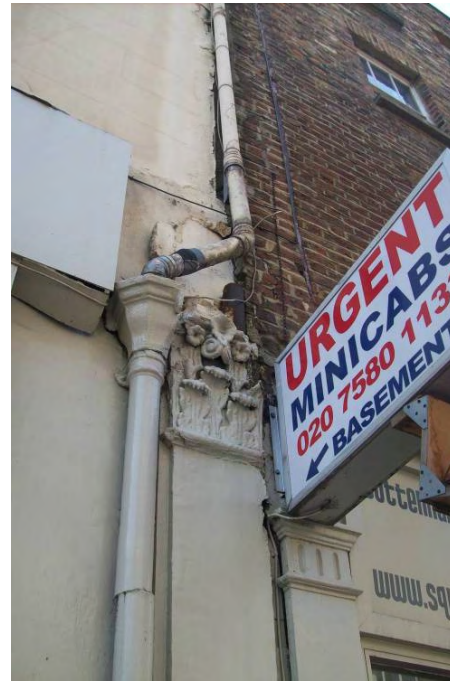
- 3.2.4 The north west downpipe (Tottenham Street) has a uPVC rainwater head and upper section, which appears to have a leaking joint and/or a blockage at second floor level, where the **12**

There is a further leak at the awkward junction between the lower section of cast iron pipe at fascia level, which is affecting the rendered surface.

Photo 12 – Defective rainwater goods at Tottenham Street elevation (3.2.4)

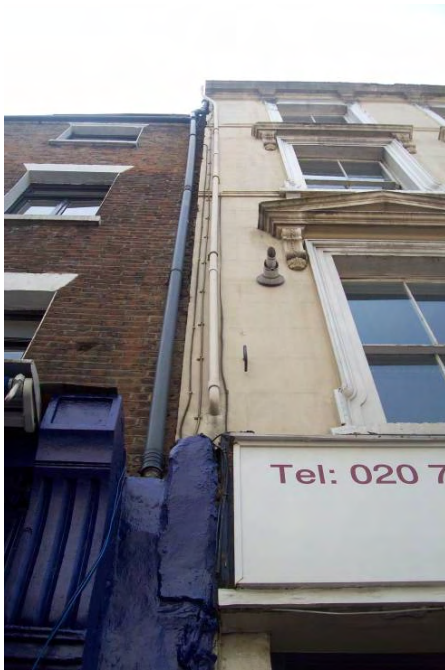
| 3.2.5 | The second outlet is on the southern side of the roof fronting Charlotte Street. The pipe appears to run internally until first floor level. The downpipe is not performing adequately, as there are signs of damp penetration below the outlet in the third floor flat (see later item 3.12.9). Internal downpipes are inherently unsatisfactory and it is recommended that an external downpipe is introduced. | 13 |

Photo 13 – Rainwater outlet on south side of Charlotte Street elevation (3.2.5)

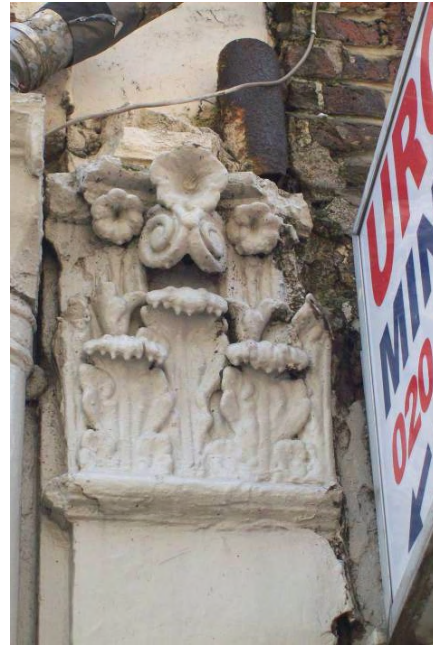
- The general condition of the render at this level is reasonable; although there is damage to the capital on the right hand pilaster which needs to be repaired.

Photo 14 – Damaged detail of capital on Tottenham Street elevation (3.3.4)

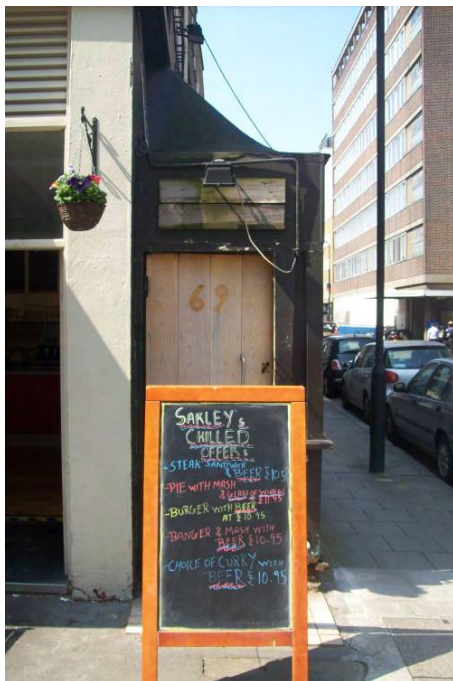
- 3.3.5 The poorly built and detailed access structure has a felted monopitch roof over a glazed timber screen built on a low brick plinth. **15**
- The structure is in a very poor condition and will need to be rebuilt, if the present access arrangement to the basement is to be retained.

Photo 15 – Poorly built access structure to basement (3.3.5)

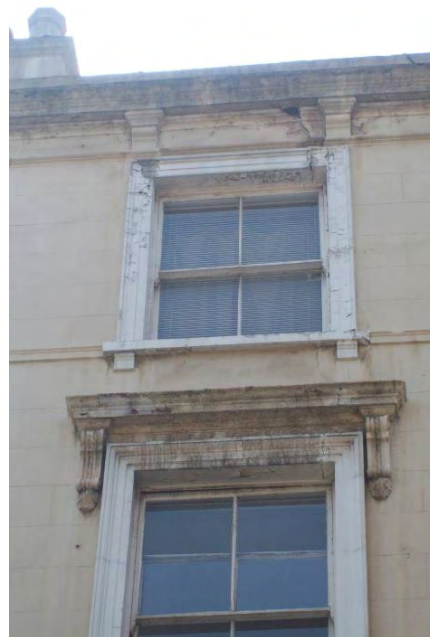
- 3.3.8 The rendered surface at the higher levels has areas of minor surface cracking, and decorations are generally poor, although significant structural cracking is limited to two vertical fractures on the Tottenham Street elevation.

- The first fracture runs from the parapet on the north east corner through the third floor window, terminating at the head of the second floor window below. The movement is not apparent internally (see later items 3.11.6 and 3.12.6); however, a repair using stainless pins and grouting will be required. **16**

Photo 16 – Vertical fracture on upper floors on east side of Tottenham Street (3.3.8)

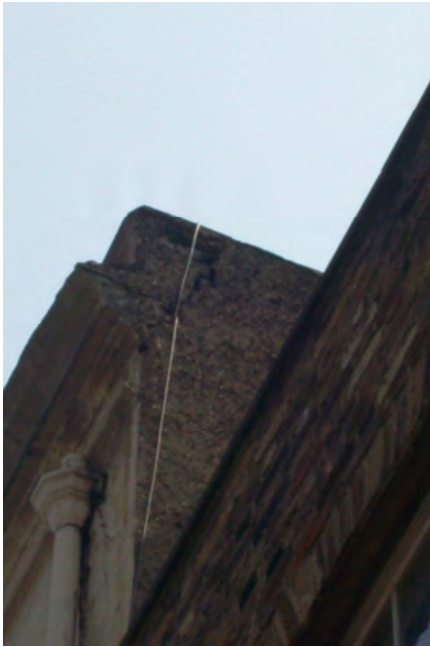
- At the west end of the elevation on the return at parapet level, there is a diagonal fracture running to just below the parapet. A similar type of repair to restrain the corner will be required. **17**

Photo 17 – Fracture in corner of parapet on Tottenham Street elevation (3.3.8)

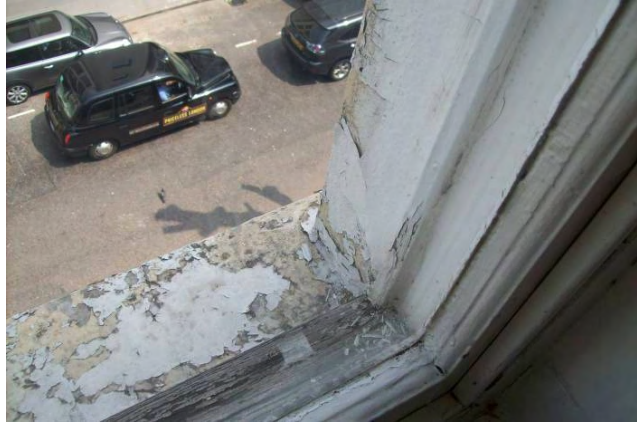
3.3.10 The stucco details appear to be basically sound when viewed from windows and ground level, although the decorations are flaking in many places. Removal of flaking paint and careful repair where required should bring the features back to a good condition. **18**

Photo 18 – Exfoliation of stucco to upper cills (3.3.10)

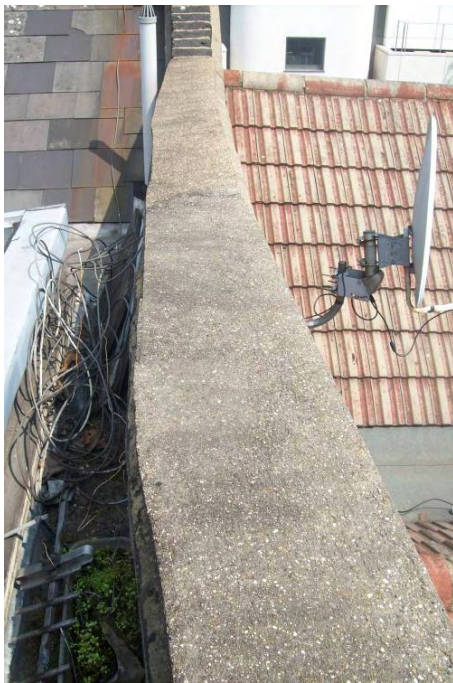
Photo 19 – Deflection to south parapet (3.3.12)

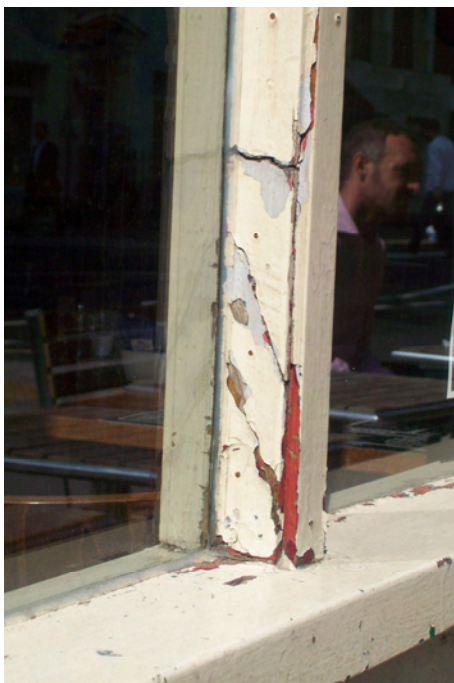
3.4.8 The joinery and glass are in fair condition; although there is evidence of piece in timber repairs to the base of the mullions. The general design of the shop front is rather uninspiring, and it is not in keeping with the principal elevation facing Charlotte Street.

Photo 21 – Piece in repairs to shop front joinery (3.4.8)

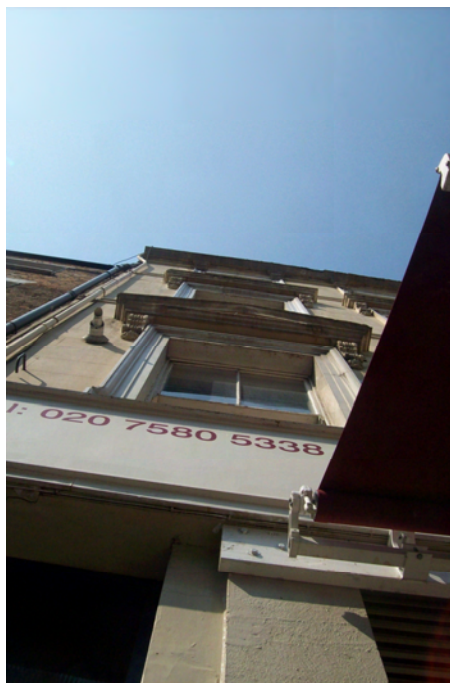
3.4.9 There are ply fascias on both elevations above the ground floor openings. The fascias are in very poor condition, especially on the Tottenham Street elevation.

Photo 22 – Ply fascia to Charlotte Street (3.4.9)

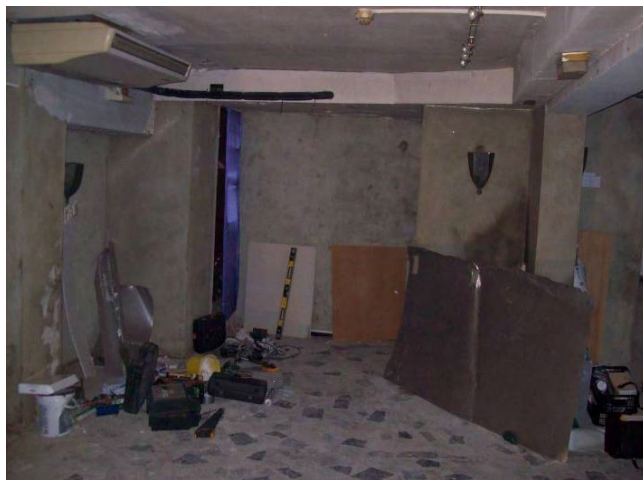
3.7.2 The floor finishes generally are a mixture of granolithic screed with some clay and vinyl tiles, and are generally in poor condition.

Photo 24 – General view of basement (3.7.2)

The floor finishes will require replacement. The introduction of an effective damp proof course and insulation will require the breaking up and relaying of the present screed, and the installation

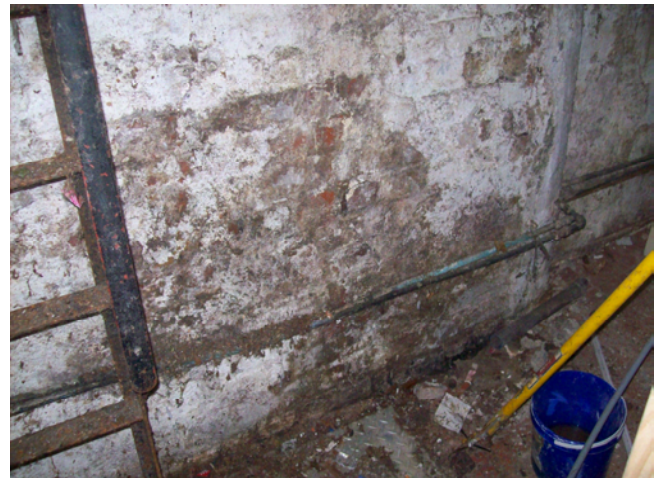
Photo 28 – Damp to external basement wall on east side (3.7.8)

3.7.9 The prevalence of damp in the basement walls will require some form of tanking system coupled with dry lining, and it is recommended that a specialist company be engaged to report on the present situation and propose what remedial measures are required.

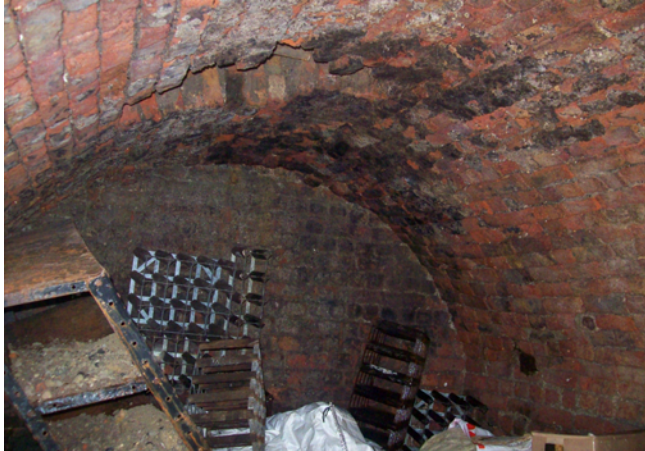
3.7.11 The second, western, vault is in its original, unimproved condition. The brickwork is loose jointed and damp.

Photo 29 – Brick vault (3.7.11)

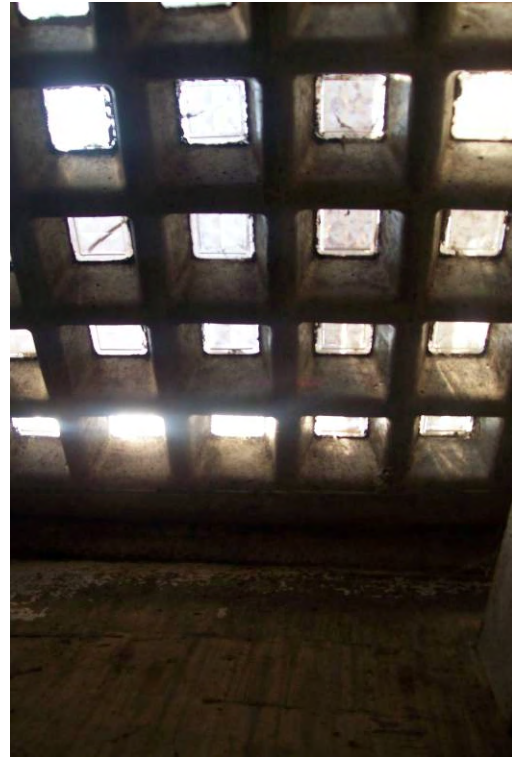
The concrete is breaking up in many places, threatening the structural integrity of the whole arrangement, and total replacement will be required.

Photo 30 – Area light from below (3.7.14)

Although when viewed externally, only minor repair and repointing seems to be required, the concrete frame is heavily eroded when inspected from the basement (see later item 3.7.14). The area lights will need complete replacement.

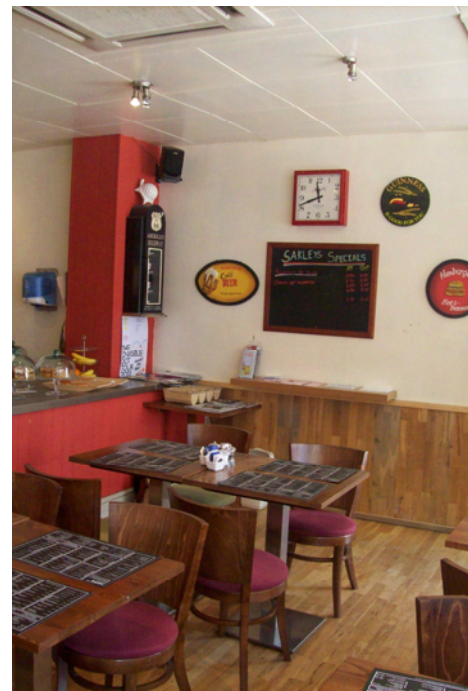
| 3.8.2 | The floor finish is timber boarding overlaying the original floor; thus raising the floor level by one step. The boarding has been laid recently, and is in good condition. | 32 |

Photo 32 – View of café (3.8.2)

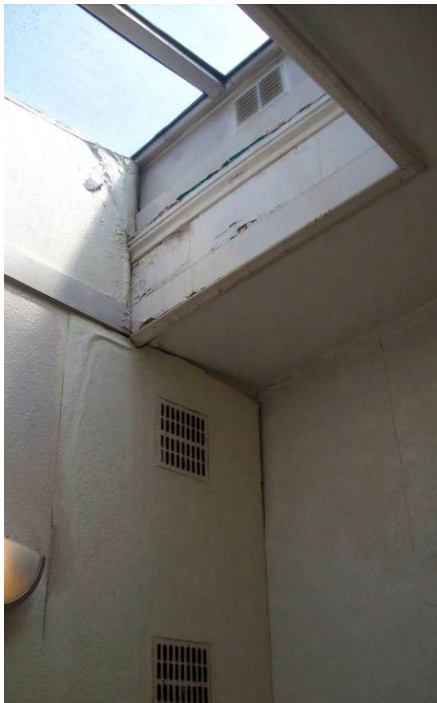
- 3.9.8 A large glazed rectangular laylight occupies much of the ceiling area. The georgian wired glass is single glazed, and the laylight leaks badly. It requires replacement with a new double glazed and properly ventilated unit.

Photo 35 – Defective laylight (3.9.8)

When the laylight is replaced, it would be sensible to install two separate rooflights to independently serve both the landing and the bathroom.

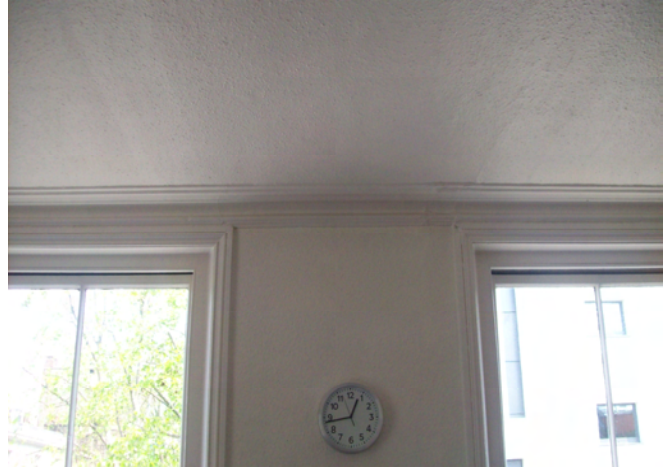
This suggests limited failure of the lintols over the window openings on this wall (see previous item 3.4.7).

***Photo 38 – Movement at wall/ceiling junction on
second floor (east wall) (3.11.7)***
