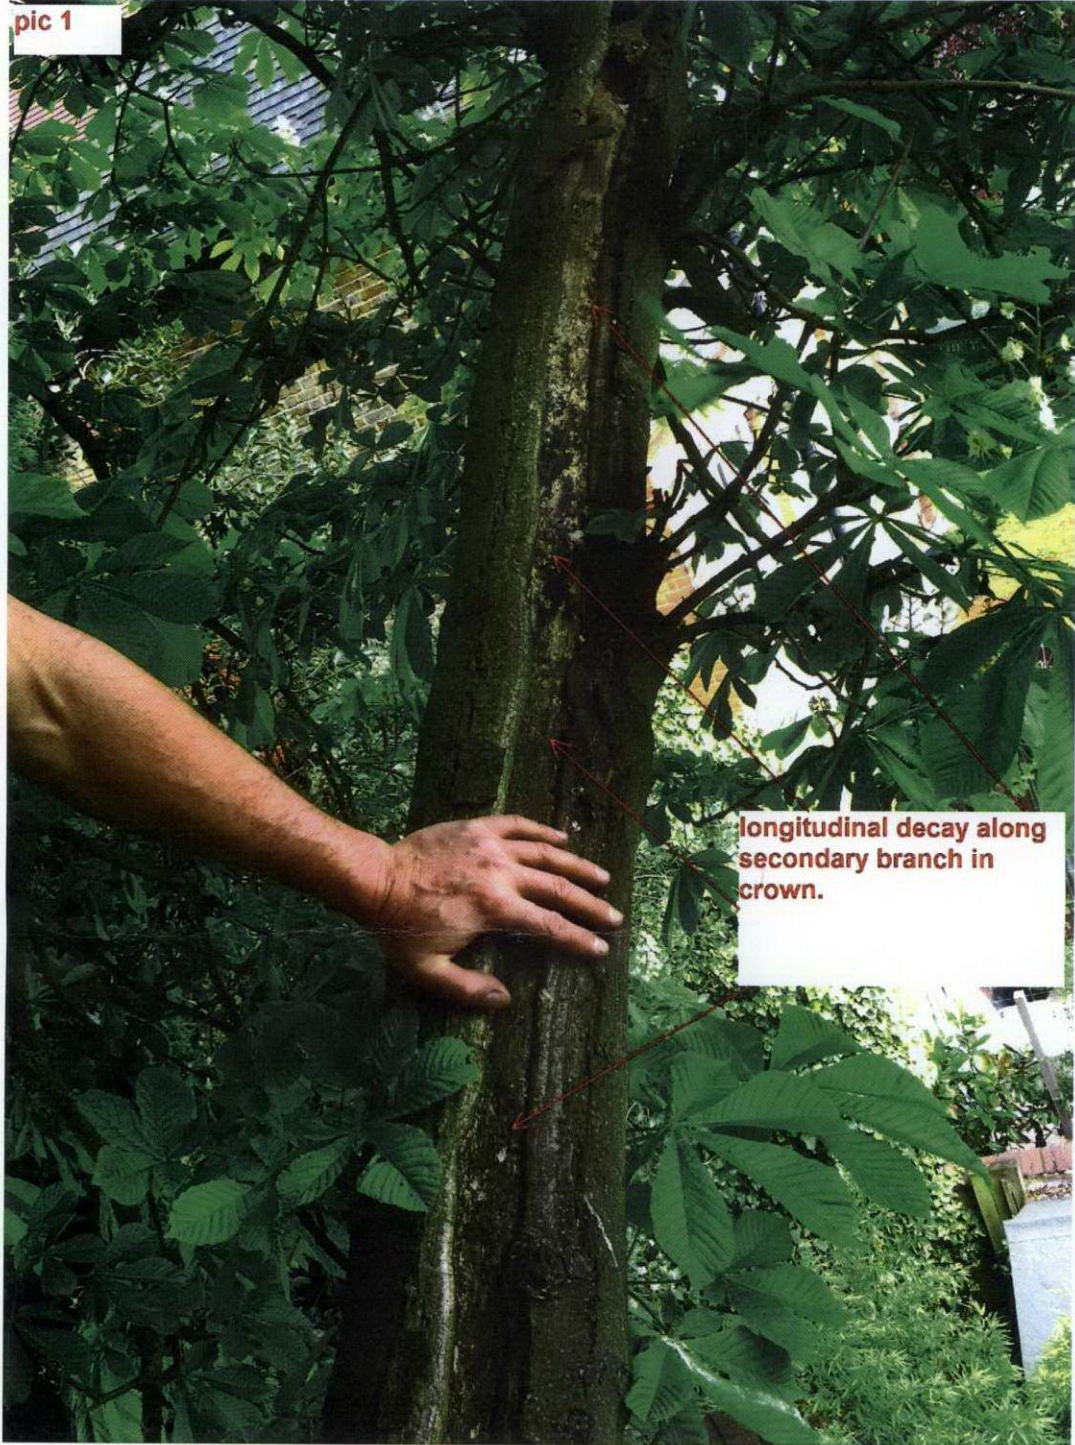
pic 1

longitudinal decay along
secondary branch in
crown.

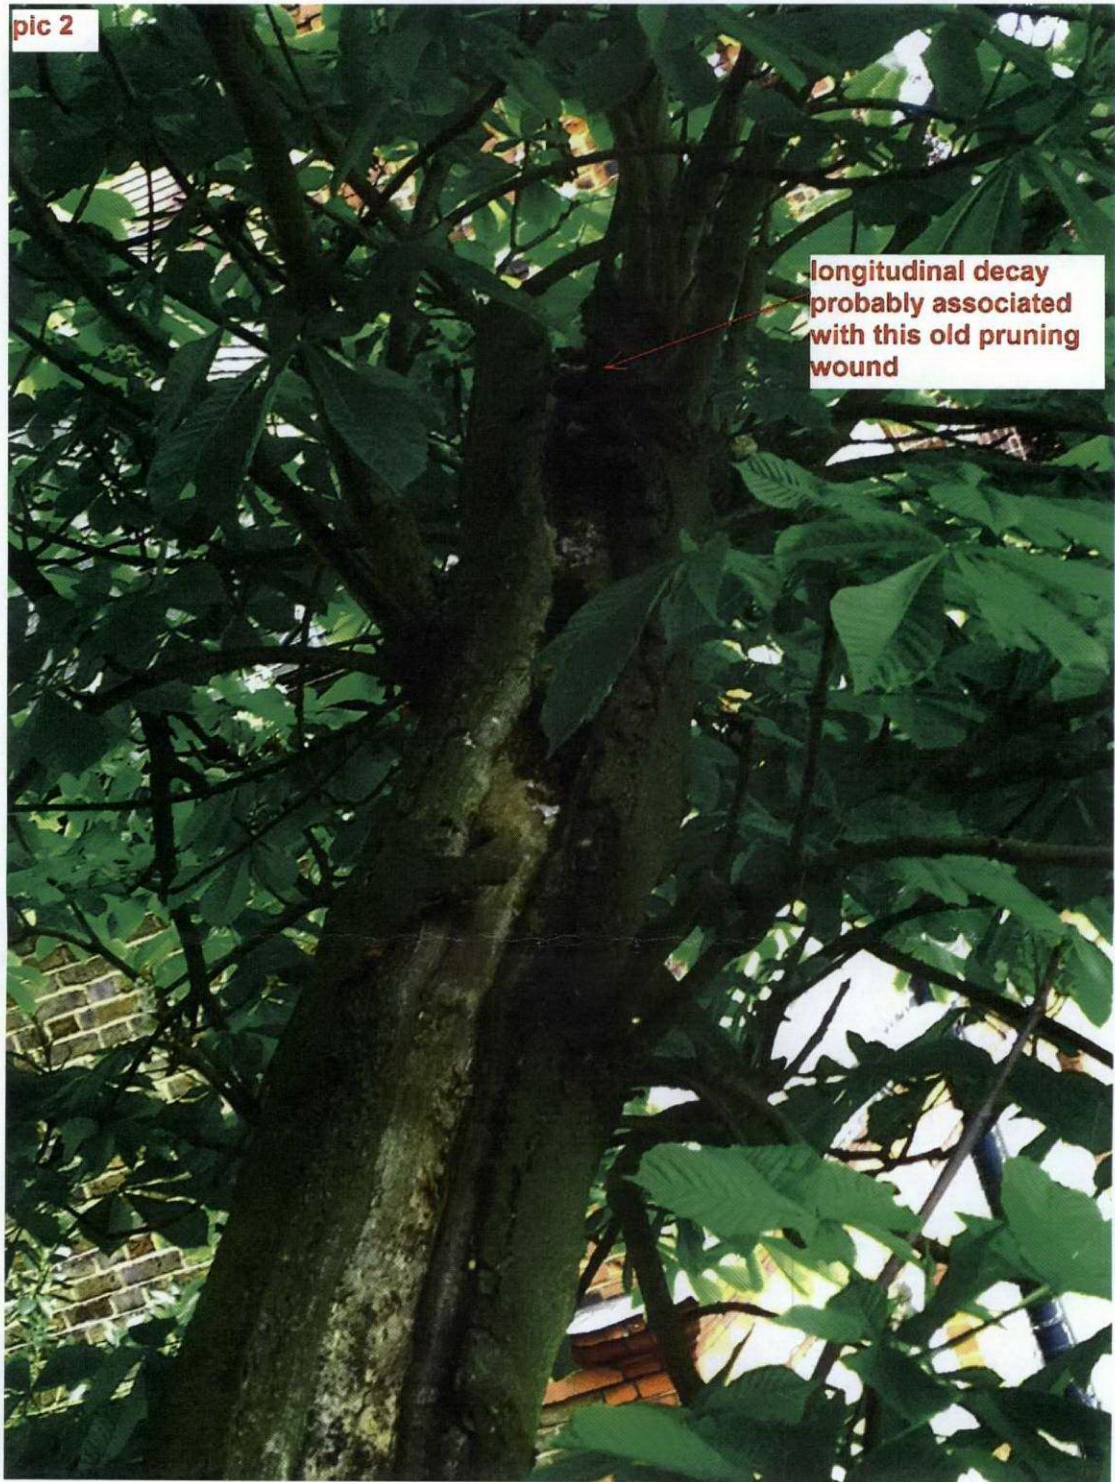
pic 2

longitudinal decay
probably associated
with this old pruning
wound

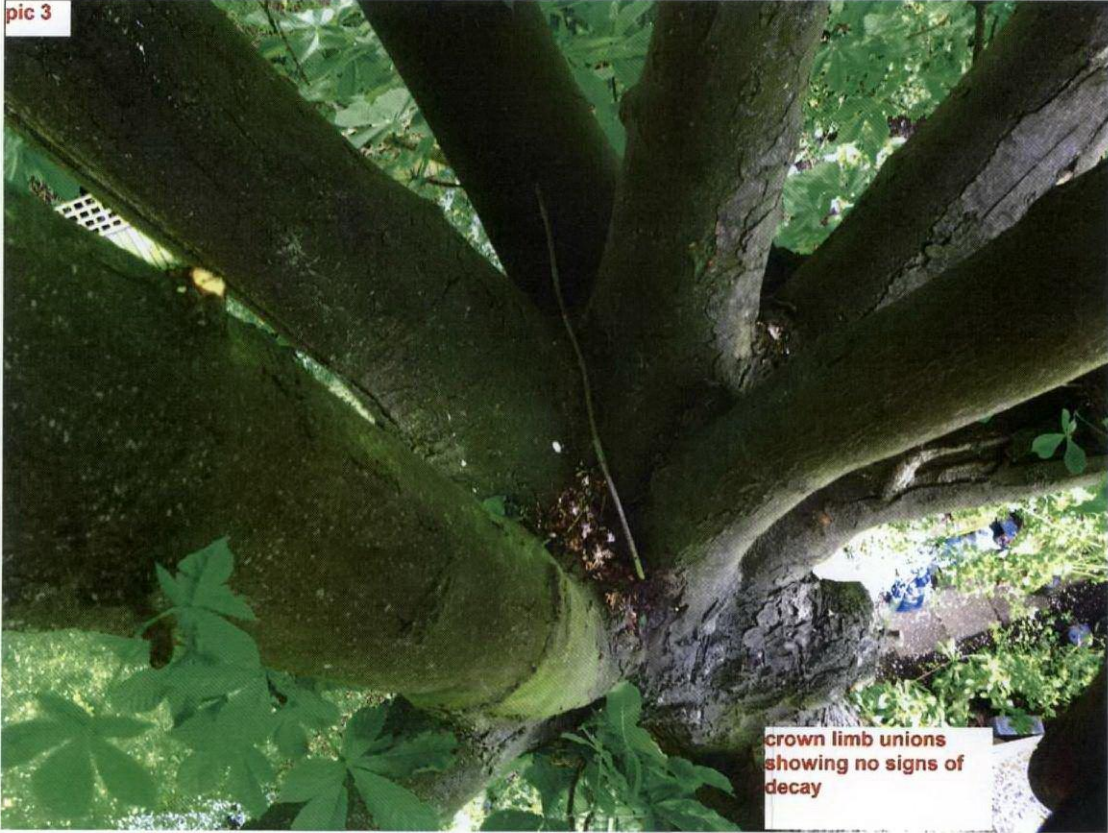
pic 3

crown limb unions
showing no signs of
decay

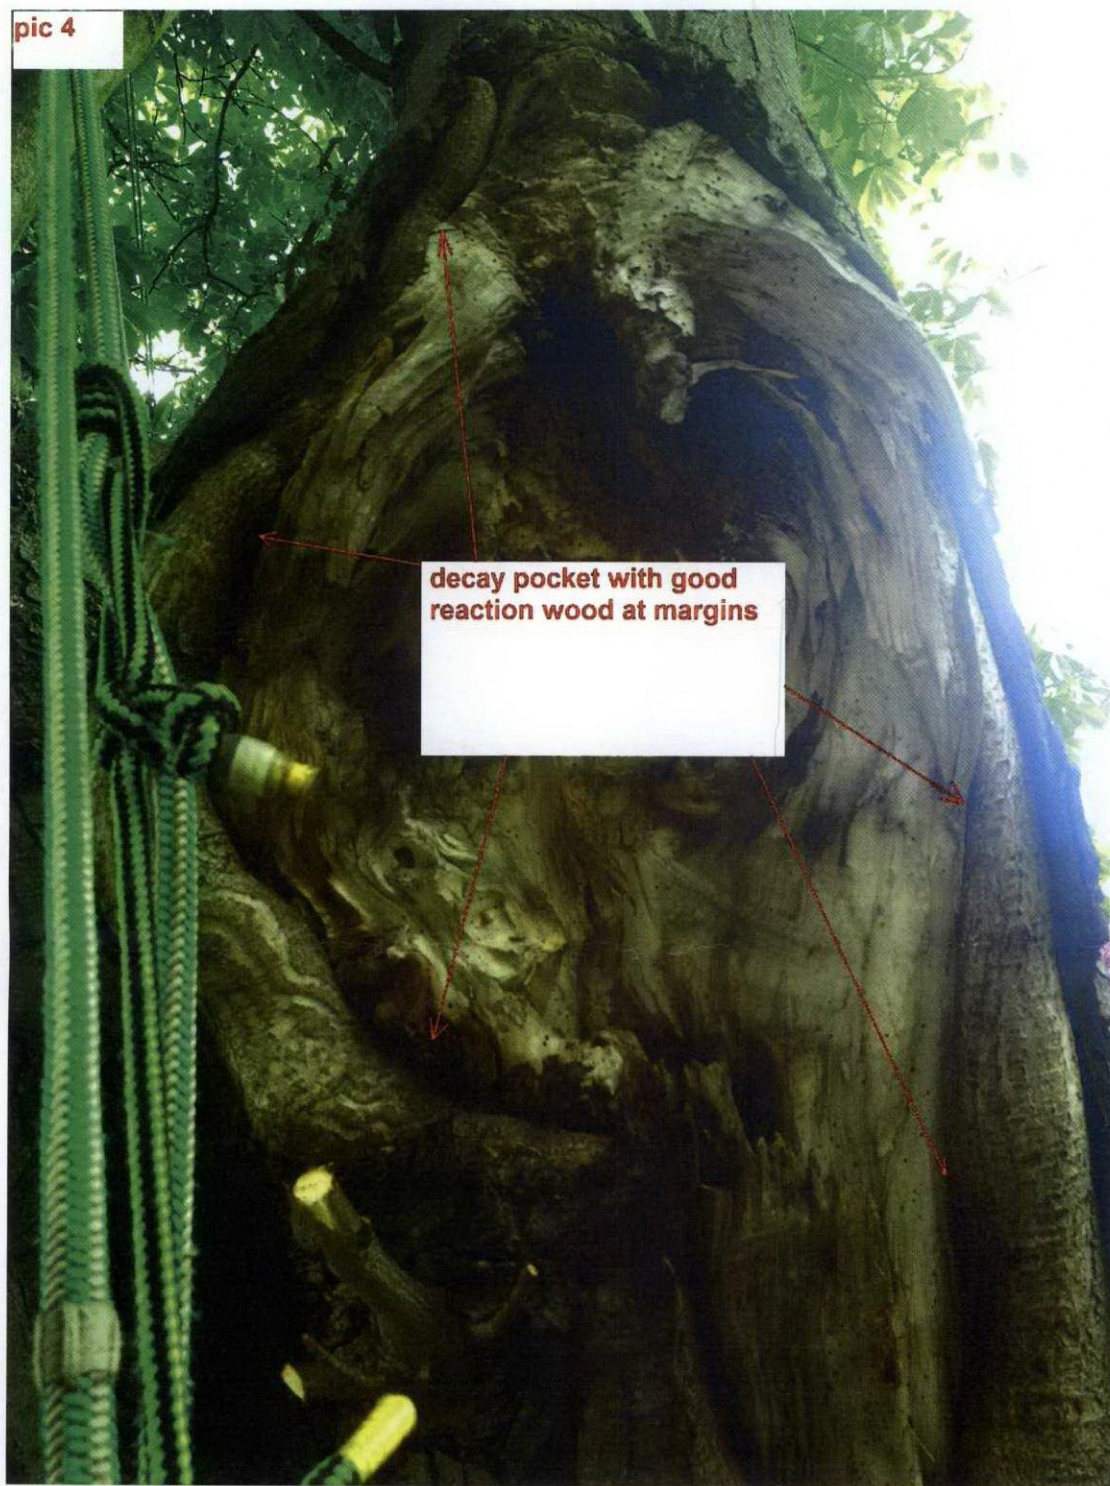
pic 4

decay pocket with good
reaction wood at margins

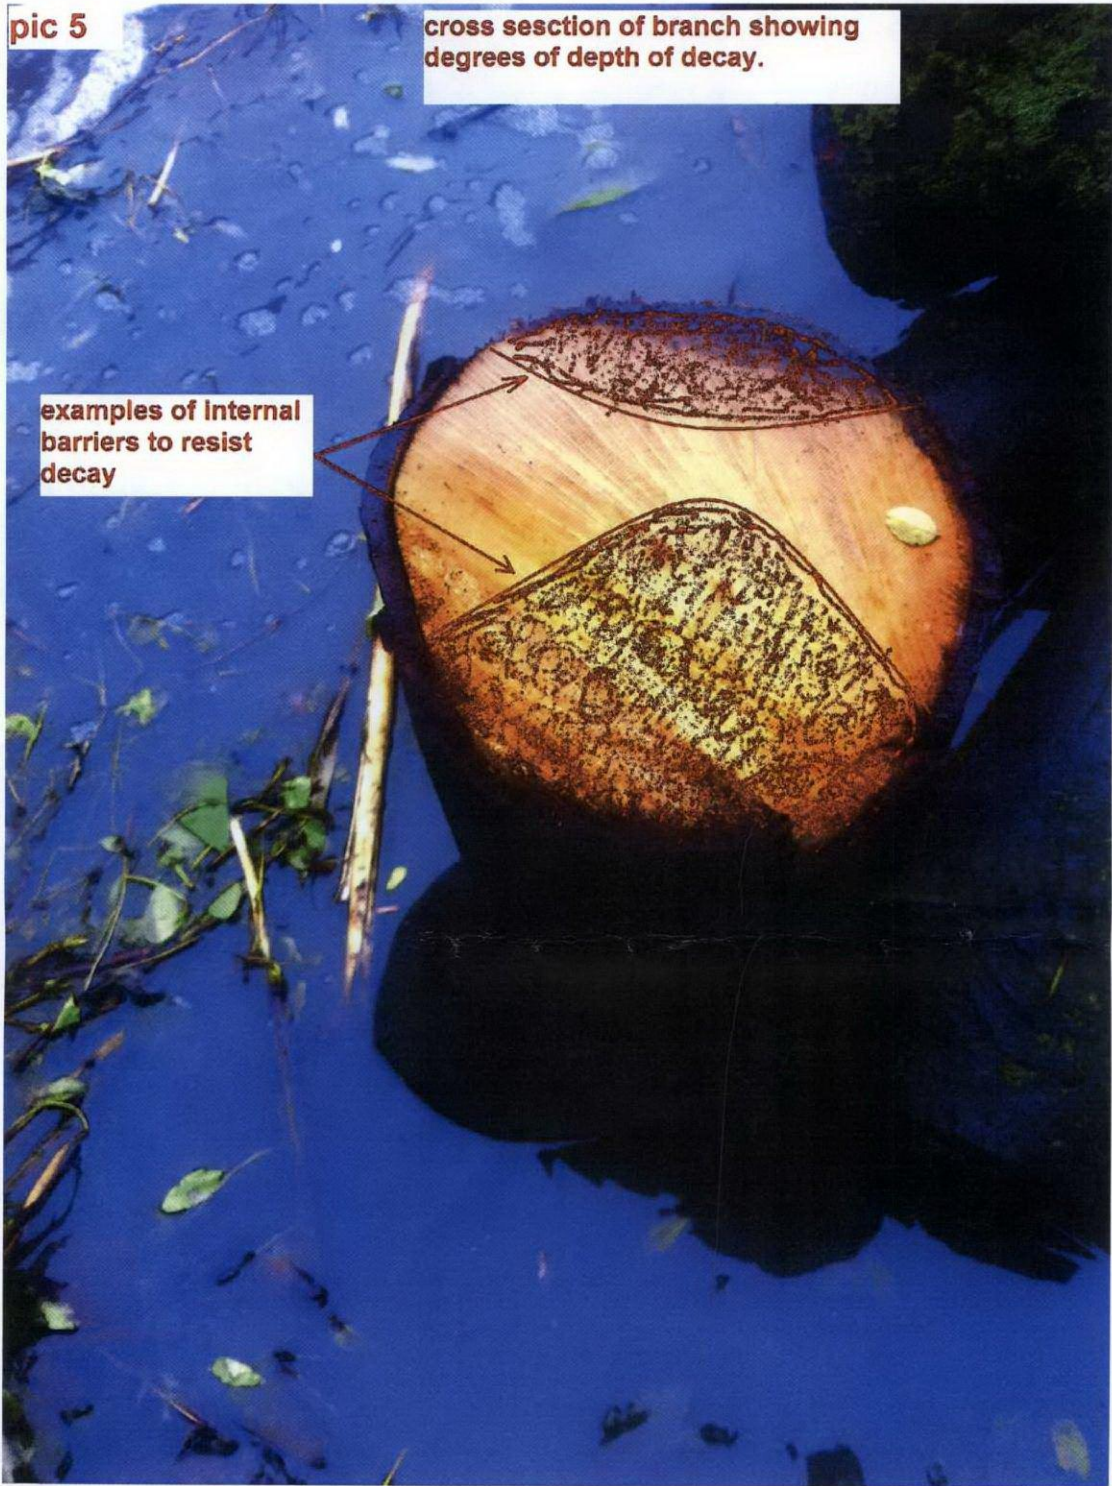
pic 5

**cross sesction of branch showing
degrees of depth of decay.**

**examples of internal
barriers to resist
decay**

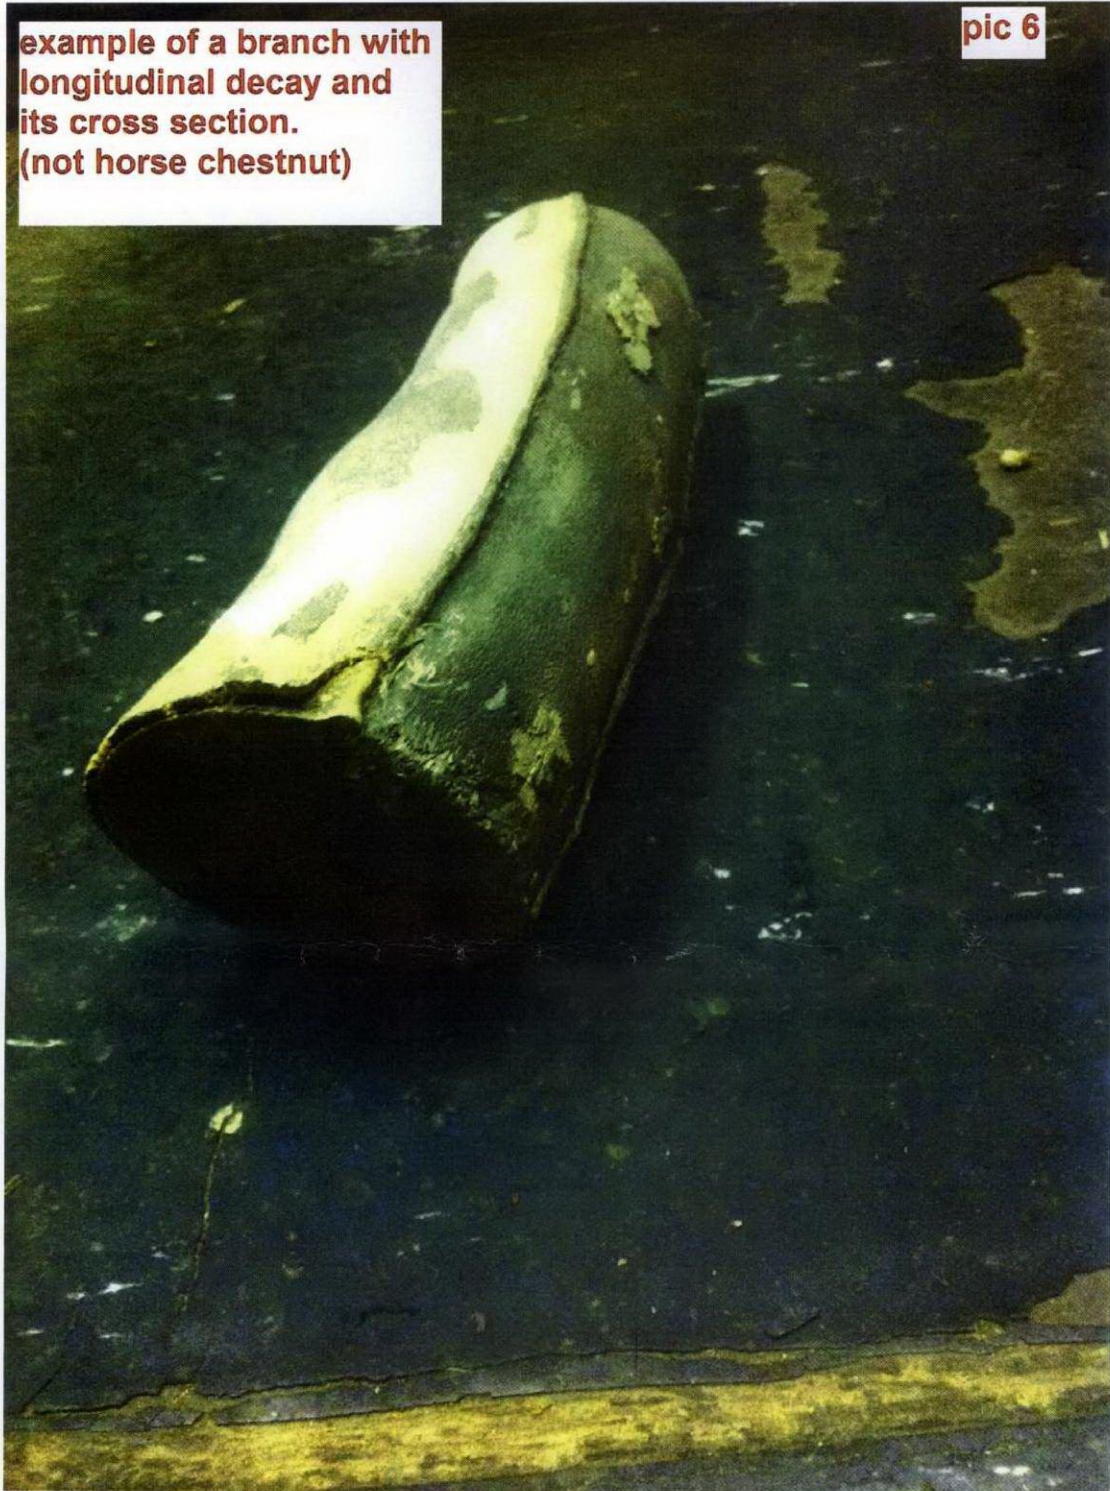
pic 6

example of a branch with
longitudinal decay and
its cross section.
(not horse chestnut)
