## **Arboricultural Impact Assessment and Method Statement**

12 Provost Road  
London  
NW3

Client: K & T London Ltd

21 May 2012

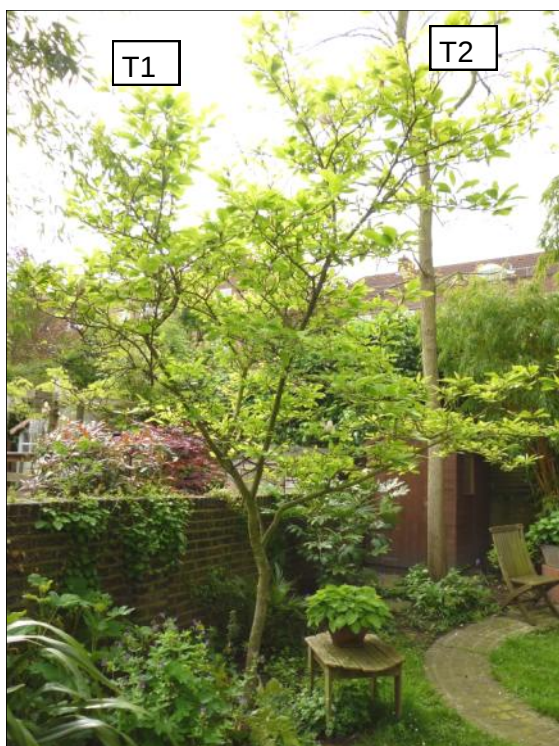
This young small tree is in good condition. It has not yet realised its full potential and will ultimately become an attractive tree providing softening and screening between gardens. The tree is shown in photograph 1.

There is no impact from the proposed sunken garden, but the ground is shown to be raised under the canopy. Raising the soil level more than 75mm around trees is harmful as it compresses the soil below and impedes gaseous exchange which is essential for root health. Generally raised soil level around trees results in significant tree decline and in some cases death after a few years. The tree protection plan shows an area hatched yellow where the ground should not be altered. This area should be fenced during works to prevent soil compaction and to prevent the roots and crown being damaged.

1. Photo of T1 magnolia and T2 false acacia

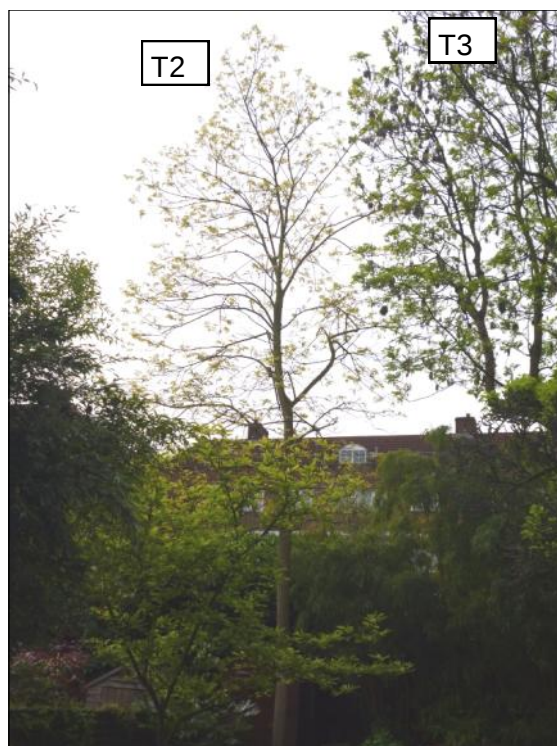
This tree is reaching early maturity and has a slender trunk and a high crown. It is a pleasing focal point at the end of the garden (photo 2). Currently it is growing near a shed which will be removed as part of the landscaping.

I recommend moving the location of the sunken garden west to avoid the root protection area. There should be no ground level changes and the area should be fenced during works.

2. Photo of T2 false acacia and T3 ash.

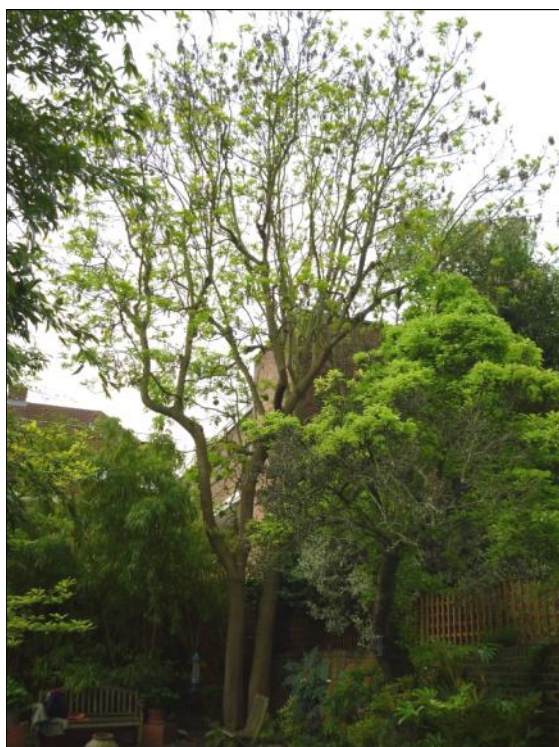
This is a large tree overhanging the garden to the south and west. It was originally triple stemmed, and one of the stems was removed at the base some time ago. The tree has crown lifted in the past, resulting in rather angular branch formations and some of the new growth may be weakly attached. Whilst this structure is not ideal, this does not make the tree dangerous. However, the roots are most likely the cause of the cracking of the boundary wall, which is shown on photo 6. This cracking is significant. The crown of the tree touches the property to the south and it can be seen from the communal parking areas of the building complex off Adelaide Road. It can also be seen from 11 and 13 Provost Road. The tree has been classified as C grade (low value) due to its previous management and the fact that it is cracking the wall. It is a very wide and large tree in proportion to the garden size.

The sunken area as shown on the architect's plans would result in root severance as most tree roots are in the top metre. The excavation would be 2m from the trunk, and therefore large structural roots are likely to be growing here. Severance of the main roots is likely to lead to loss of physiological function, although it is unlikely to lead to instability as only a small section would be severed, and only on one side. I therefore recommend removing this tree and moving the sunken area slightly westwards. This would enable T1 and T2 to flourish and make room for new planting.

3. Photo of T3 ash

| Tree no. | Species | Location | Proposed works | Reason |
|---|---|---|---|---|
| T3 | Ash | Rear garden of 12 Provost Road | Fell to ground level and grind stump<br>Replace with a new tree | To facilitate redesign of the garden.<br>Tree root encroachment causing cracking of boundary wall. |

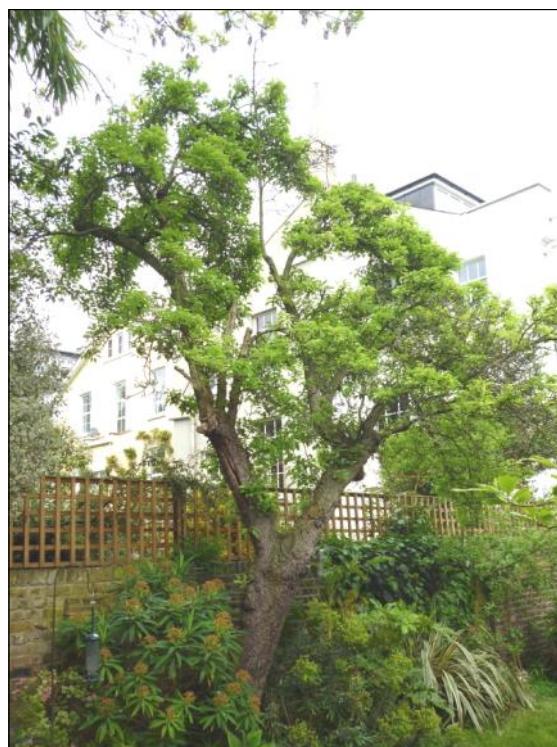
4. Photo of T4 pear

| Tree no. | Species | Location | Proposed works | Reason |
|---|---|---|---|---|
| T4 | Pear | Rear garden of 12 Provost Road | Fell to ground level and grind stump and replace | The main branch has a crack and the crown has 40% dead wood. |

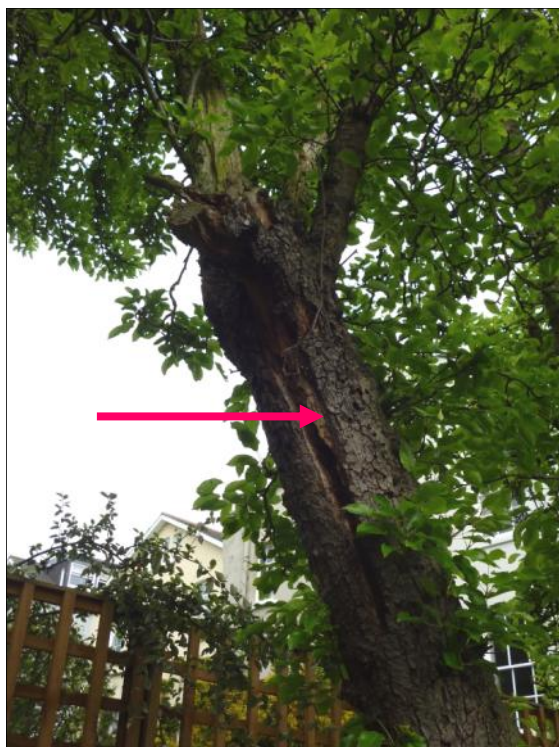
This tree is over mature with a large crack in the main branch (see photograph 5) and a significant amount of dead wood. It should be felled for safety reasons irrespective of the application.

5. Photo of crack in the main branch of T4

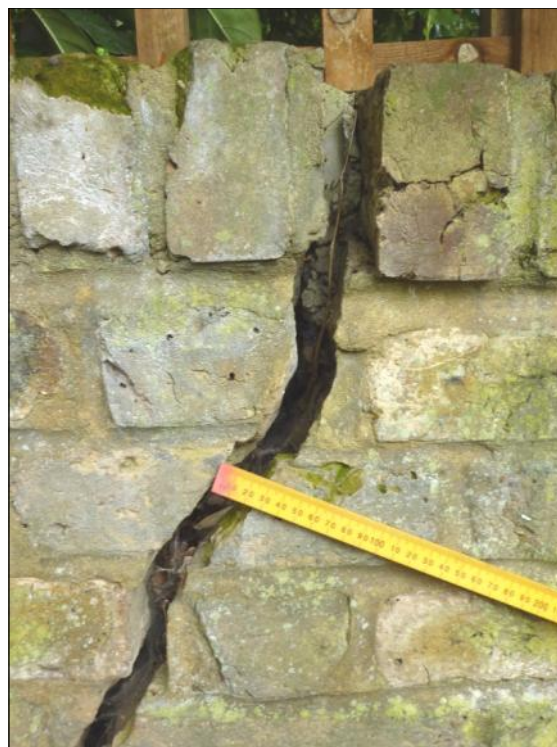
6. Photo of the crack in the wall near T3

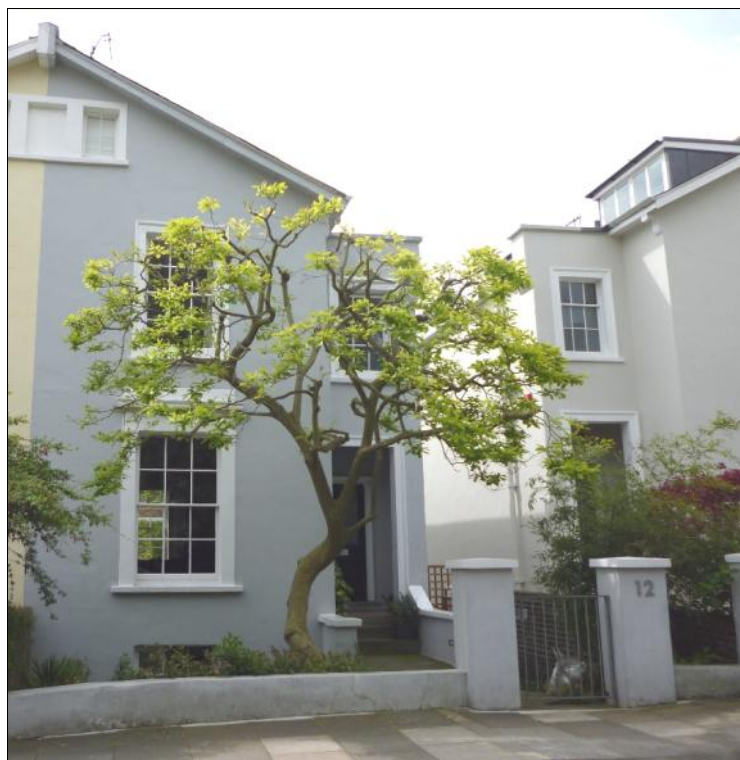
This tree is in the front garden and has recently been pruned. It is in good condition and is the dominant feature in the front garden. Its rooting area is restricted to the south by the basement.

7. Photo of T5 magnolia

| Tree no. | Species | Location | Proposed works | Reason |
|---|---|---|---|---|
| T5 | Magnolia | Front garden of 12 Provost Road | No works as this tree has been recently pruned | n/a |
