**InSewer Surveys**  
for CCTV, Sewer Location  
and Repair

LOCATION 12 Provost Road  
Camden

# CCTV Survey Report

| Date:<br>10/07/2012 | Job N°:<br>TV120715 | Weather:<br>Dry | Operator:<br>InSewer TS | section number:<br>1 | PLR:<br>RUN A X |

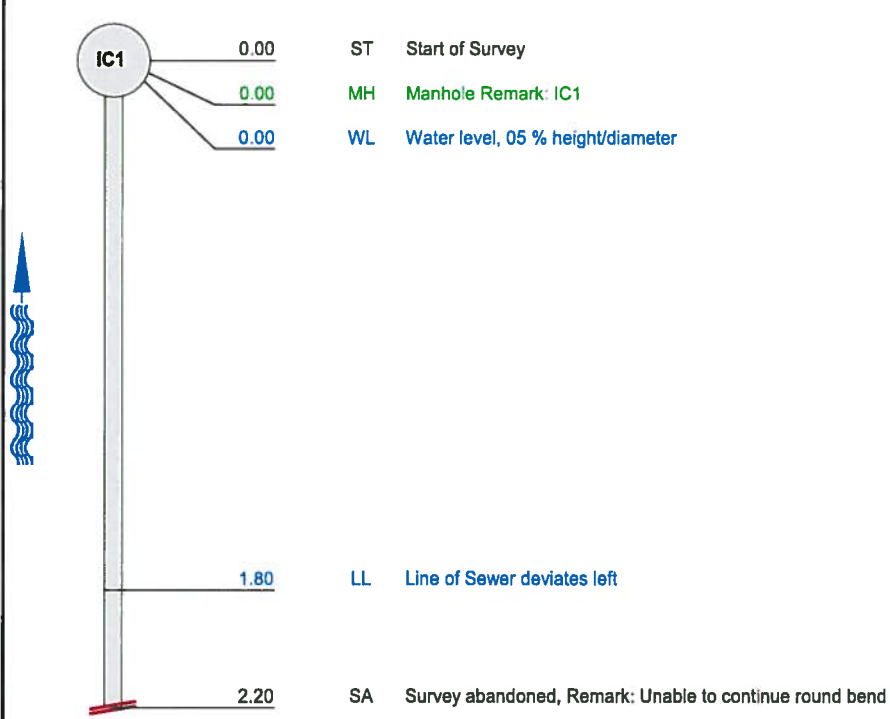
| 1.80 LL Line of Sewer deviates left | | | | | |
| 2.20 SA Survey abandoned, Remark: Unable to continue round bend | | | | | |

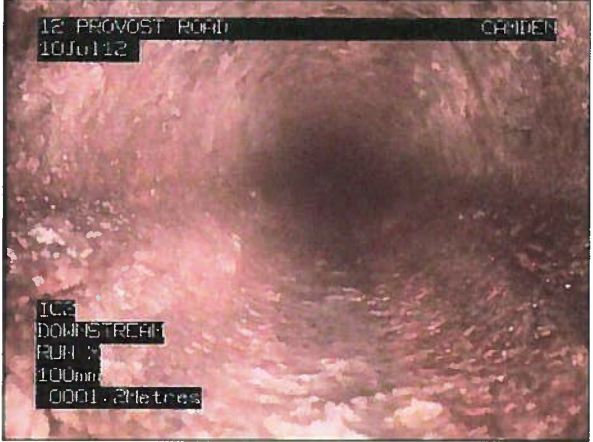
| Place:<br>CAMDEN | Road:<br>12 PROVOST ROAD | Date:<br>10/07/2012 | section number:<br>5 | PLR:<br>IC2 X | |

| | 1.20 | S1 | EM Encrustation medium, from 04 to 08 o'clock, 10% cross-sectional area loss, Start | | |
| | 2.90 | F1 | EM Encrustation medium, from 04 to 08 o'clock, 10% cross-sectional area loss, Finish | | |
