Arboricultural Consultancy for Lloyds TSB Insurance

Insured	Shane	Address	2 Netherhall Gardens, London, NW3 5RR		
Client	Halifax General Insurance	Contact	Godfrey Sims	Claim No.	100941801
MT Ref	NL/3001121501/TP	Consultant	Thomas Peppiatt	Contact No.	08702 416 180
Report Date	24/02/2012

Scope of Report: To survey the property and determine significant vegetation contributing to subsidence damage, make recommendation for remedial action, initiate mitigation action and assess recovery prospects. The survey does not make an assessment for decay or hazard evaluation.

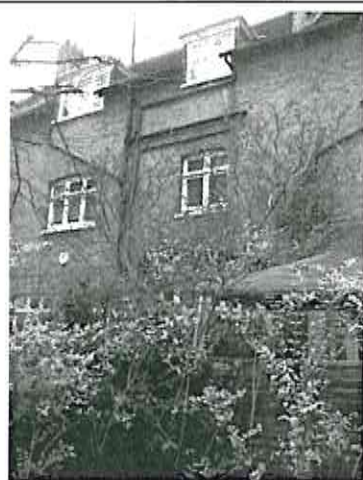
T4 (Magnolia)

Given the above information, results of site investigations and our observations on site T1 (*Prunus*) and T2 (*Apple*) are considered significant factors in the current movement. T4 (*Magnolia*), T5 (*Pear*), TG1 (*Mixed Species Group*) and SG1 (*Mixed Species Group*), are also considered causal by virtue of known species characteristics and their position in relation to the area of movement.

We have given consideration to pruning as a means of mitigating the vegetative influence, however this has been discounted. Known practice and established research (Hortlink 212) suggests that pruning is an ineffective means of controlling long term water uptake. For these reasons removal is recommended.

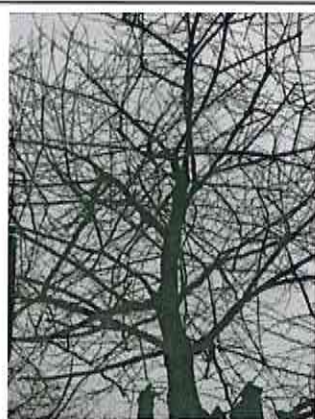
T1 (Prunus)

Roots recovered from TH1 have been formally identified as *Prunus* spp and *Pomoideae* gp. The most likely origin of the roots is T1 (*Prunus*) and T2 (*Apple*) respectively. Such circumstances confirms the potential for T1 (*Prunus*) and T2 (*Apple*) to influence soil volumes and to contribute to the damage observed.

Tree No.	Species	Age Cat	Approx. Height (m)	Distance to Building (m)	Ownership	Action	Requirement
SG1	Mixed Species Group (H) Including Privet and Pyracantha.	1	3.5	1.3	C - Insured	Remove	Remove.
T1	Prunus	1	9	3.8	A - Third Party 2A Netherhall Gardens, London, NW3 5RR	Remove	Remove and treat stump to inhibit regrowth.
T2	Apple	1	5	3.8	A - Third Party 2A Netherhall Gardens, London, NW3 5RR	Remove	Remove and treat stump to inhibit regrowth.
T4	Magnolia	1	6	4.5*	A - Third Party 2A Netherhall Gardens, London, NW3 5RR	Remove	Remove and treat stump to inhibit regrowth.
T5	Pear	1	12	4	A - Third Party 4 Netherhall Gardens, London, NW3 5RR	Remove	Remove and treat stump to inhibit regrowth.
TG1	Mixed Species Group (H) Acer x 1. Willow (Goat) x 1.	1	14	4	D - Unknown	Remove	Remove and treat stump to inhibit regrowth.
