Arboricultural Consultancy for Camden Borough Council

Insured	London Borough of Camden	Site Address	28 Caversham Road NW5 2DS
Client	Whymark and Moulton	Contact	
STS ref	CT005	Consultant	N Turnbull
Date	11/05/2012	Contact No.	07783271644

Scope of report: To assess the vegetation potentially contributing to subsidence or other damage, provide recommendations and cost estimates for remedial action, and assess recovery prospects. Provide a hazard and decay assessment to inform these recommendations.

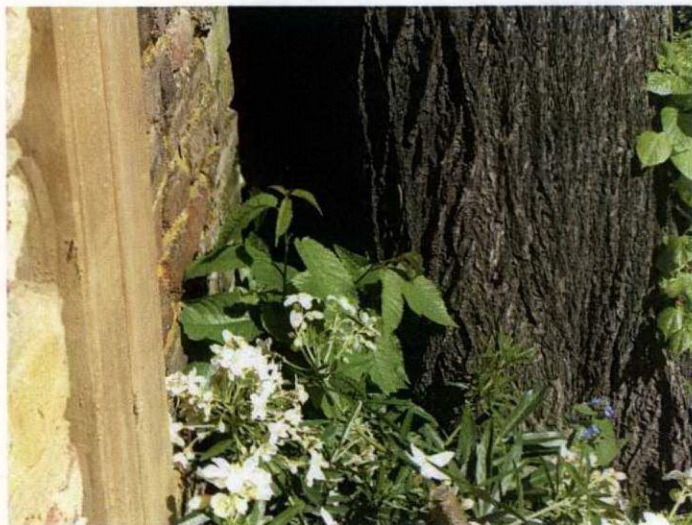
Figure 1

T1 is a mature lime and has caused damage to the wall, This damage was evidently caused by the proximity of the tree to the wall, which it is now touching (Fig1), and it will not be possible to rebuild the wall in its original position adjacent to the tree.

Allowing for the fact that any repair involving the retention of the tree will probably only be a short-to-medium term solution, and that in the meantime the wall will not conform to the norm within the conservation area, I would suggest that T1 be removed, and replaced by another tree further from the wall.

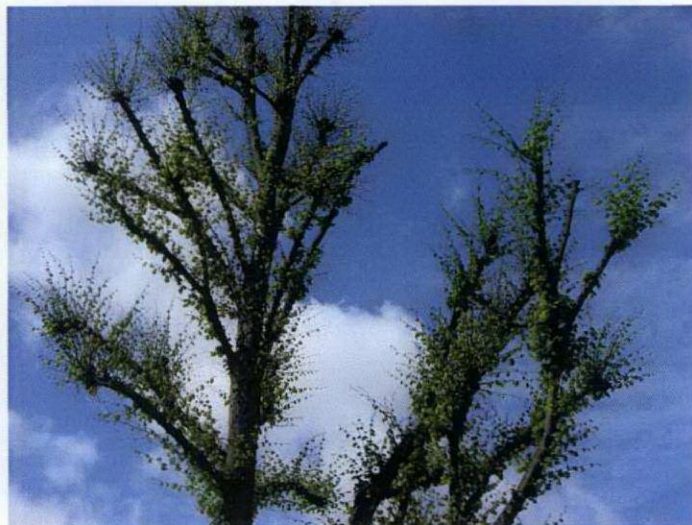
Figure 2

The tree itself, as a high pollard, does not add greatly to the visual amenity of the area, (Fig 2) although it is similar to other high pollarded trees nearby.

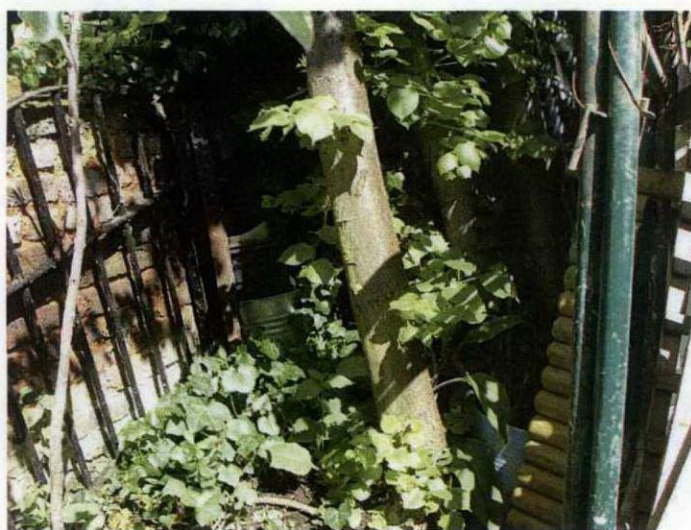
Figure 3

G3 is a group of lime stems (Fig 3), possibly coppice growing from an old stump. These are of no great visual amenity value and will eventually threaten damage to the adjacent walls. They should be removed and the stump(s) either ground out or poisoned.

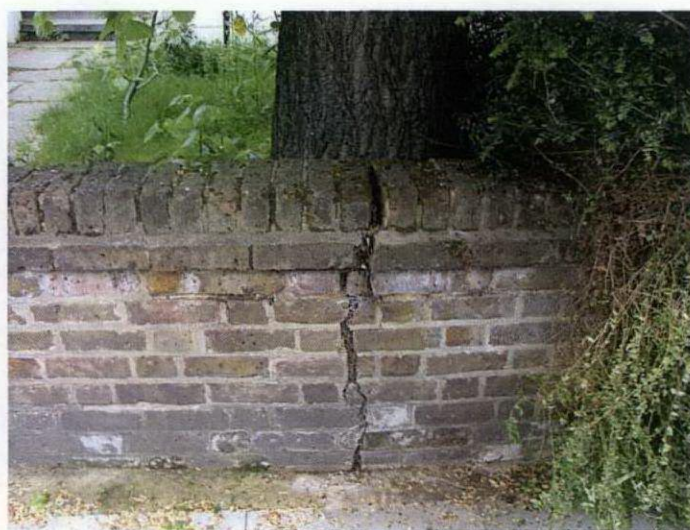
Figure 4

It was noted on leaving the site that a lime tree in front of the property is also damaging the low boundary wall (Fig 4), although this would not pose a hazard if it were to fail, other than the loose bricks obstructing the footpath.
