Planning & Listed Building Conditions Discharge

0706 \_7.04\_120626

Facade Cleaning and Investigation Trials Report

Facade Condition Survey Report

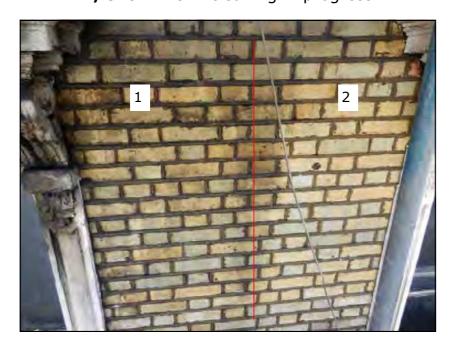
**PR/CT02:** 2nd floor post cleaning. N01 DOFF clean, level of surface soiling reduced. N02 DOFF/Neolith clean, level of surface soiling improved.

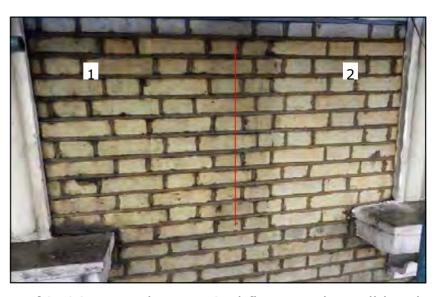
**PR/CT03:** Post cleaning 2nd floor window sill level. N01 DOFF clean, level of surface soiling reduced. N02 DOFF/Neolith clean, level of clean improved.

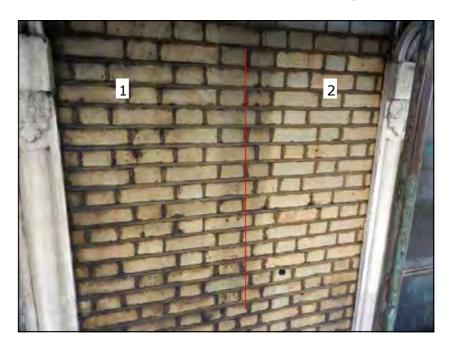
**PR/CT04:** Post cleaning 1st floor level. N01 DOFF clean, level of surface soiling reduced. N02 DOFF/Neolith clean, level of clean improved.

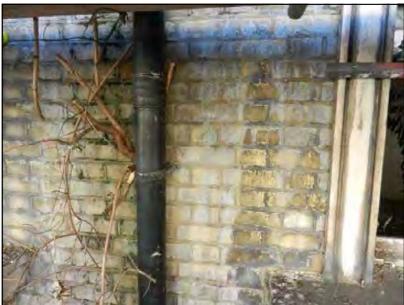
In locations of staining from blocked downpipes there was less obvious difference in appearance with hardened deposits remaining on the surface.

**PR/CT06:** Post clean, surface soiling improved but hardened deposits remain. Further cleaning required to improve finish.

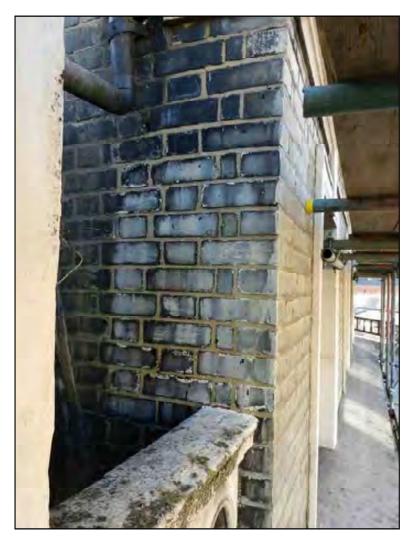
PR/CT07: Pentonville Road elevation 3rd floor flank. Area of brickwork cleaned using 1 No application of dilute Neolith 625 and DOFF hot wash.

A degree of soiling was removed but the result was patchy.

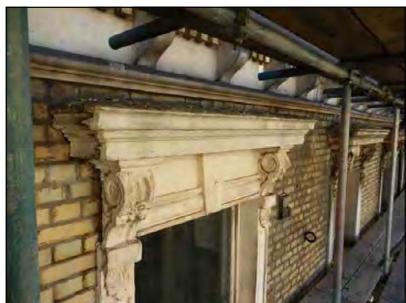
**PR/CT09:** Post clean heavier surface soiling remains in less exposed locations. Paint stripping maybe required in order to provide a suitable background for re-decoration.

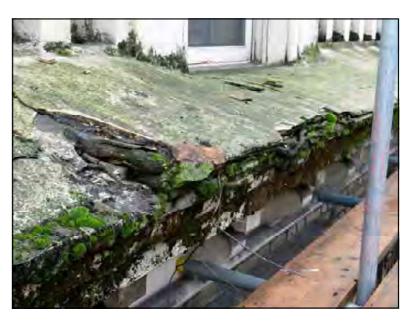
**LB/OP10:** Lower cornice Pentonville Road. Stucco visibly saturated and failing.

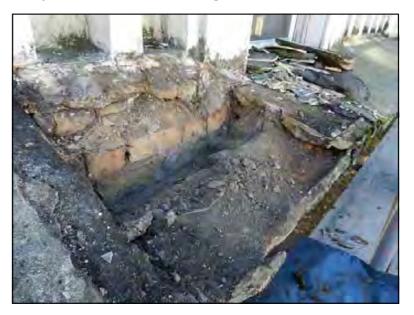
**LB/OP11:** Following removal of the hard dense top screed the original substrate mortar was found to be very loose and friable.

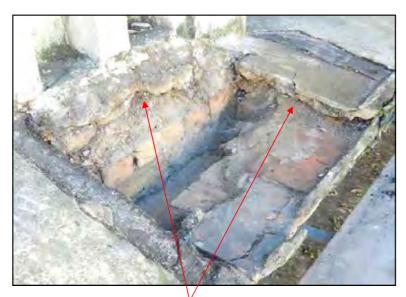
**LB/OP11:** The hard dense cement mortar screed was found to have de-bonded from the original lime mortar.

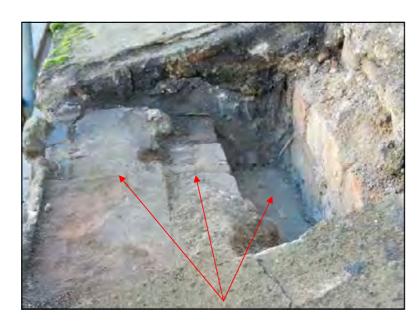
The exposed sections of cornice showed a typical projecting stone slab that had been built out in brick and tile creasing to form the basic shape of the nosing and then hand run in mortar. The substrate mortar was found to be damp and friable, bricks and tiles where loose and could be easily removed.

**LB/OP12:** The construction of the stucco cornice has been exposed showing the cantilevered stone slab off which corbelled brickwork and tile creasing has been built to form the basic shape of the cornice. The detailing is applied by hand running mortar over the formwork.

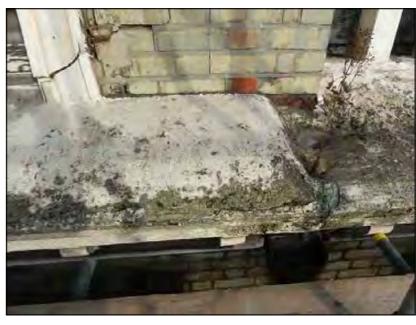
**LB/OP13:** The upper cornice has been similarly screeded with a hard dense cement mortar.

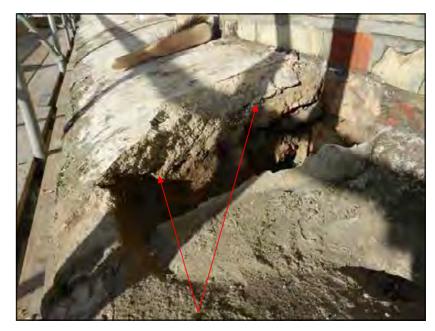
**LB/OP14:** The applied cement screed is very thick and has de-bonded from the original stucco mortar.

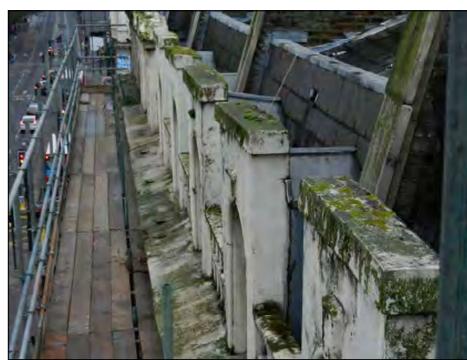
**PH. N01.** Dormer windows render loose and de-bonding, brickwork substrate frost damaged. Take down and re-build

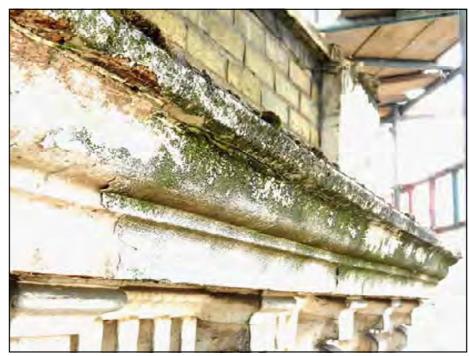
**PH. N02.** Cement mortar repair to upper cornice loose and de-bonding from the original substrate, continuous fracture through nosing. Remove complete and repair.

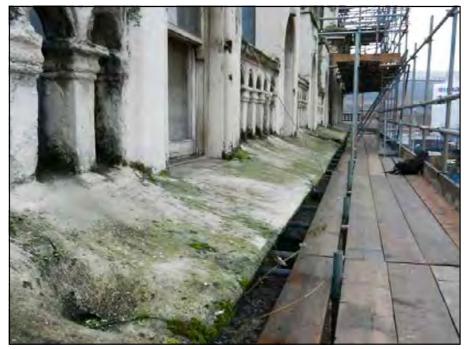
**PH. N03.** Cement mortar repair to lower cornice loose and de-bonding from original substrate, fracture through nosing, downpipe outlets blocked, weathering detail to window sills ineffective. Remove complete, repair substrate and revise weathering detail.

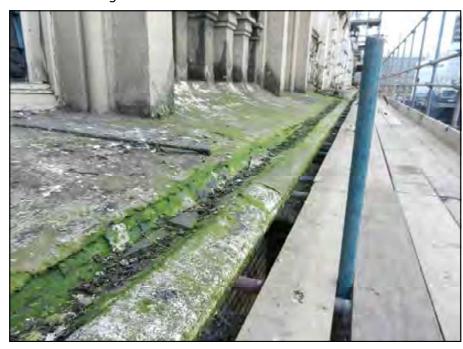
**PH. N04.** Original cornice detail with front gutter running to downpipe outlet. Flaunching below window sills and less built up to the base of balustrade.

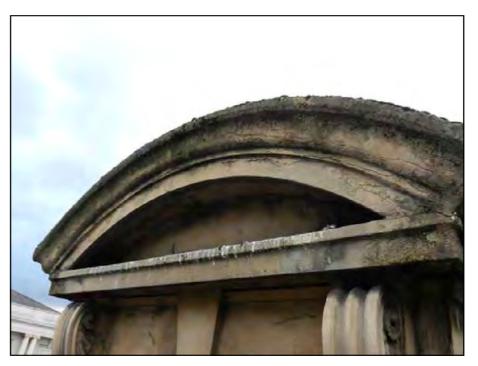
**PH. N05.** Curved pediment dormer window heads fractured and loose stucco, frost damaged brick and tile substrate. Take down and re-build new.

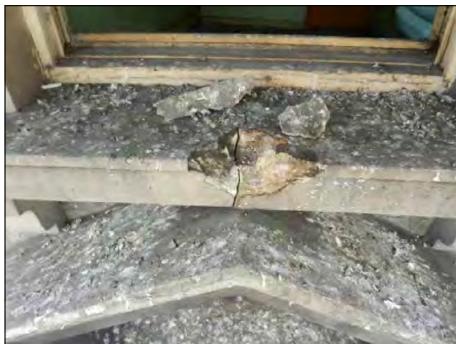
**PH. N06.** All natural Bath stone window sills cement mortar repaired. Repairs are loose and failing. Remove mortar and assess condition of exposed stone for most appropriate option on repair or replacement.

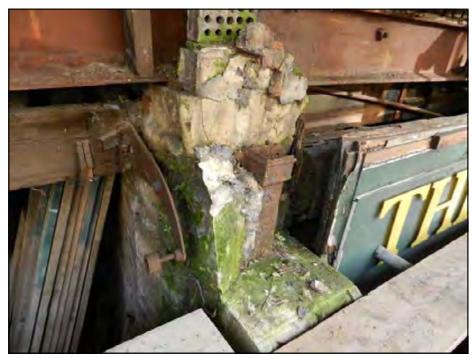
**PH. N07.** Natural Bath stone ground level pilasters. Stonework has been damaged by corroding embedded downpipes and inappropriate cement mortar repairs.

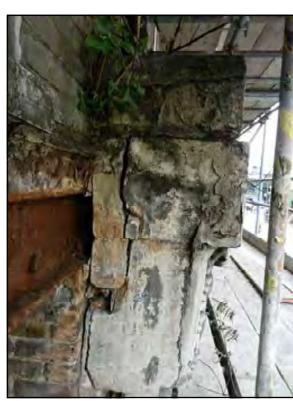
**PH. N08.** Top section of pilaster fractured and displaced. Carved detailing painted and mortar repaired.

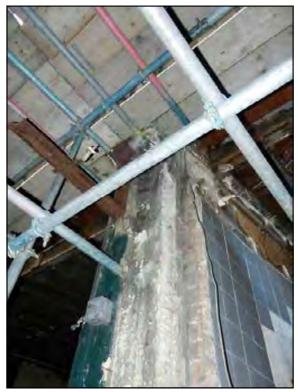
**PH. N09.** Lower section of pilaster which has been previously cut and altered to accommodate a change in shopfront.

Stonework has also been tiled and painted over.

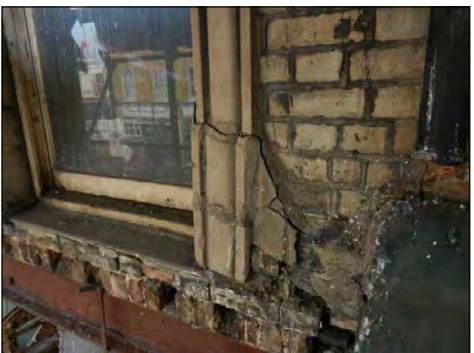
**PH. N010.** Moulded stucco window surrounds loose and de-bonded from the brick substrate. Carefully remove and repair to match original detailing.

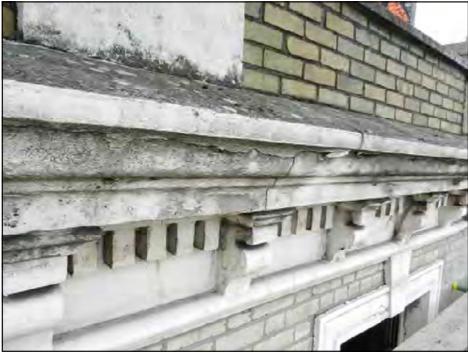
**PH. S01.** Cement mortar repair to upper cornice loose and de-bonding from the original substrate, continuous fracture through nosing. Remove complete and repair.

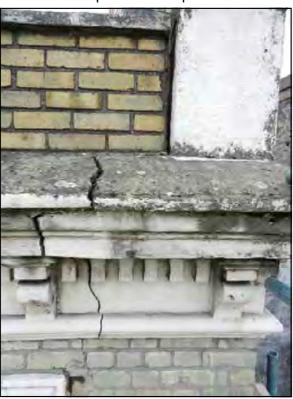
**PH. S02.** Significant fracture and displacement of stucco cornice. Carefully take down and re-build incorporating pre-cast corbel and dentil blocks

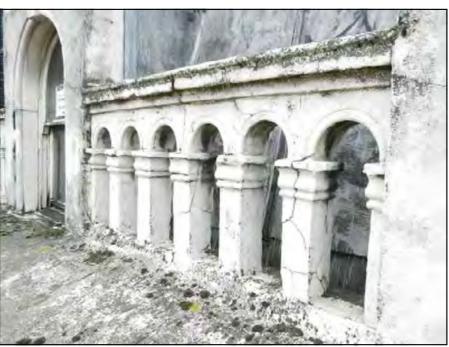
**PH. S03.** Sections of balustrade are fractured and extensively eroded. Remove and replace using pre-cast units.

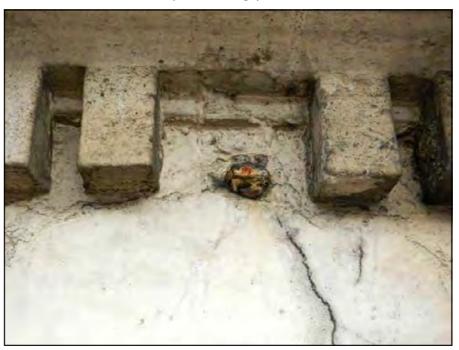
**PH. S04.** Dentil blocks missing from cornice damaged due to corrosion of embedded fixing dowel. Cut out corroded fixing and replace with new pre-cast block secured using stainless steel threaded rod.

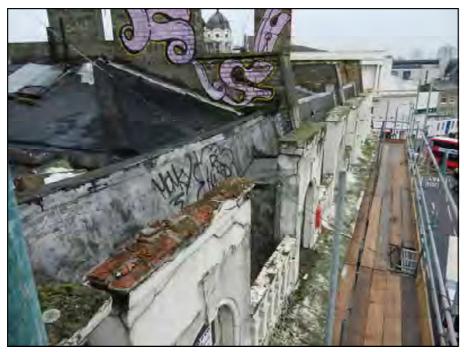
**PH. S05.** Dormer windows render loose and de-bonding, brickwork substrate frost damaged. Take down and re-build

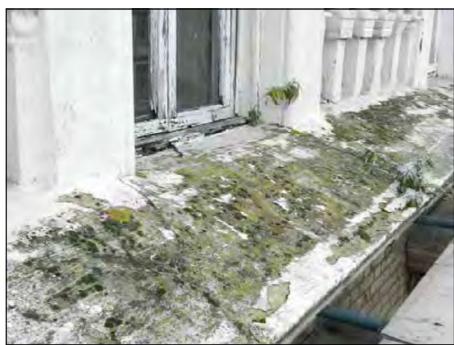
**PH. S06.** Cement mortar repair to lower cornice loose and de-bonding from original substrate, fracture through nosing, downpipe outlets blocked, weathering detail to window sills ineffective. Remove complete, repair substrate and revise weathering detail.

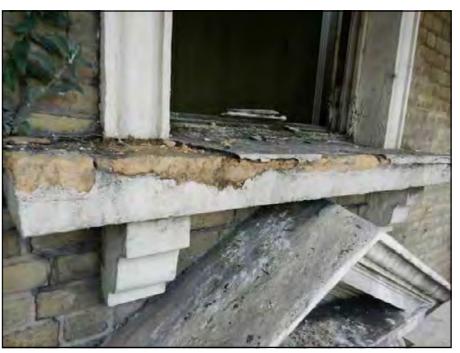
**PH. N07.** All natural Bath stone window sills cement mortar repaired. Repairs are loose and failing. Remove mortar and assess condition of exposed stone for most appropriate option on repair or replacement.

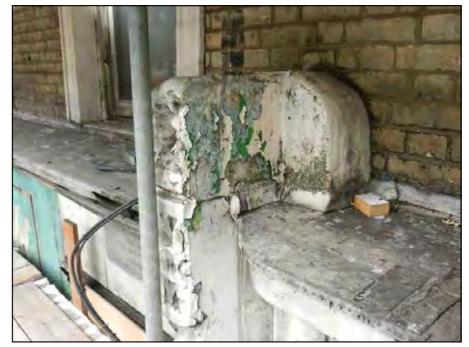
**PH. N08.** Natural Bath stone pilasters have been dramatically altered to accommodate previous change in shopfront. Remove and replace with new to match original carved detailing.

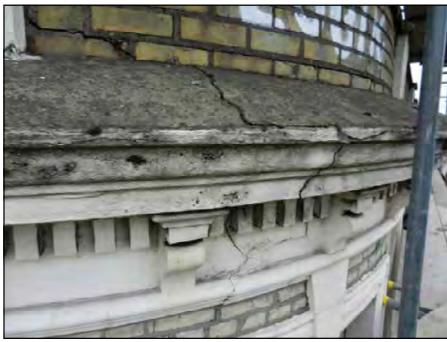
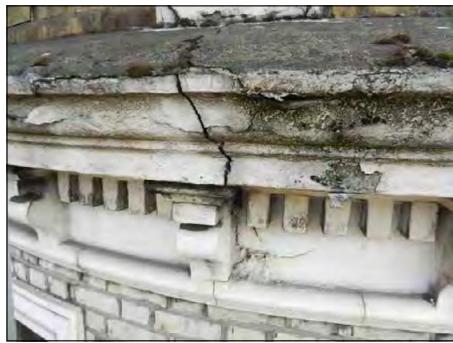
**PH. EW01 EW02.** Significant fractures through upper cornice and parapet wall possibly due to thermal movement. Replace and repair sky surface and nosing as previous. Introduce control measures as necessary in accordance with structural engineers specification to prevent further possible movement.

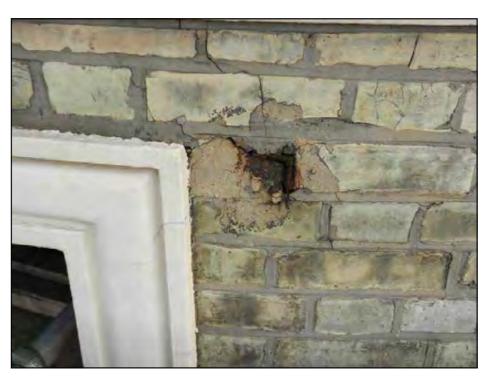
**PH. EW03.** Corroding sections of embedded steel and redundant fixings are causing damage to brickwork and stucco. Carefully cut out and repair using new matching bricks and stucco render
