**19 Park Village West
London NW1**

ARBORICULTURAL INSPECTION REPORT

March 2012

TMC Ref: 11058R

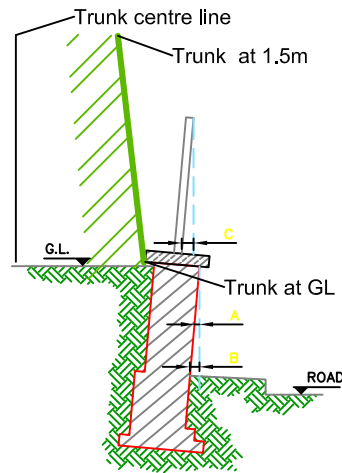
WALL MOVEMENT ANNOTATION

- 3.1 I have seen the various plans and photographs indicating damage to the boundary wall. Appended as RG1 is an extract of the engineer's drawings which show the trunk of the London plane tree and displacement of the boundary wall³. Clearly the growth of the trunk and, I suspect, roots on the inside of the wall, are causing this displacement. Furthermore, I would be surprised if the footings of the wall have not been damaged and lifted by the tree's roots. In the same way the corner pier has also been damaged by the tree's trunk and roots.

³ RG1 - Section - Wall movement

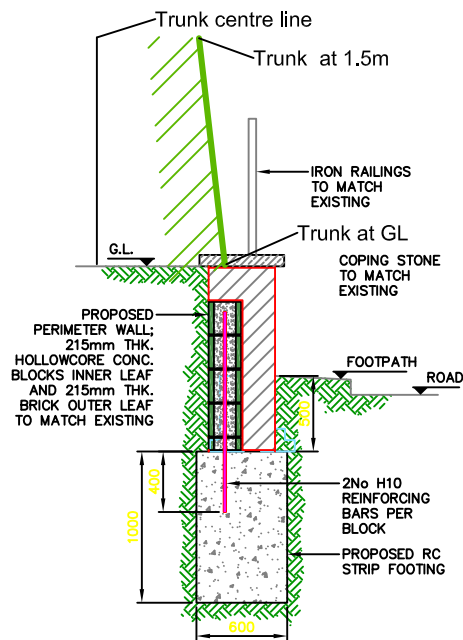
TYP. SECTION THRU' PROPOSED PERIMETER WALL

- 3.2 I note that if the wall is to be restored it would be rebuilt on the boundary as indicated on the engineer's plans. On an extract of this plan⁴ I have indicated the dimensions of the trunk at ground level within the garden. This shows that the wall cannot be rebuilt in its current location without cutting into the trunk and main roots running down the inside of the wall. The same applies to the corner pier.

- 3.3 Furthermore, the additional depth of foundation and reinforcement would sever any anchorage roots crossing below the existing footing and into the surrounding highway. Deciduous trees support themselves in tension and this tree is exposed to the southwest. The roots under the wall are therefore vitally important in maintaining the tree's stability. Indeed, field studies⁵ have shown that even for trees of 85cm trunk diameter the minimum root plate radius should be some 3 - 4 metres to maintain stability.

⁴ RG1 - Section thru Proposed Perimeter Wall

- 3.4 In the event of the wall and pier being reconstructed further from the trunk, it would need to be at least 1 meter from the base of the trunk to allow for the increasing girth and buttress root expansion. In this event, any major root would need to be bridged by the footings to maintain the tree's stability.

- 4.1 Clearly, it is impractical and would be severely damaging to the health and stability of the tree to reconstruct the wall and corner pier in its current location. To move the wall's location, which in my assessment should be a minimum of 1 metre from the trunk at ground level, and bridge any major roots, is also impractical as it would encroach onto highway land and the carriageway of Park Village West.
- 4.2 The only options are therefore either to remove the tree and rebuild the wall on the boundary line or retain the tree and demolish the wall. The latter option raises a further problem in that the garden is some 0.8m higher than the public highway and the soil within the garden would therefore need to be retained in some way.
