INVESTIGATION REPORT

CRACK DAMAGE

Name of Insured: Mutley International Ltd

Carmichaels Ref: 10/52271/NGH

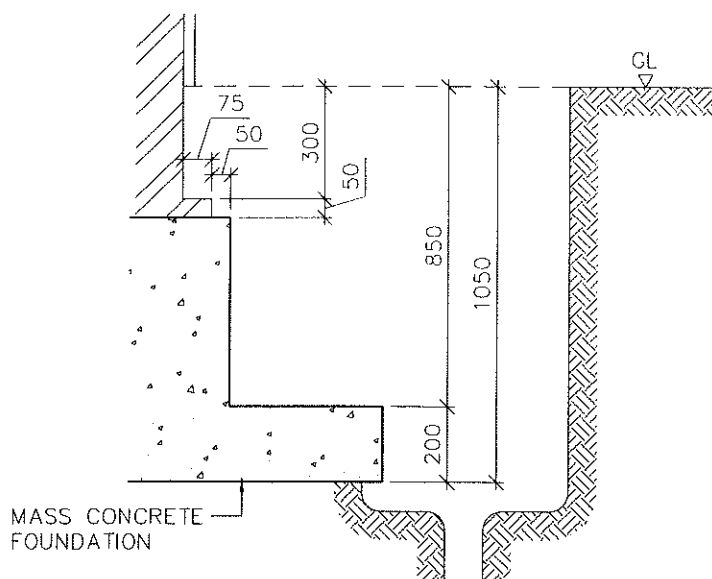
Job Number: 11322
 Borehole Number T.H.1
 Location:

The foundations to the house were found to be mass concrete strip footings founded at various depths as follows. In Trial Hole 1 at the front bay, the foundation was 1.05m deep and founded on a stiff silty clay. In Trial Hole 2 at the front right hand corner the foundation was 0.55m deep and again founded on a stiff fissured silty clay. A third trial hole was attempted at the front right hand corner of the flank wall but had to be aborted because of the presence of pea shingle and drainage running down the side of the property.

Roots were found below foundation level in both Trial Hole 1 and Trial Hole 2. In Trial Hole 1 these were identified as being from the Plane tree in the public footpath outside the property, and also from some of the shrubs close to the front wall of the property. In Trial Hole 2 roots were found from the clematis growing close to this corner of the house and also from the privet hedge within the neighbours property along the right hand boundary.

Daily Prog.	Water Level	Insitu Tests	Samples Taken	Sample Depths	Remarks	Depth (m)	Strata Descriptions	Red. Level	Legend
						0.00	TOPSOIL + roots		
		PP	D	1.05	PP=180-210	1.05	Orange sandy CLAY with silt partings.		
		PP	D	2.00	PP=150-170	2.00	Stiff orange brown silty CLAY with occasional selenite crystals and roots.		
		PP	D	3.00	PP=180-250	3.00	Stiff orange brown silty CLAY with occasional selenite crystals.		
		PP	D	4.00	PP=110	4.00	Stiff red brown mottled silty CLAY with rootlets.		
							Firm mottled red/brown very sandy CLAY/clayey SAND.		
							End of Borehole

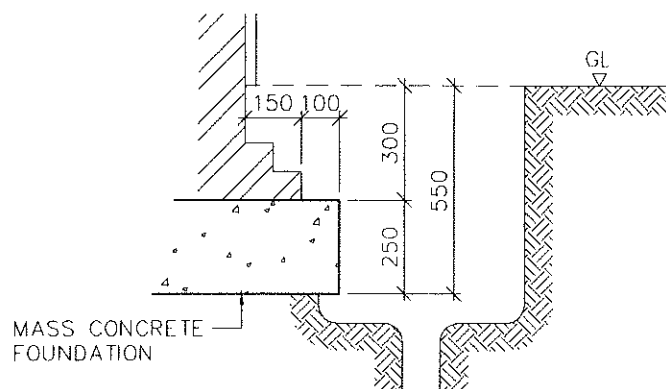
Contract: 18 FERNCROFT AVENUE HAMPSTEAD, LONDON		Coordinates:
Client: MUTLEY INTERNATIONAL LTD		Date: 08/12/11
Equipment & Methods HAND DUG	Job Number: 11322 Borehole Number T.H.2 Location:	Orientation: VERTICAL Ground Level:

Daily Prog.	Water Level	Insitu Tests	Samples Taken	Sample Depths	Remarks	Depth (m)	Strata Descriptions	Red. Level	Legend
						0.00	TOPSOIL + many roots		
		PP	D	1.00	PP=200-230	0.60	Stiff fissured mottled red/grey/ brown silty CLAY with many fine rootlets.		
		PP	D	1.00	PP=200-240	1.00	Stiff fissured mottled red/grey/ brown silty CLAY with occassional roots.		
		PP	D	2.00	PP=70-100	2.00	Firm red brown silty. very sandy CLAY with fine rootlets.		
		PP	D	3.00	PP=210-230	3.00	Stiff red brown silty fine sandy CLAY with occassional fine rootlets.		
		PP	D	4.00	PP=70-90	4.00	Soft to firm red/brown mottled grey very sandy CLAY.		
							End of Borehole

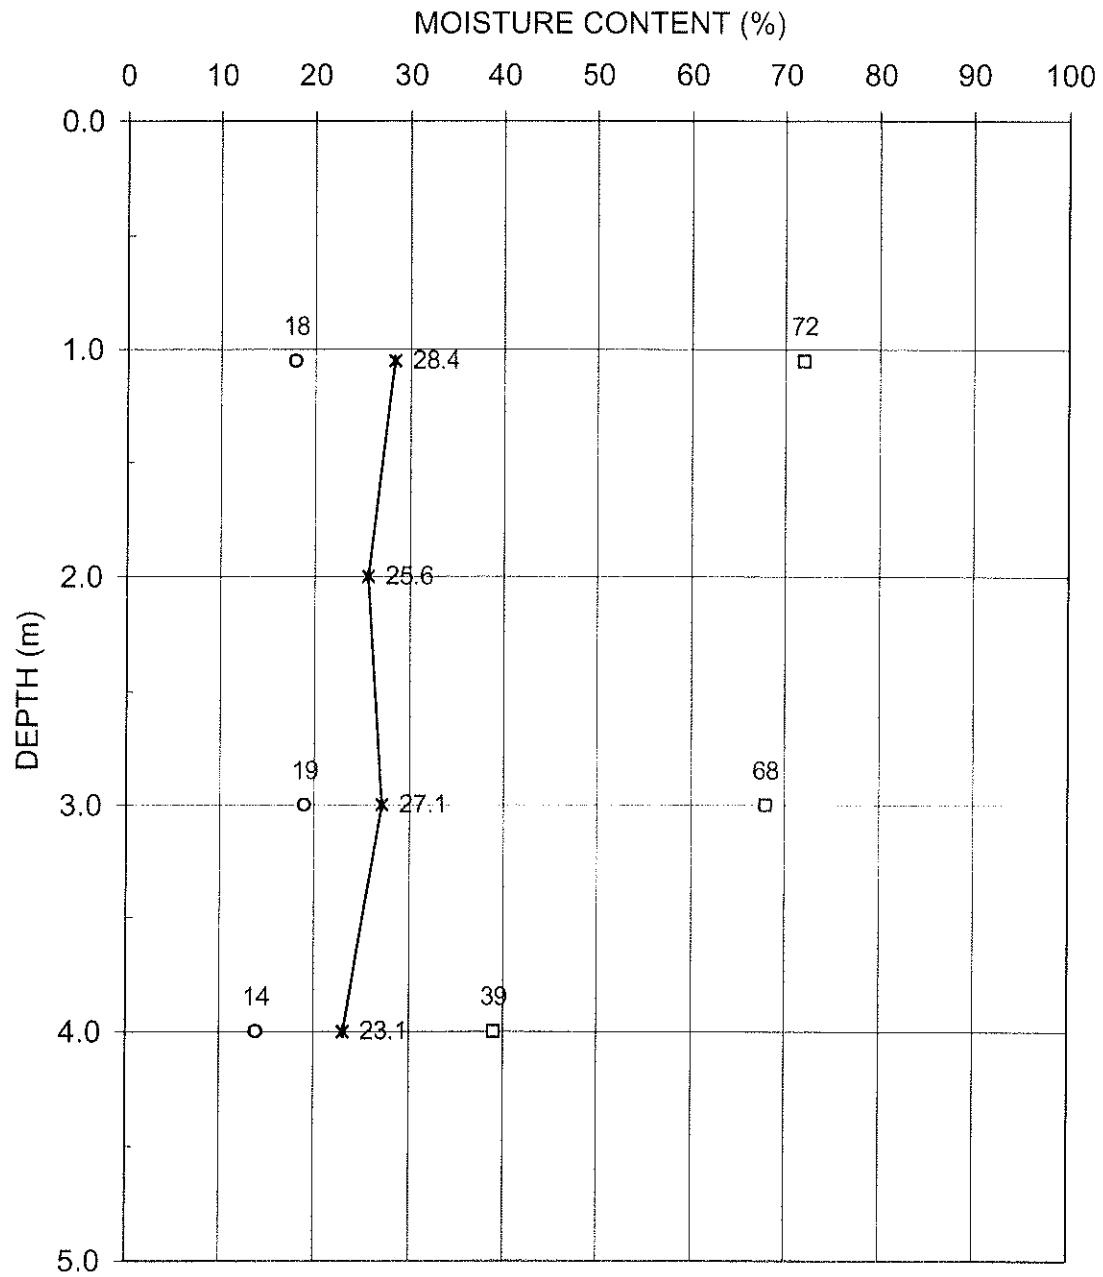
Location :	18 Ferncroft Avenue, Hampstead, London		Job ref:	05133/17
			BH/TP no:	TH1
Checked				
Approved			Date	14-Dec-11

Analysis of retrieved soil samples has confirmed the upper layers of the clay as being of high shrinkability, although below 3 to 4 metres depth the clays became more sandy and were analysed as being of medium shrinkability. Comparison of moisture contents with Atterberg Limits indicates that within Trial Hole 1 the clay soil was slightly desiccated down to 3m depth, but in Trial Hole 2 no desiccation was indicated at the time of investigation.

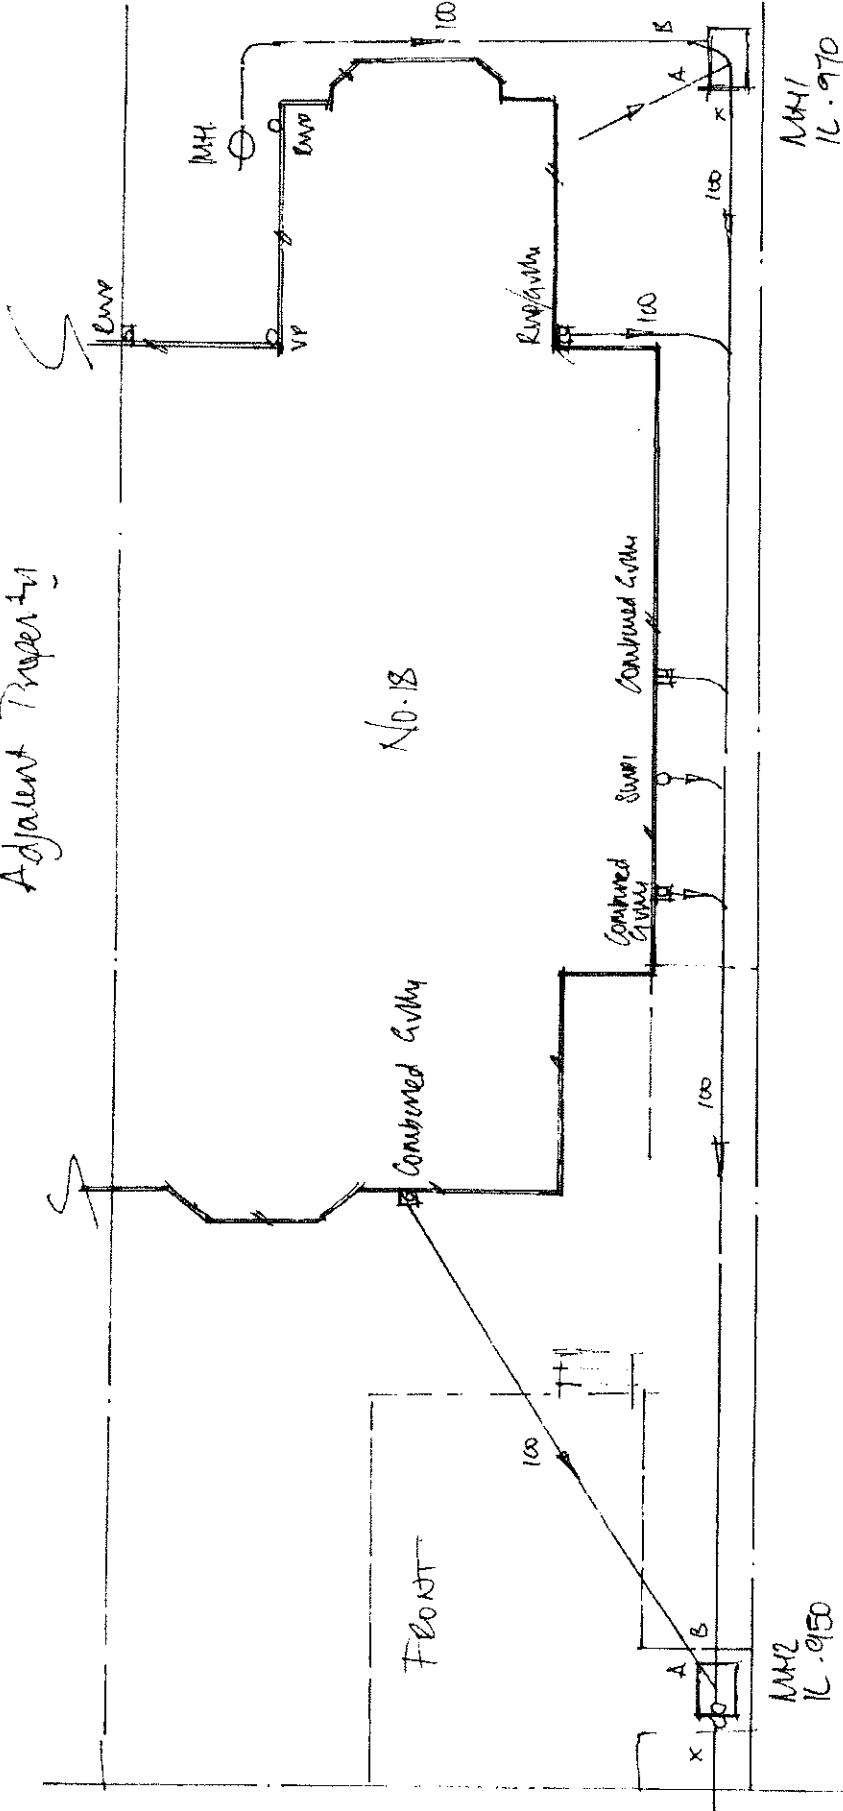
Site: 18 FENCOTE AVE.	Job No: K7997
Description: DRAINAGE LAYOUT	Drawing No: 1
	Scale: NTS
	Drawn By: 11/11

No defects were found in the main sewer run between manholes 1 and 2 down the right hand side of the property. However, in the run from manhole 2, connection A, towards the combined gully of the front elevation of the house, a number of defects were found including circumferential cracks, encrustation and root infiltration.

The CCTV drain survey found no defects from the main sewer run down the right hand side of the property between Manhole 2 at the front and Manhole 1 at the rear, although it was not possible to survey the branch runs. However, defects were found within the run from Manhole 2 at the front to the combined gully adjacent to the front elevation wall. These defects would allow leakage under normal use and could cause softening of the clay soils and loss of support to foundations.

Manhole 2, Connection A: Excavate and replace gully, provide suitable benching and kerbing for gully, replace pipe downstream to suitable connection and clean remainder of drain run to remove roots prior to installing a liner down to the manhole.

MH2 Connection A to excavate and replace gully, provide suitable benching and kerbing for gully.
To replace downstream to suitable connection, the remainder of the run to Manhole needs to be pre cleaned and all roots removed. When completed we will install a felt impregnated liner in the pipe to MH.
