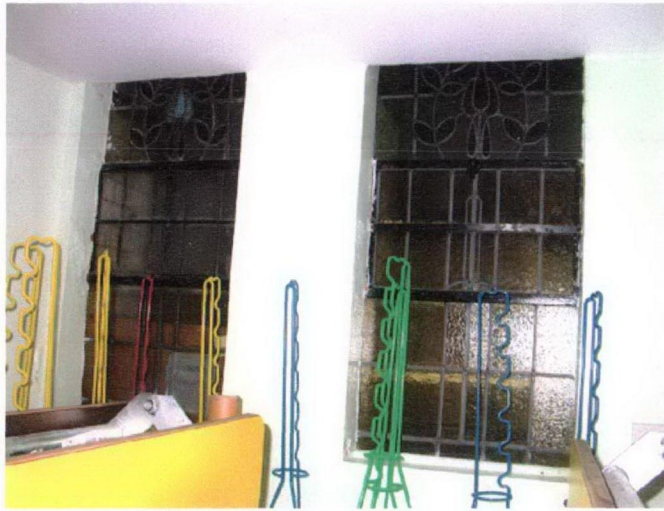
**8.** Ground floor NE elevation windows  
(removed)

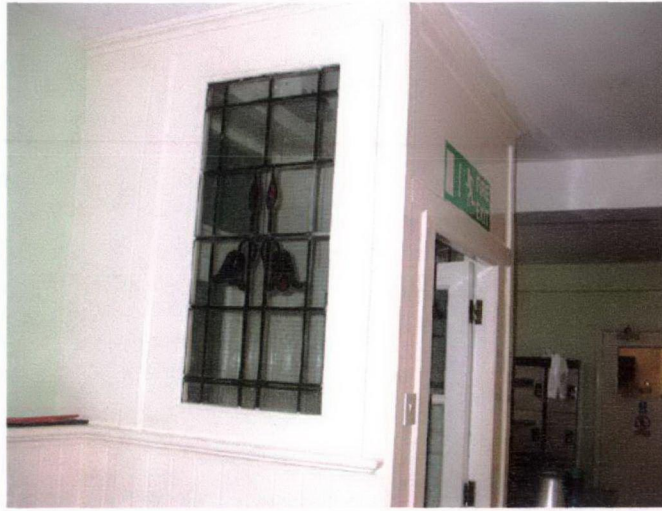
**9.** Ground floor rear vestibule  
Panels reused

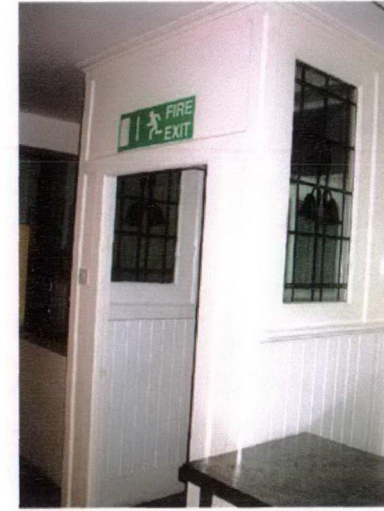
**10.** Ground floor rear vestibule  
Panels reused

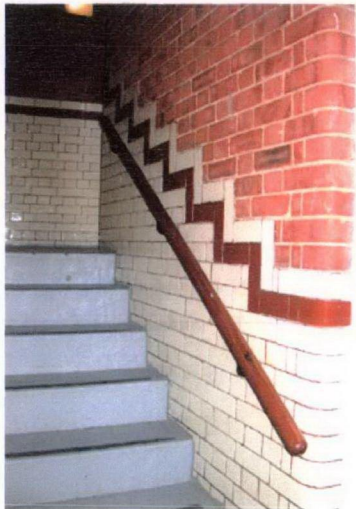
**11.** Landing 1 to rear staircase  
(removed)

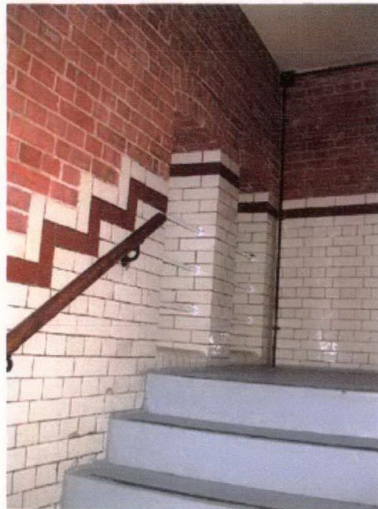
**12.** Landing 1 to rear staircase  
(removed)

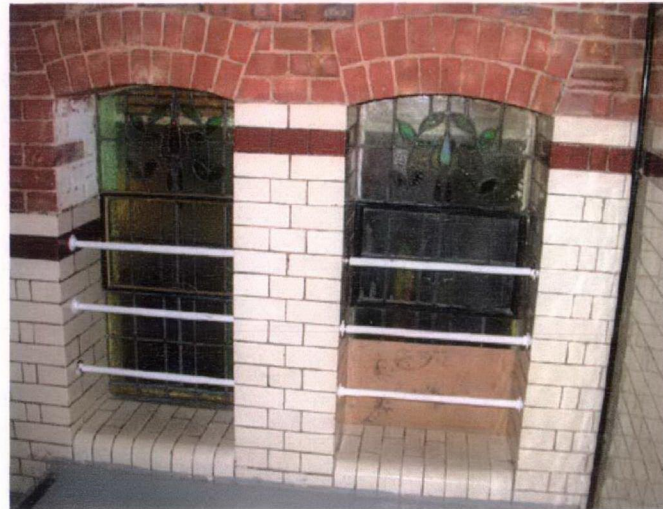
**13.** Ground floor NE elevation windows  
(removed)

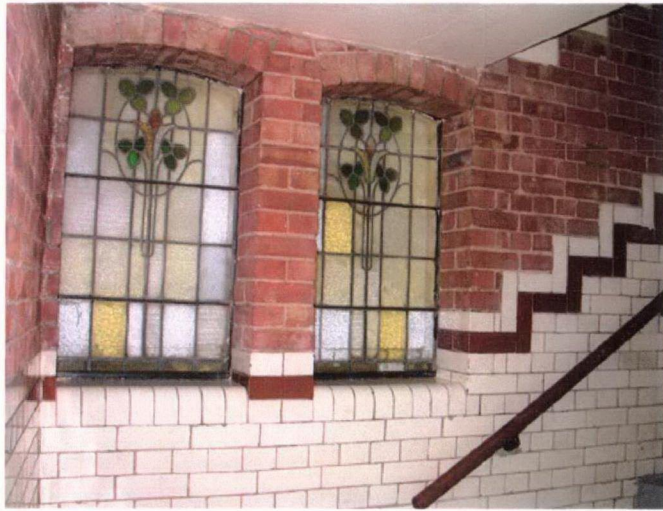
**14.** First landing of rear staircase windows (retained)

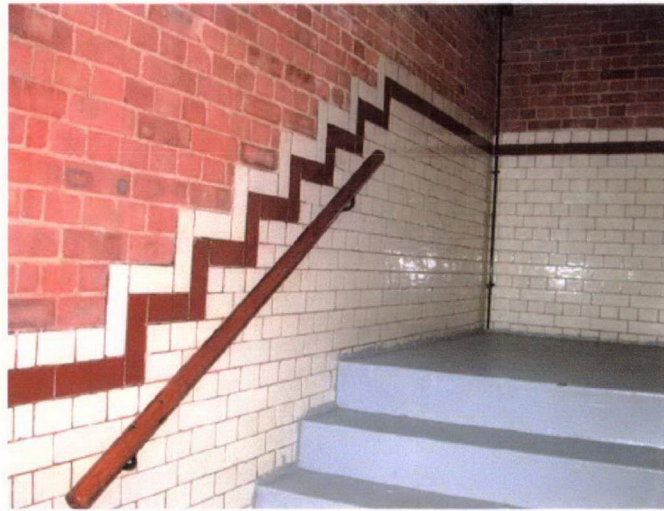
**15.** Rear staircase (removed)

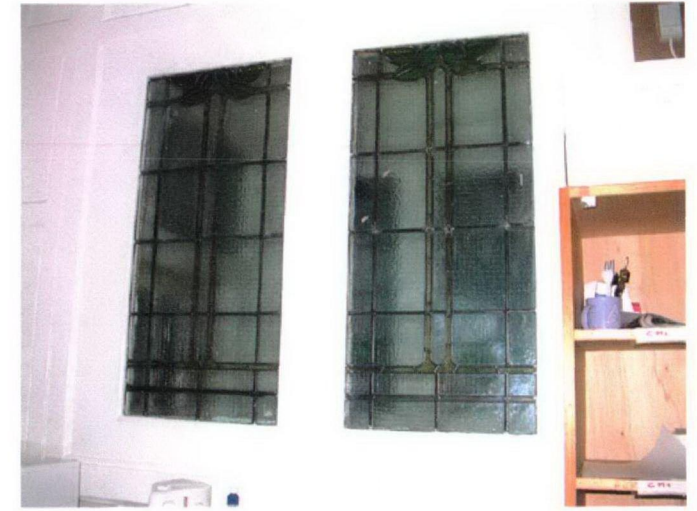
**16.** First floor rear vestibule Panels reused

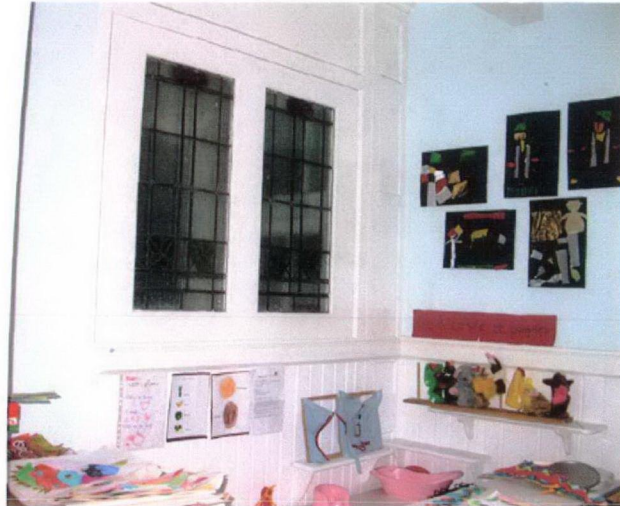
**17.** First floor rear vestibule Panels reused

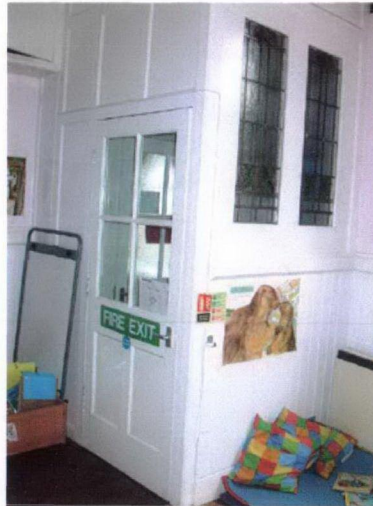
**18.** First floor front vestibule Panels reused

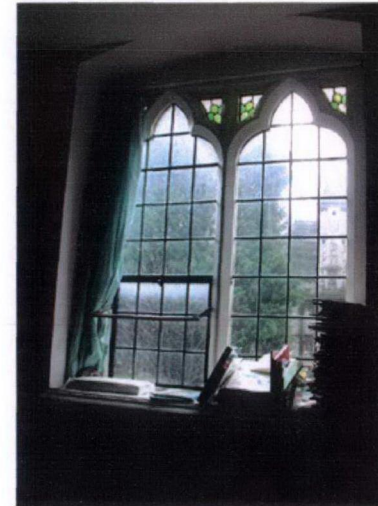
**19.** First floor front elevation window (retained)

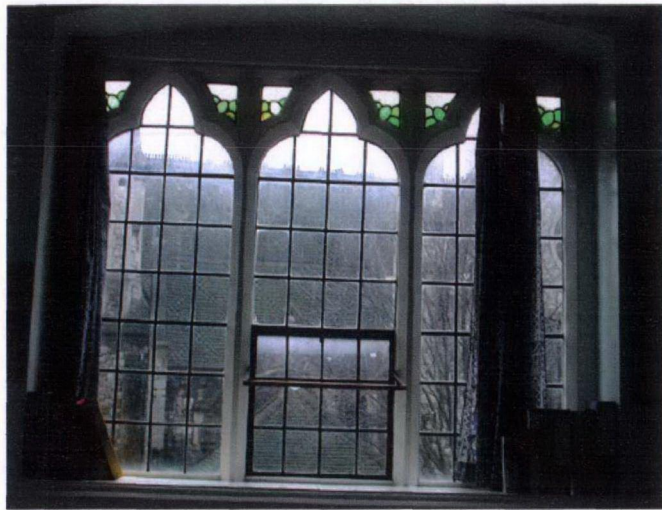
**20.** First floor front elevation window  
(retained)

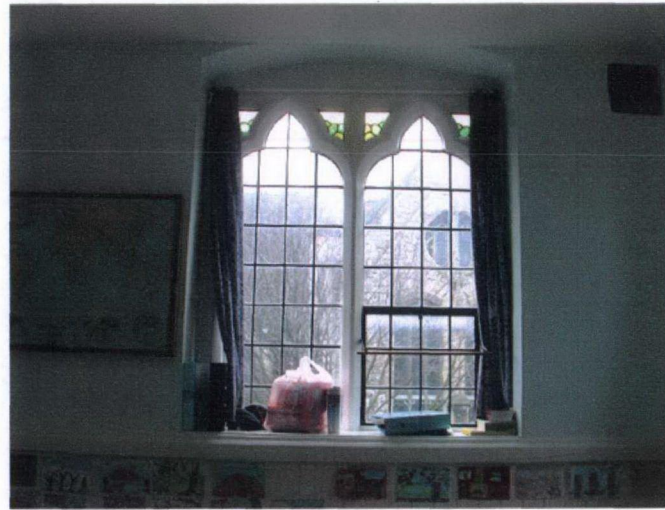
**21.** First floor front elevation window  
(retained)

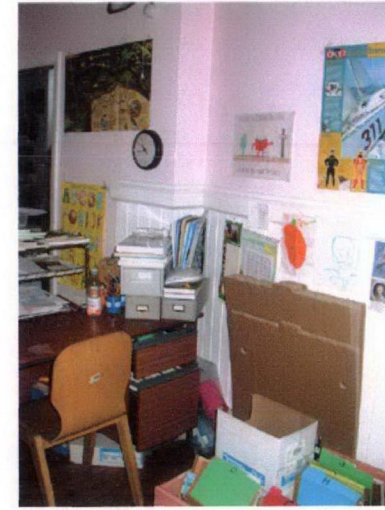
**22.** Timber boarding removed partially

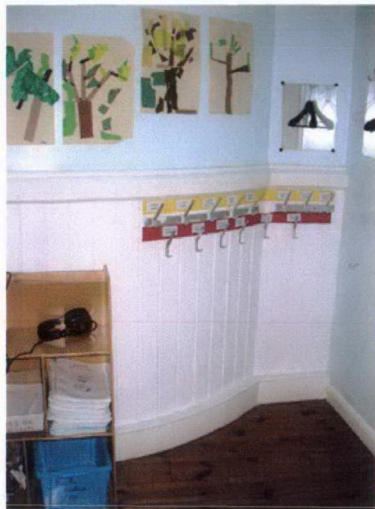
**23.** Timber boarding removed partially

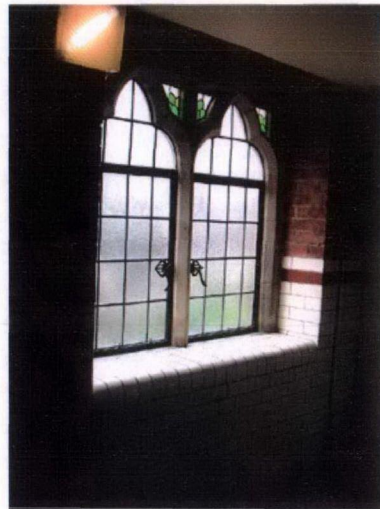
**24.** Landing 3 to front staircase window  
(retained)

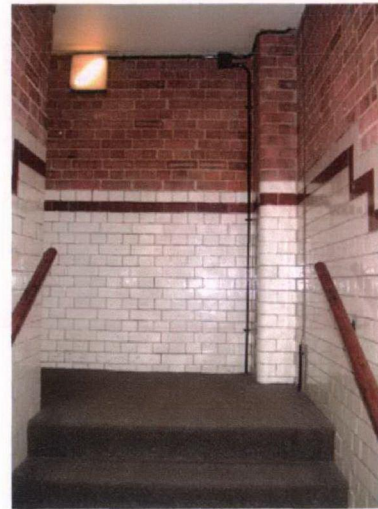
**25.** Landing 4 to front staircase  
(removed)

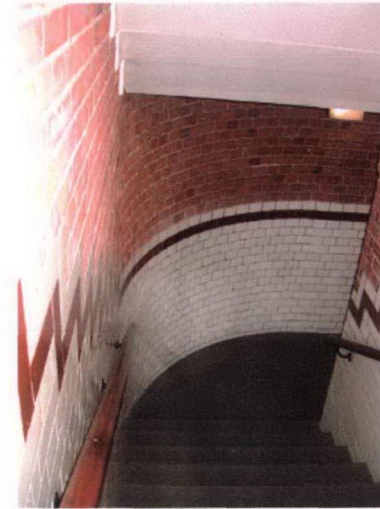
**26.** Landing 4 to front staircase  
(removed)

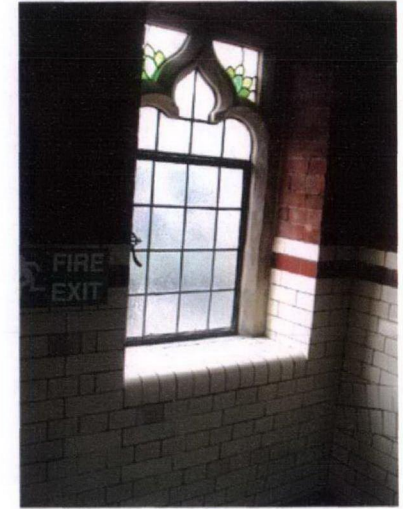
**27.** Landing 5 to front staircase window  
(retained)

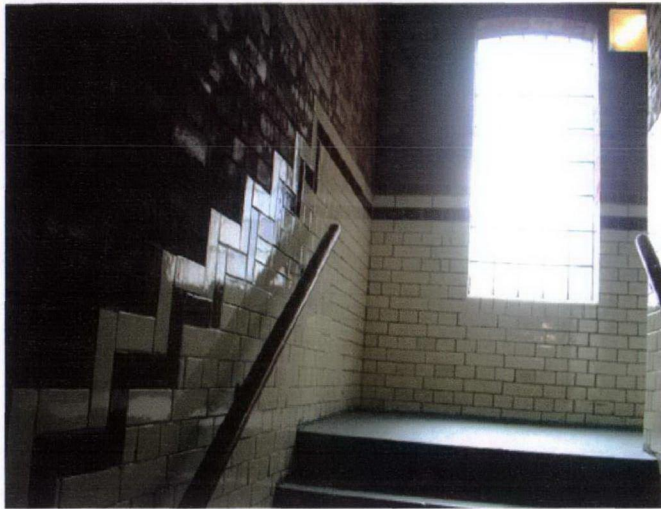
**28.** Landing 6 to rear staircase  
(removed)

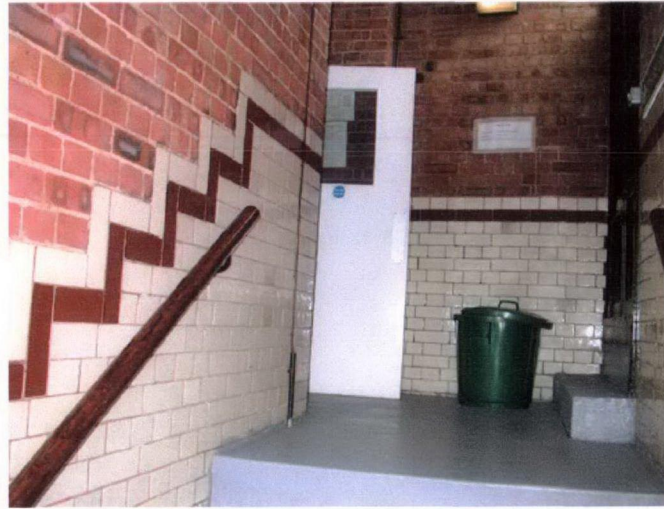
**29.** Landing 7 to rear staircase  
(removed)

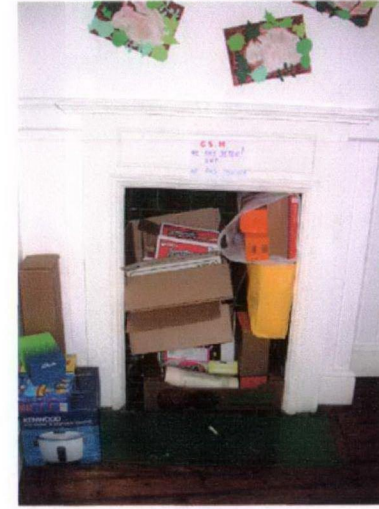
**30.** Fireplace 1 reused

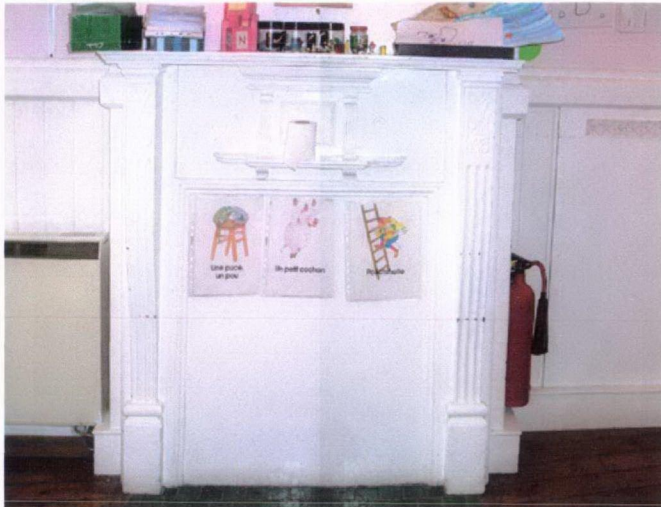
**31.** Fireplace 2 reused

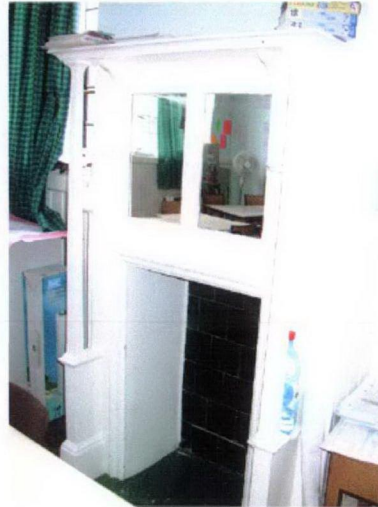
**32.** Fireplace 3 reused

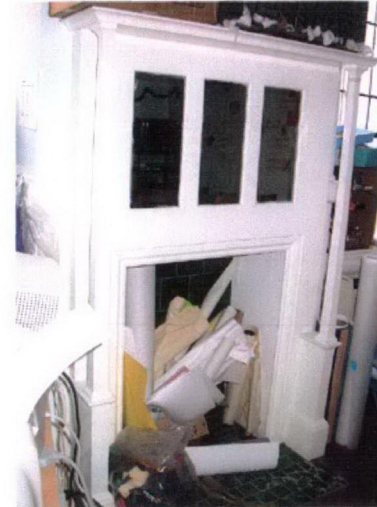
**33.** Fireplace 4 reused

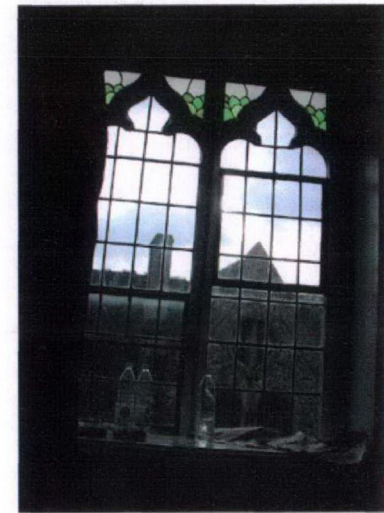
**34.** Second floor front elevation window  
(retained)

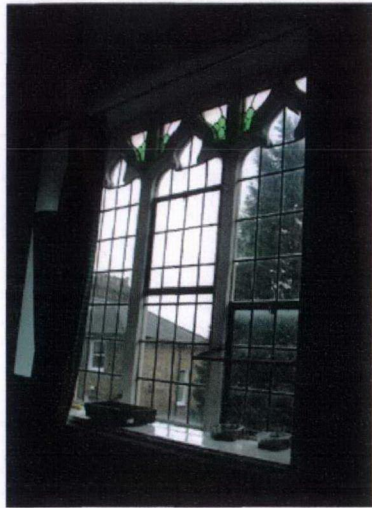
**35.** Second floor front elevation window (retained)

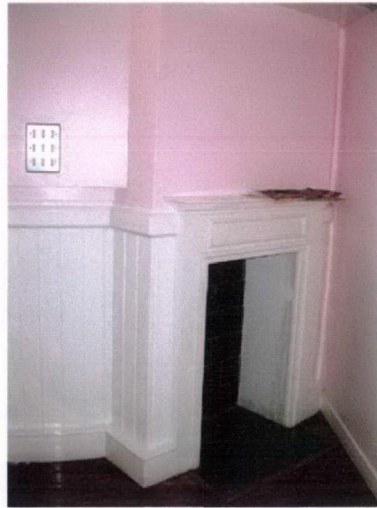
**36.** Fireplace 5 reused

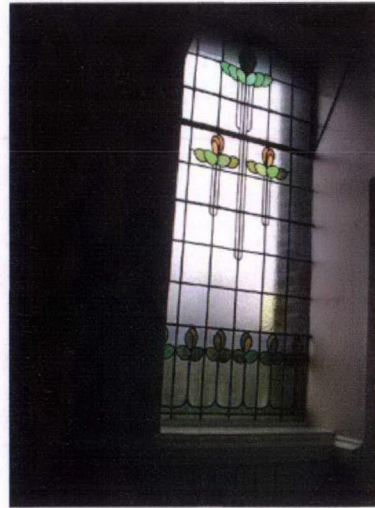
**37.** Second floor NE elevation window to hall (retained)

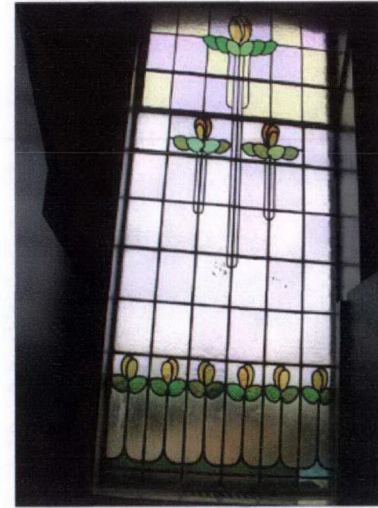
**38.** Second floor NE elevation window to wc (retained)

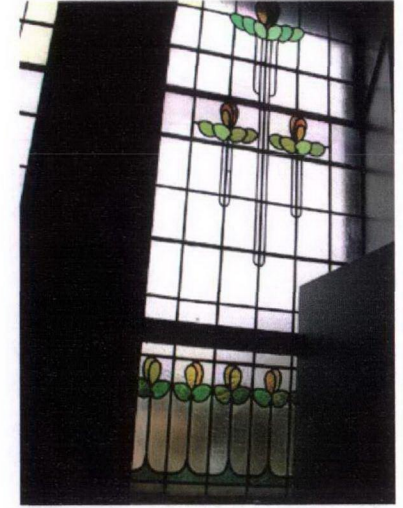
**39.** Second floor NE elevation window to wc (retained)

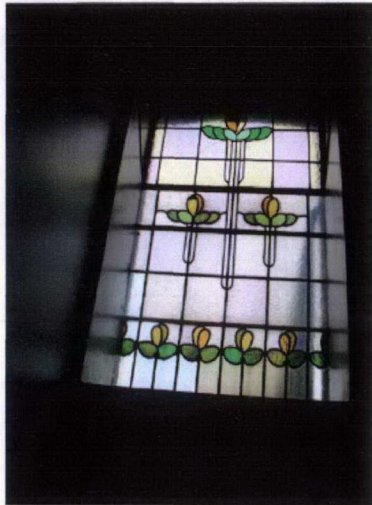
**40.** Second floor NE elevation window to wc (retained)

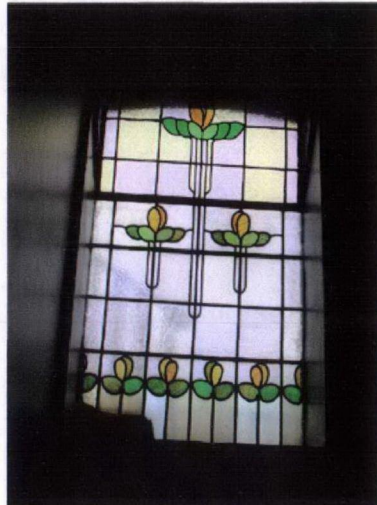
**41.** Second floor NE elevation window to wc (retained)

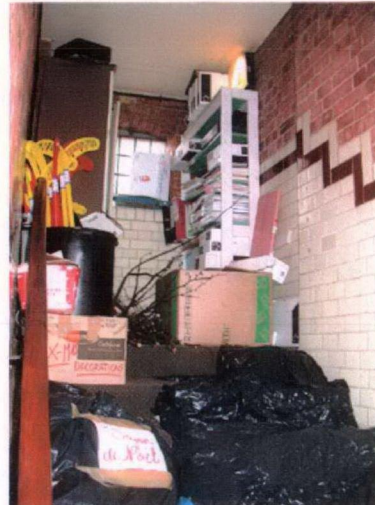
**42.** Landing 6 to front staircase (removed)

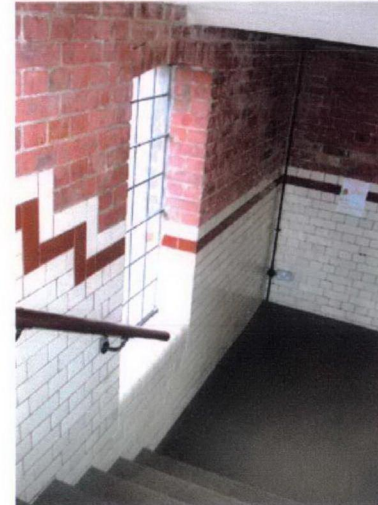
**43.** Landing 4 to front staircase (removed)

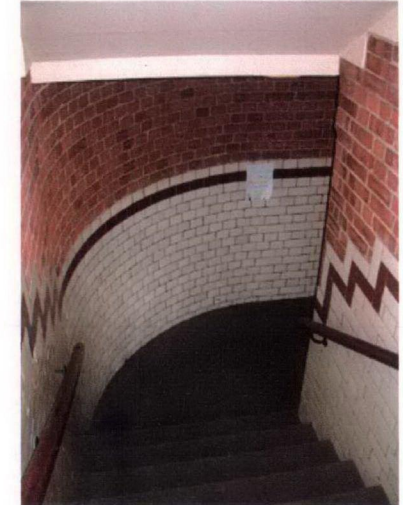
**44.** Landing 1 to front staircase (removed)
