# Arboricultural Assessment Report

## Detailed Report on Trees

| | <b>Risk Address:</b> | Lord Stanley, 51 Camden Park Road, London, NW1 9BH |
| <b>Refs:</b> | <b>OCA Ref:</b> | 47366 |

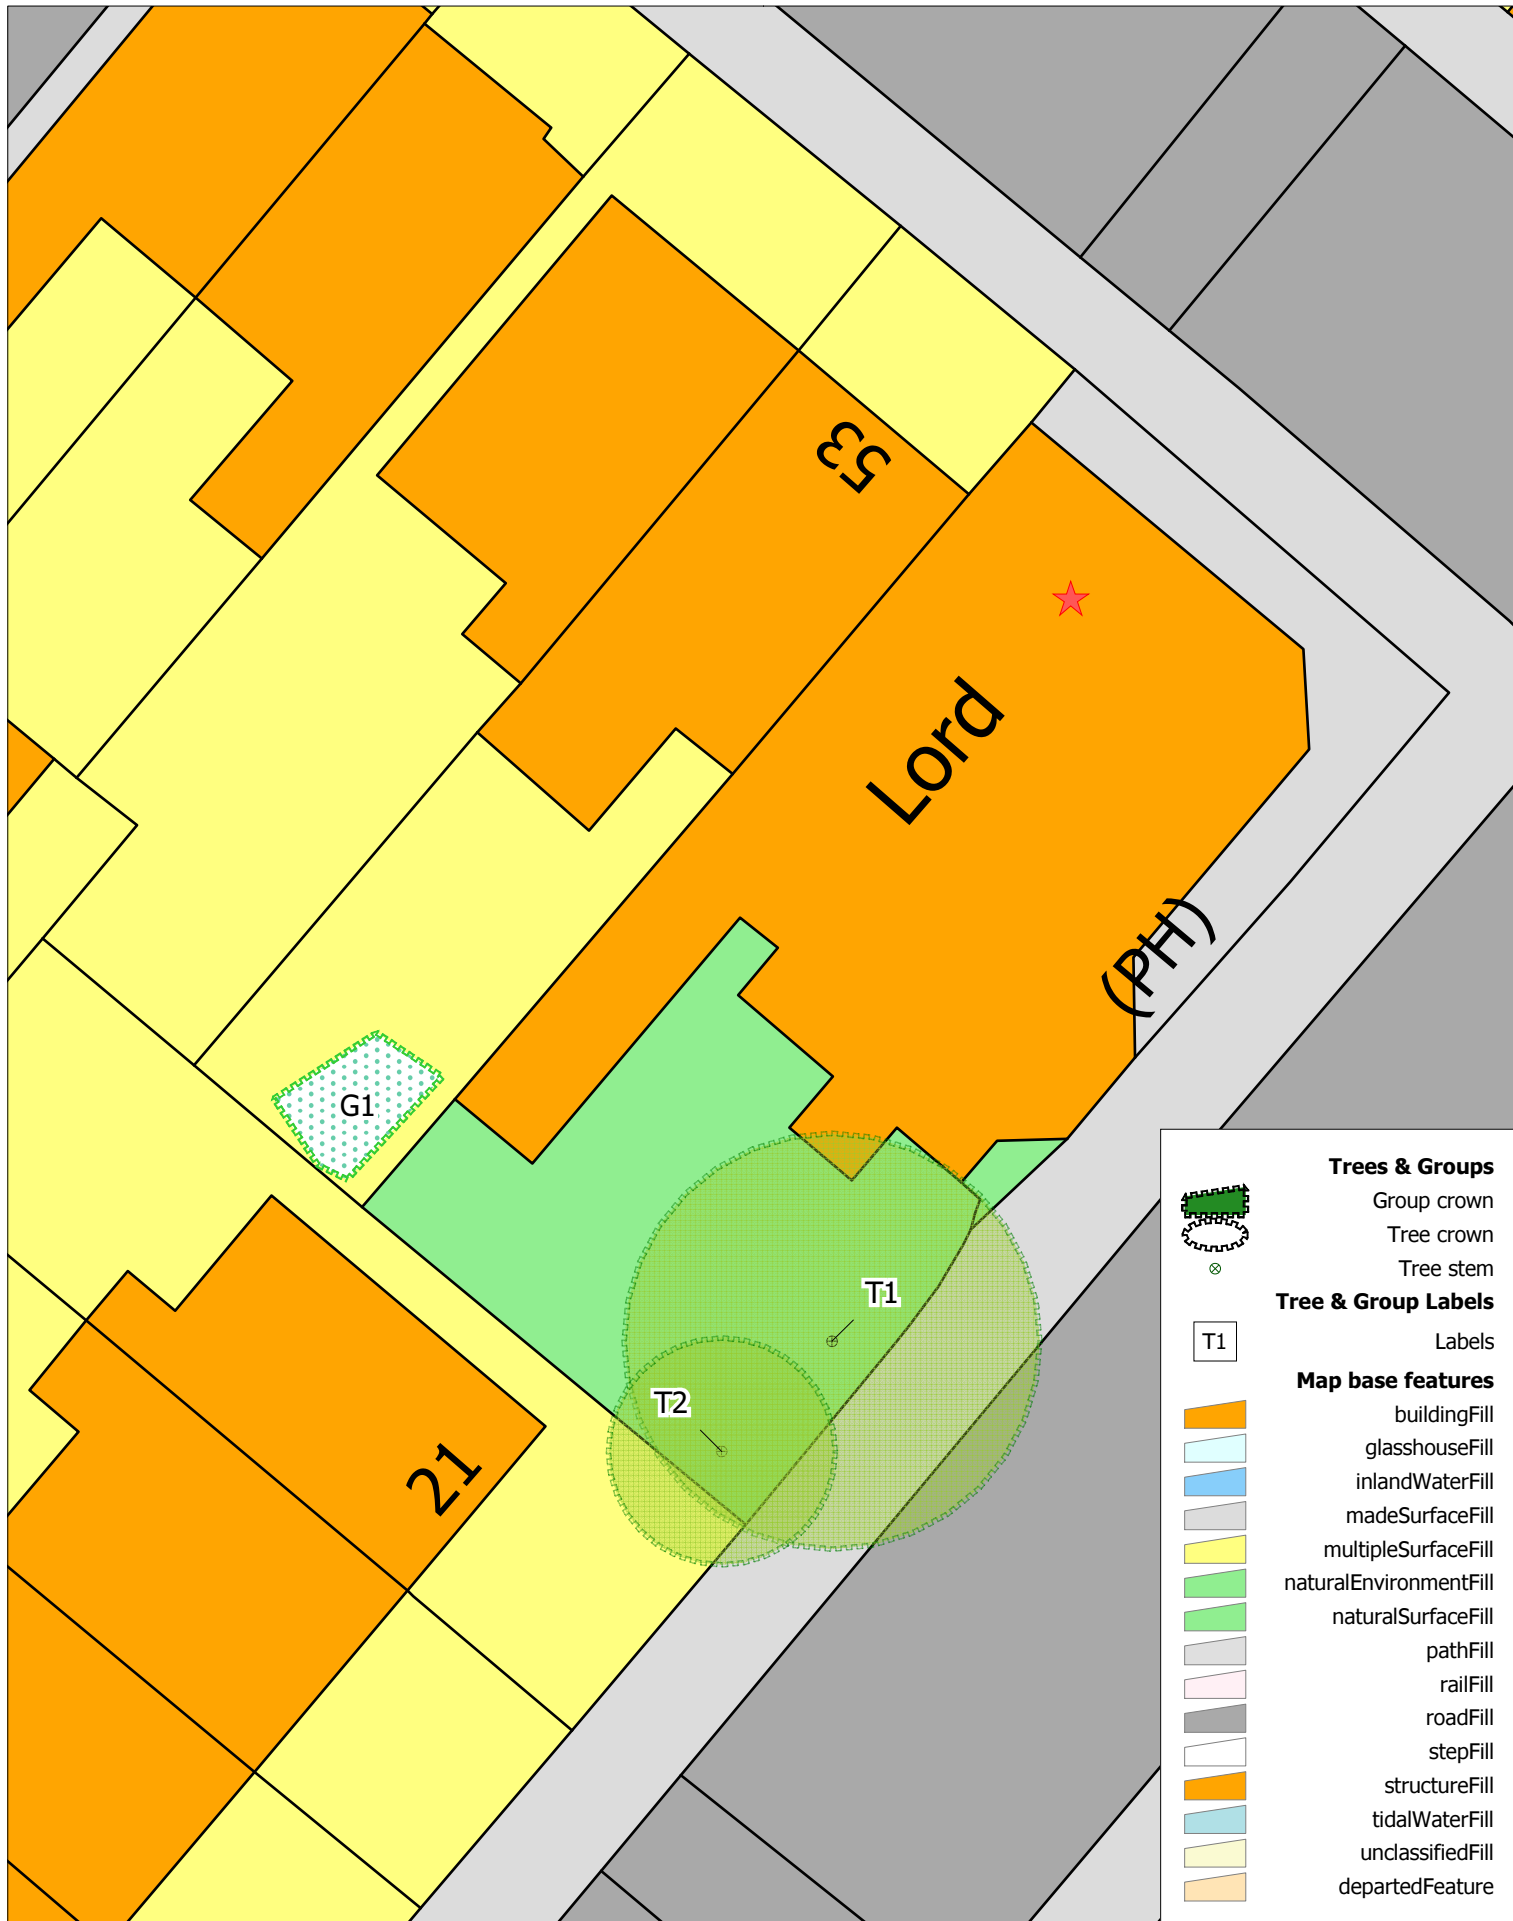
Location: LORD STANLEY, 51 CAMDEN PARK ROAD, LONDON, NW1 9BH  
 Job Ref.: 47366  
 Survey Date: 29/03/2011  
 Scale: 1:200 @ A4

| Tree No | Common Name | Age Class | Condition | Height (m) | Crown Spread (m) | Stem diam. (mm) | Dist to bldg (m) | Pruning history | Recommendation | Tree work constraints | Notes | Owner address | Owner |
|---|---|---|---|---|---|---|---|---|---|---|---|---|---|
| T1 | Sycamore | MA | F | 14.2 | 11 | 460 | 2.6 to main building | Crown lifted. | Fell and treat stump. | Limited access | Some basal decay and included union. | Lord Stanley, 51 Camden Park Road, London, NW1 9BH | PH |
| T2 | Sycamore | MA | F | 12.1 | 6 | 410 | 7.3 to main building | Crown lifted. | Fell and treat stump. | Limited access | Basal decay. | Lord Stanley, 51 Camden Park Road, London, NW1 9BH | PH |
| G1 | Mixed Species | EM | F | 7.5 | 4 | 150 | 2.5 | Reduced >5 years ago | No work required. | Limited access | All dimensions estimated due to third party ownership. Included Cotoneaster. | 53 Camden Park Road, London, NW1 9BH | P3P |

| Tree No: | Species | Works Required |
|---|---|---|
| T1 | Sycamore | Fell to as close to ground level as is practicable and treat stump with an appropriate herbicide to prevent future growth |
| T2 | Sycamore | Fell to as close to ground level as is practicable and treat stump with an appropriate herbicide to prevent future growth |
