**ENGINEER'S REPORT**

**INSURED NAME:** Punch Taverns PLC

**RISK ADDRESS:** Lord Stanley Public House  
51 Camden Road  
London  
NW1 9BH

**ENGINEERS REFERENCE:** 10389

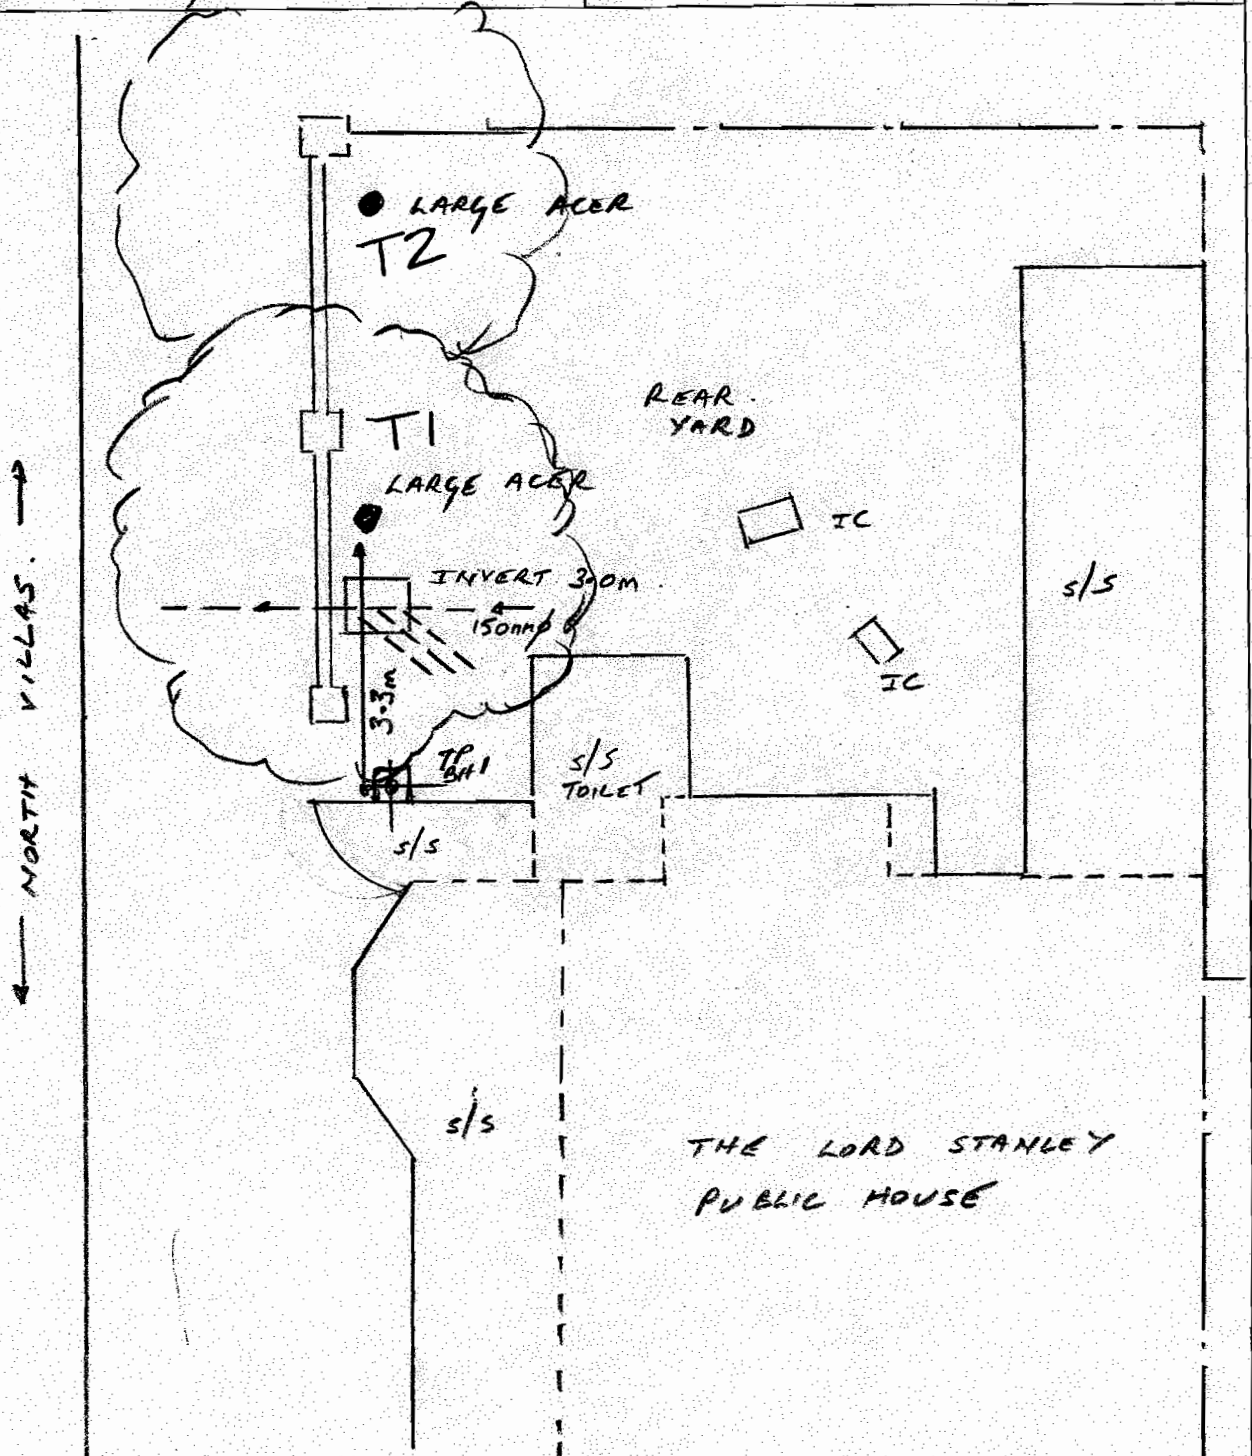
# Site Plan:

A single trial pit and borehole were excavated to the rear left hand corner as indicated on the attached site plan prepared by Soiltech Surveys.

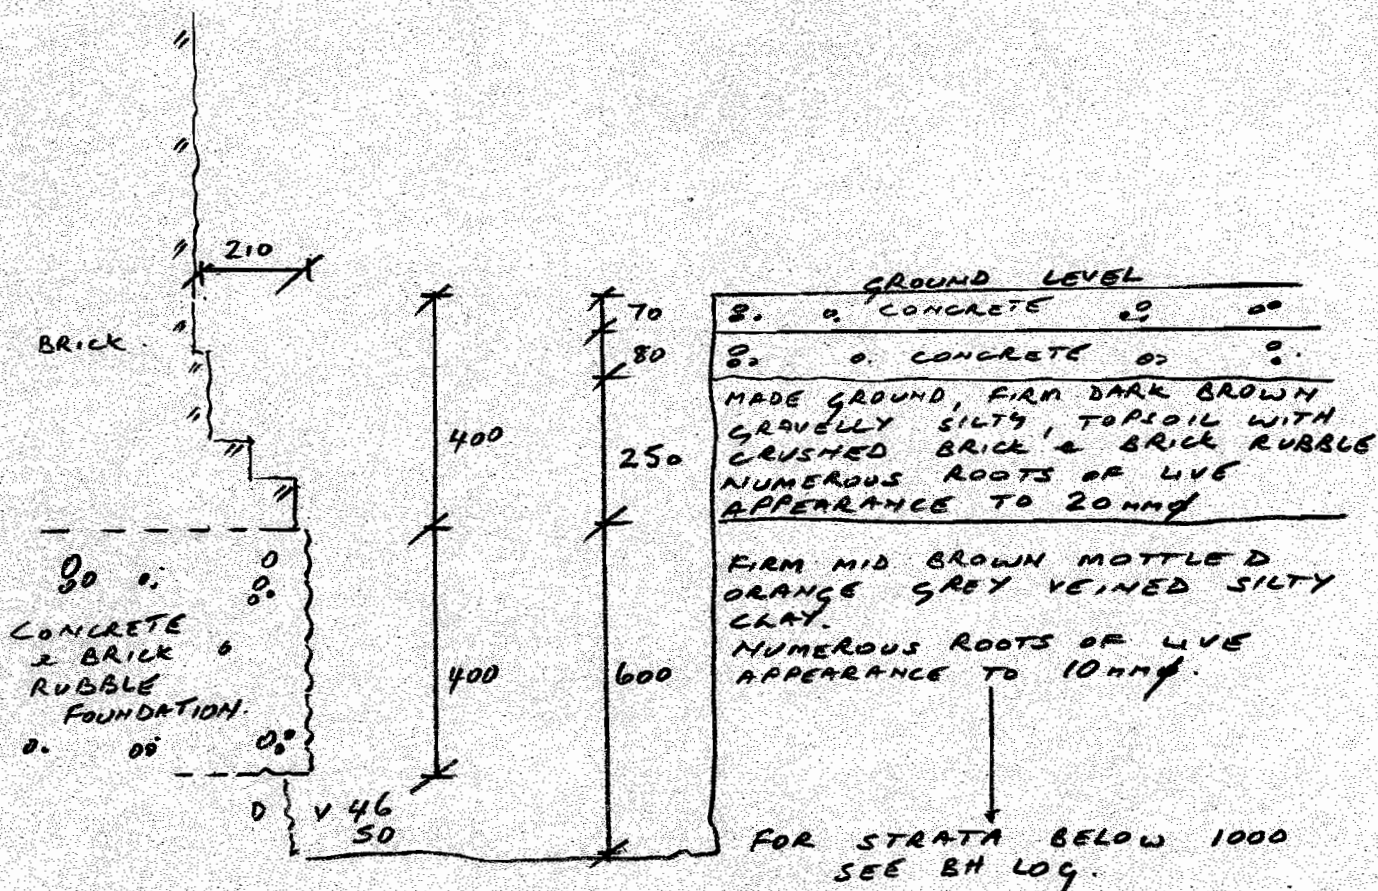
Trial pit No: /	Sheet: 10E1	<b>Soiltech Surveys</b> Foundation Investigation & Test Drilling Tel/Fax: 01245 496389
	Ref No:	
Not to scale:	Date: 05-01-2011	Site: THE LORD STANLEY PUBLIC HOUSE 51, CAMDEN PARK ROAD LONDON NW1.
Client: RICHARD F GILL & ASSOC

Foundations were seen to comprise a shallow concrete strip resting 800 mm deep below ground level on firm silty clay. A borehole within the trial pit revealed similar silty clays to termination at 4 m deep, with fragmentation from 1.3 m to 1.7 m deep.

Roots of live appearance up to 10 mm in diameter were noted at underside of foundation with fine live roots to 3.5 m deep within the borehole. Roots taken from the trial pit and borehole and sent for analysis were identified as live Acer roots.

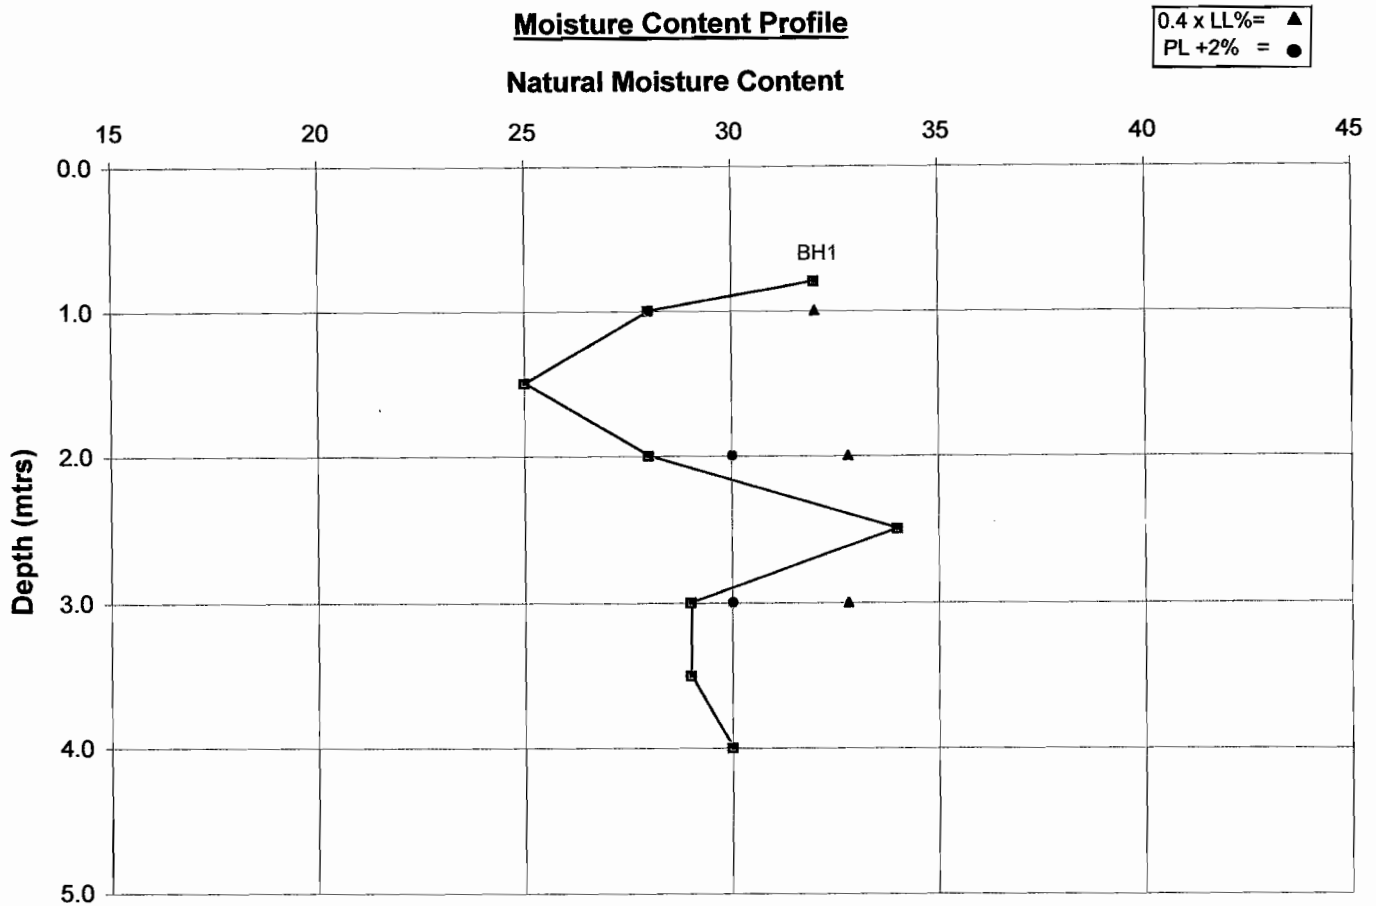
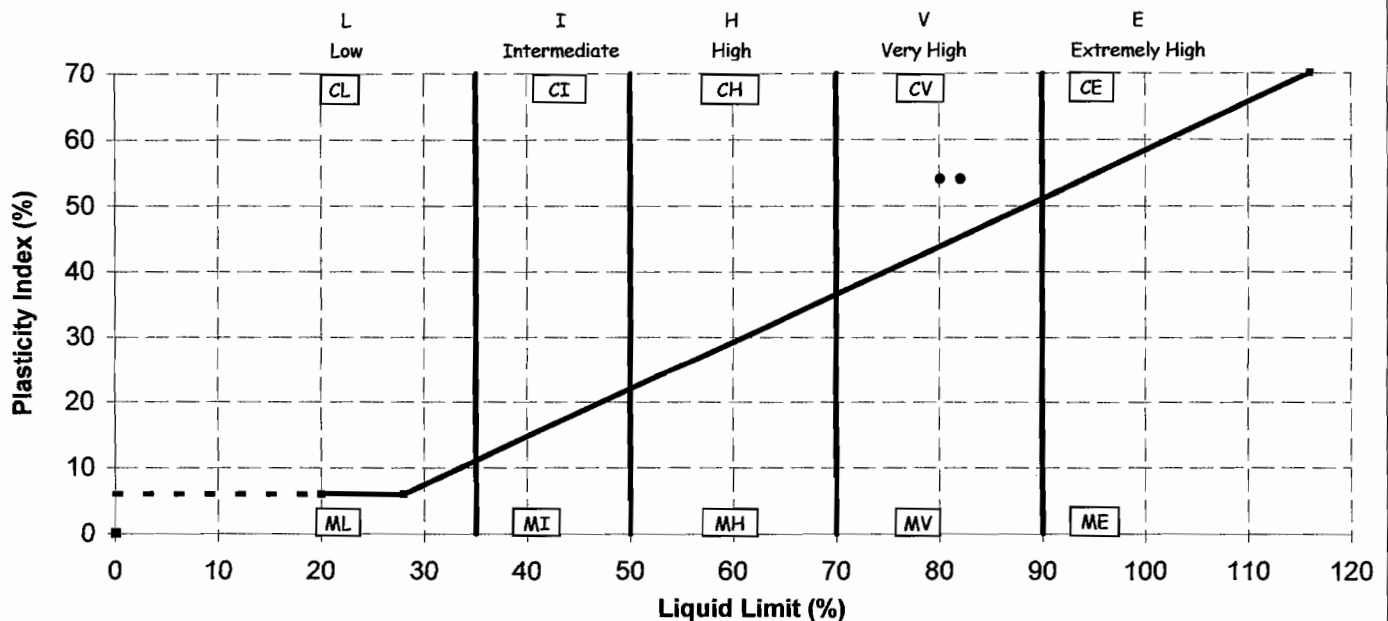
## Moisture Content Profile

Laboratory testing indicates clays of very high plasticity with clear desiccation between 1 and 2 m deep and probably no desiccation at 2.5 m deep and below.
