Ref: BA3234rev1

Date: 02/03/2012

RE-ASSESSMENT OF PLANE TREE IN REAR GARDEN.

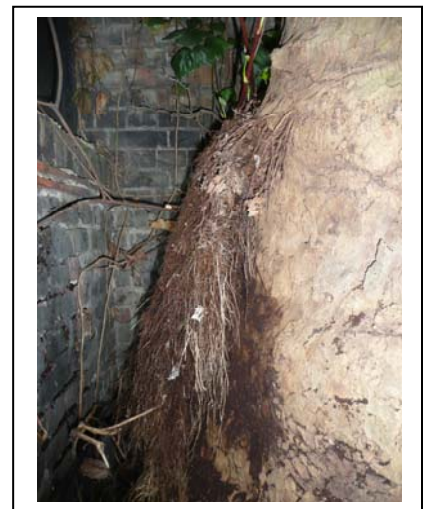
Comments: The tree is located in a narrow bed in the northwest corner of the garden close to the rear and side boundary walls. The area between the stem and the wall is filled with leaves which have accumulated over the recent seasons as shown in the photograph. Cracking can be seen in the nearby walls.

The northern and western tree buttress touches the wall at a low level, when measured at 600mm above the ground the face of the stem has a gap of approximately 200mm between the brick work and the tree.

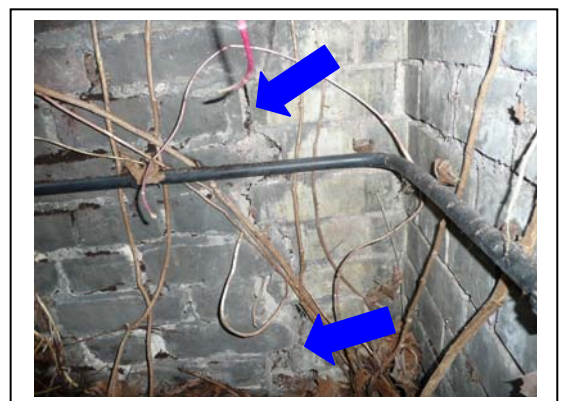
Closer assessment of the western wall shows a large step crack which extends vertically from a point close

to the stem as indicated by the blue arrow in the photograph opposite. Elsewhere the western boundary has a series of smaller step cracks which I assume is a result of direct damage.

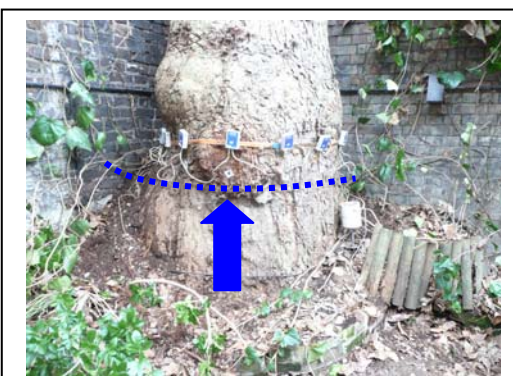
Closer assessment of the stem shows a distinct flaring of bottle butt normally an indicator of internal decay, which prompted the internal assessment. Unfortunately, due to the presence of the wall I was unable to accurately measure the stem dimension as would normally be undertaken using the Picus equipment, to get around this the north-south axis of 1250mm and the east-west axis of 1300mm were used to create an ellipse and the sensor points were set at equal intervals.

The assessment height is approximately 800mm above ground level, at a point where the stem

circumference is 3800mm indicated by the blue dotted line on the photograph above. This is the same location as the assessment in 2011 to enable a comparison of the results. The blue arrow shows the position of Sensor 7.

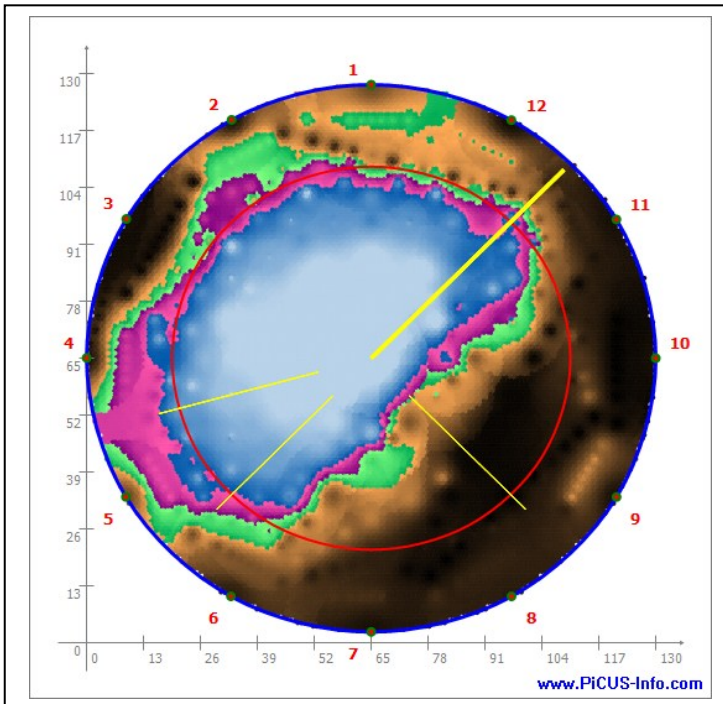
2011 Results

The Tomograph shows that the internal section of the stem has been affected by a section of stem decay indicated by the blue and magenta areas, which in a significant area goes beyond normal safe limits shown by the red line which shows the position of the 30% stem radius.

The yellow line on the tomography indicates the likely presence of internal cracks, which may have accelerated the spread of the decay fungi and may have adversely affected the tomography by increasing the time of flight for the sound signal.

A significant area of decay is present in the north western section of the stem indicated by the Blue section.

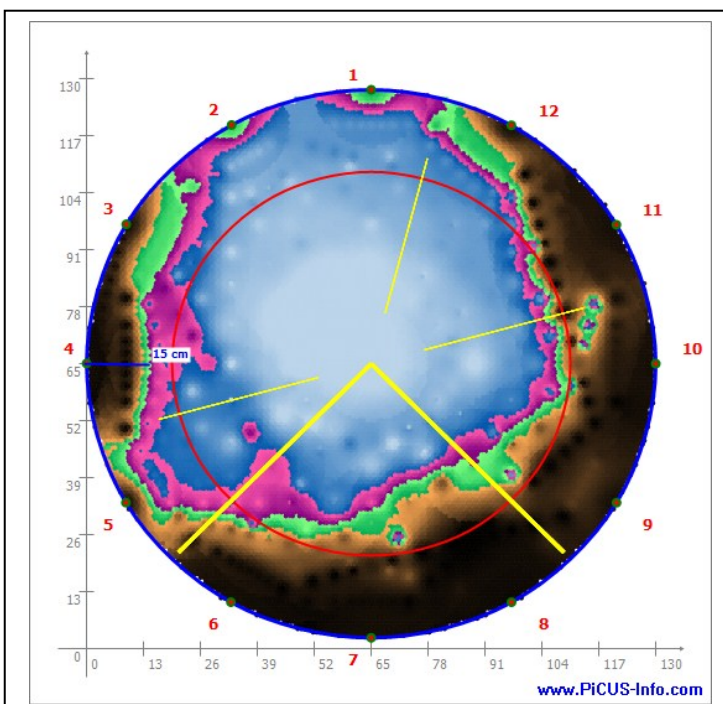
2012 Results

The yellow line on the tomography indicates the likely presence of internal cracks which are more defined than previously.

The extent of internal decay is significantly increased in volume and breached the Red minimum safety line in several places.

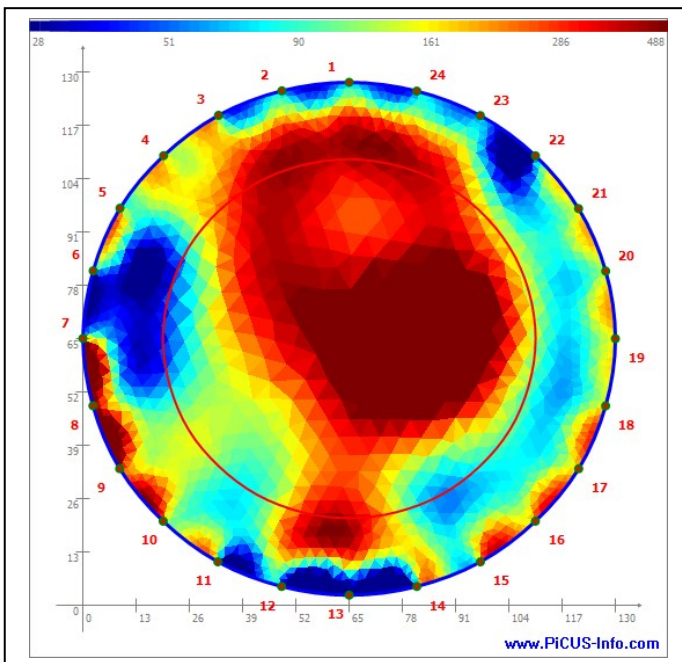
2011 Results

The results show the tree to have an area of elevated resistance or drying of the wood in the central section indicated red.

The additional red areas on the outside of the stem around sensor 7 to 10 and particularly sensors 15 to 18 indicate restrictions in sap flow likely a response to the competitive environment.

The central section of the stem has a significant elevation in drying, indicating the area is affected by advanced decay.

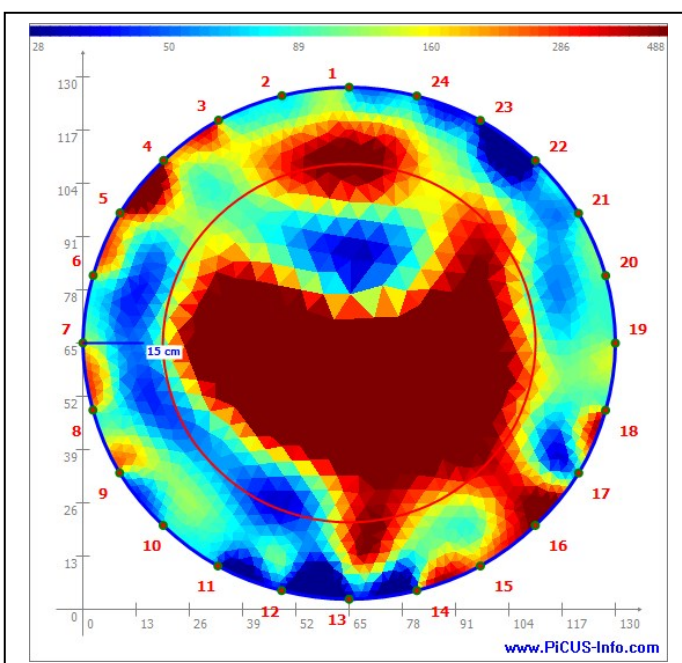
2012 Results

The outer stem has a higher moisture content which is assumed to be related to moisture storage during the dormant period.

The additional blue area in the northern stem is expected to be a response of elevated moisture content in the decayed element.

The area of elevated resistance (red) closely follows the pattern of decay shown in the sonic result of this year. Showing the central section of the stem has a significant elevation in drying, indicating the area affected by advanced decay.

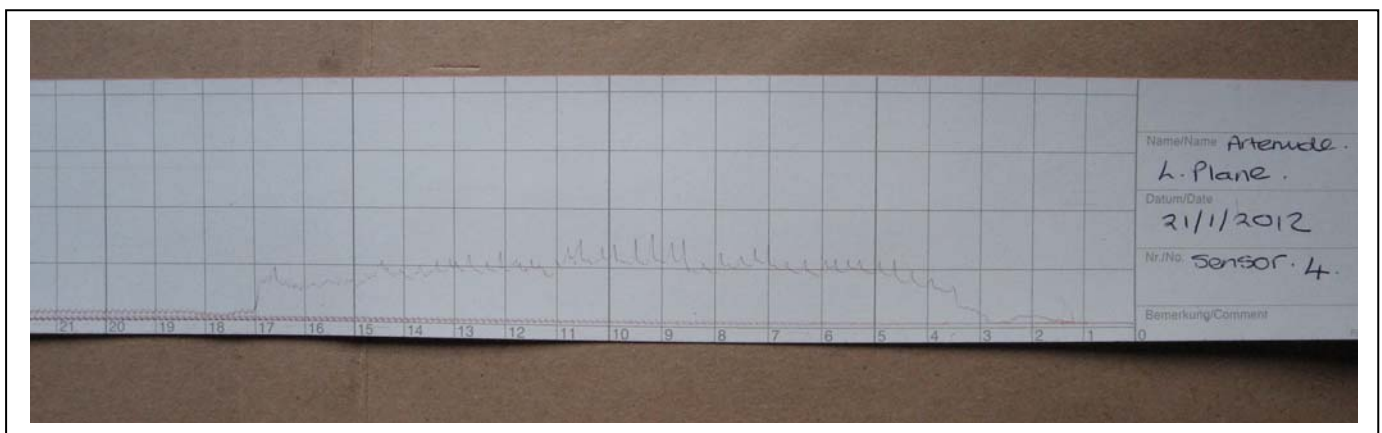
A third successful assessment was made on the western stem at sensor point 4 which was chosen as the most likely to have soft sections of the stem based upon the tomogram results and sounding with a mallet (this area of stem produced a distinct hollow sound when struck).

The results show the tree to have typical increasing wood quality through the bark and the vascular tissue from 3 cm on the trace, with relatively low quality wood extending to 17cm into the stem before hitting a cavity. This gives the tree a sound wall thickness of only 14cm and aligns well with the results on the tomographs above on which I have drawn a 15cm line on the represent the location of the Resistograph.

The decay in the lower stem has caused the stem to thin to 14cm at sensor 4 which leaves the tree predisposed to Euler buckling, which is a situation which is neither predictable or manageable.

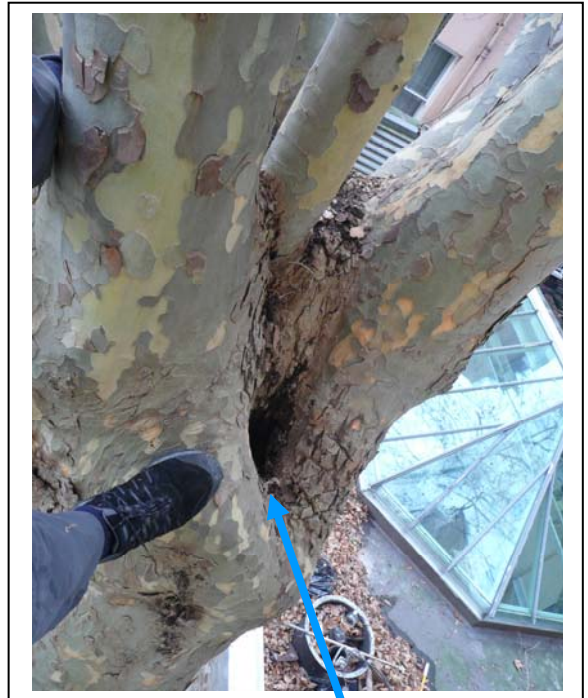
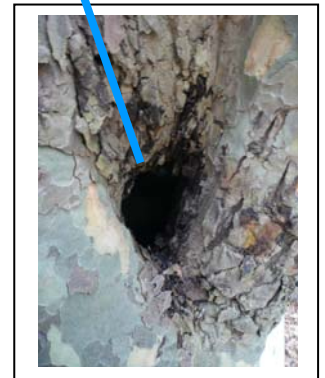
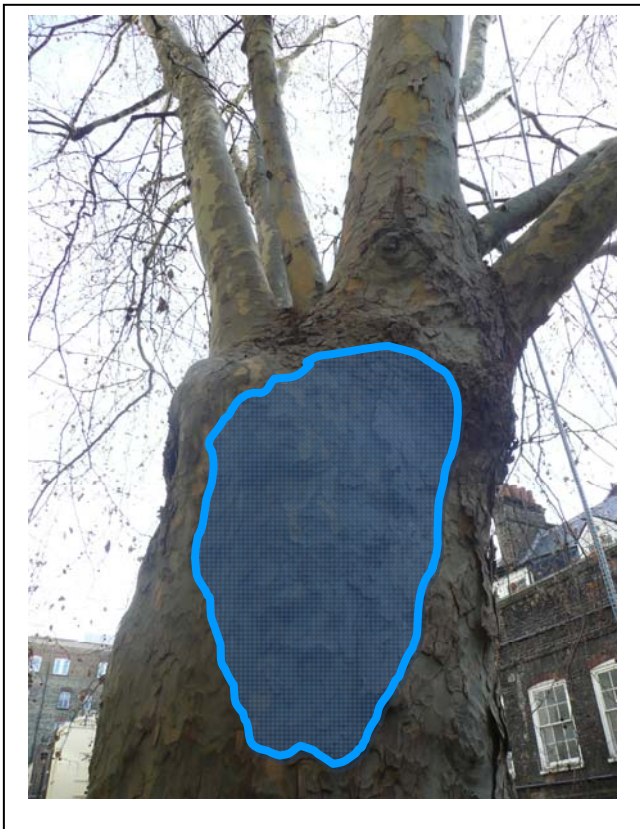
This shows a hole on the north western face of the stem, leading to a cavity that extends both below the main collection of branch attachments and down the stem to some 1200mm.

I have attempted to show the extent of the cavity on the photograph below indicated by the blue shading.

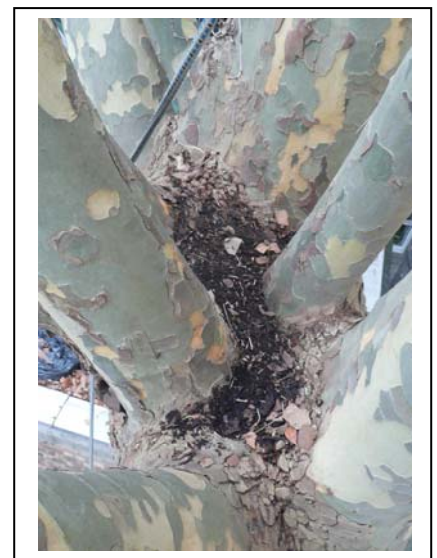
The main canopy attachments are typical of such a previously lopped tree with a slight depression which is filled with organic matter. The feature is typically congested and included unions can be expected to develop as the stems increase in diameter, leading to the formation of a series of tightly formed unions liable to collapse.

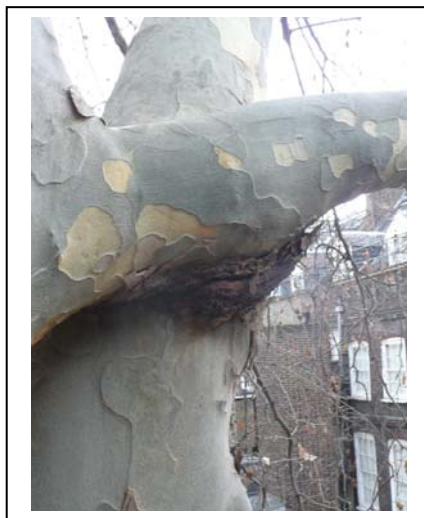
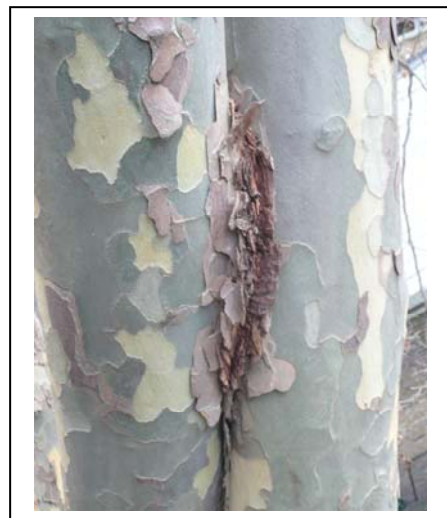
Elsewhere in the canopy a series of rubbing main leaders and crossing and rubbing main branches can be seen as shown in the photograph below. These can be expected to develop into abrasion wounds and become a site for pathogen entry, ultimately leading to branch failure.

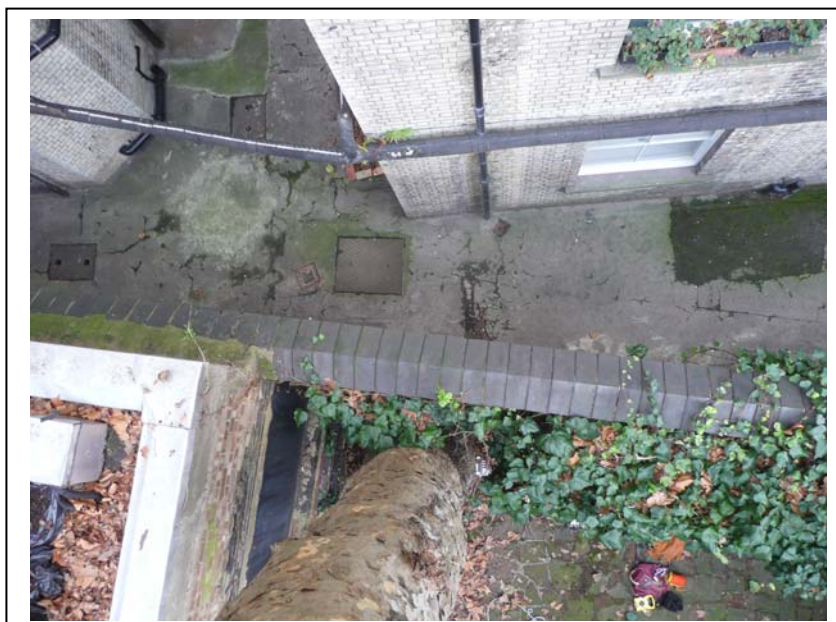
Whilst in the tree a quick visual assessment of the neighbouring land shows signs of direct root damage to the wall with the boundary wall being deflected out of position as shown opposite.

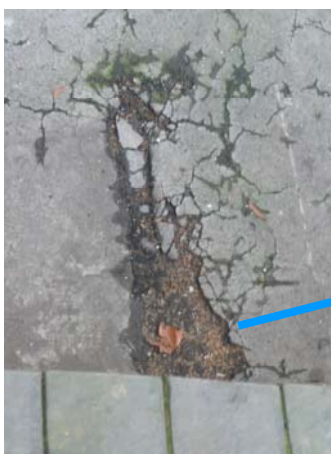
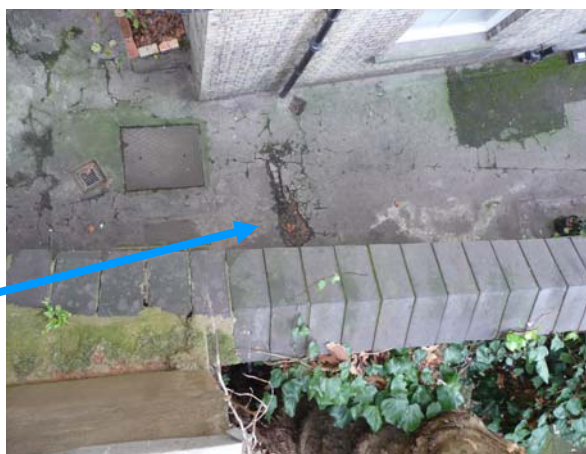
In addition to this the neighbouring footpath has suffered direct damage from tree roots as shown in the photograph opposite which could form a trip hazard.
