**Pictures in support of application to renew or repair windows
To No.1 Roger street & No. 1 Doughty Street**

Photos in support of the application to Camden Council to repair
and renew windows

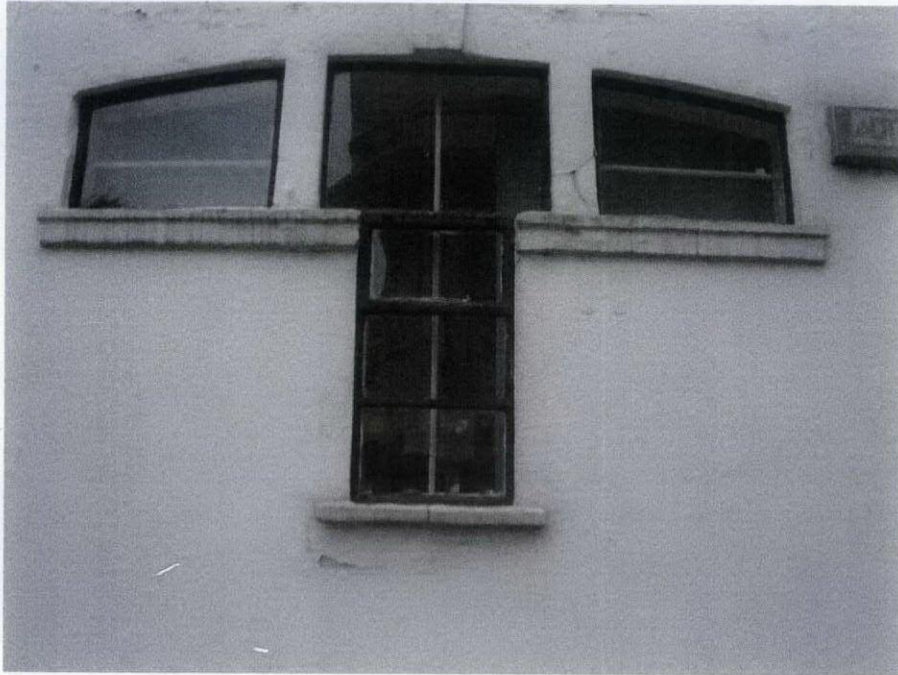
Drawing No. 1 is a typical window situation on Roger Street which is slowly disintegrating and is now unopenable.
Drawing No. 2 is a window in Doughty House and again is in a very poor state of repair, and no longer openable

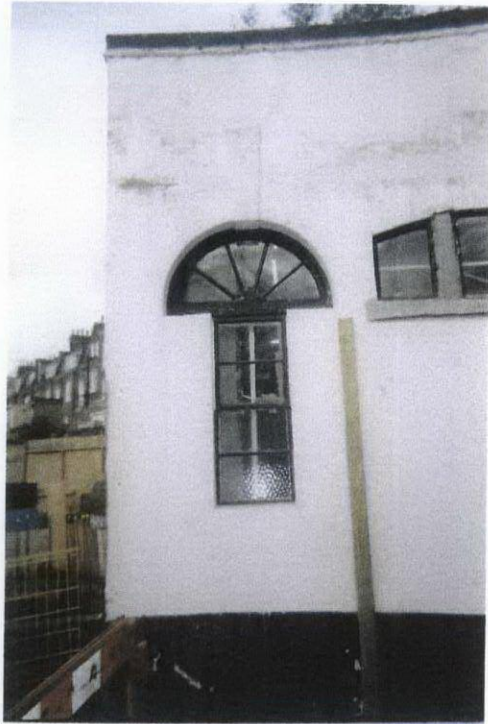
Drawing No. 1 is of Roger Street
Which is the end of the building
Where a new building is under
Construction with Aluminium

windows

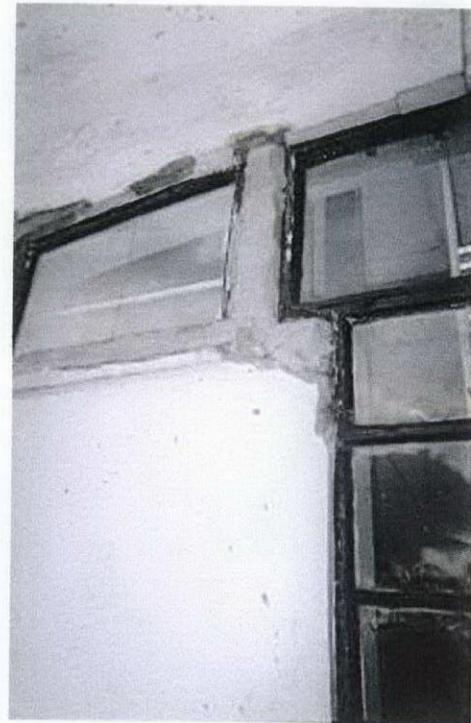
Drawing No. 2 is also of Roger
Street showing the bad
condition of the window and its
surround
