BRITISH MUSEUM -  
KEB LEADWORK PROJECT

SUMMARY OF OBSERVATIONS ON  
CONDITION OF EXISTING STRUCTURE

| CPA/420/102 | |

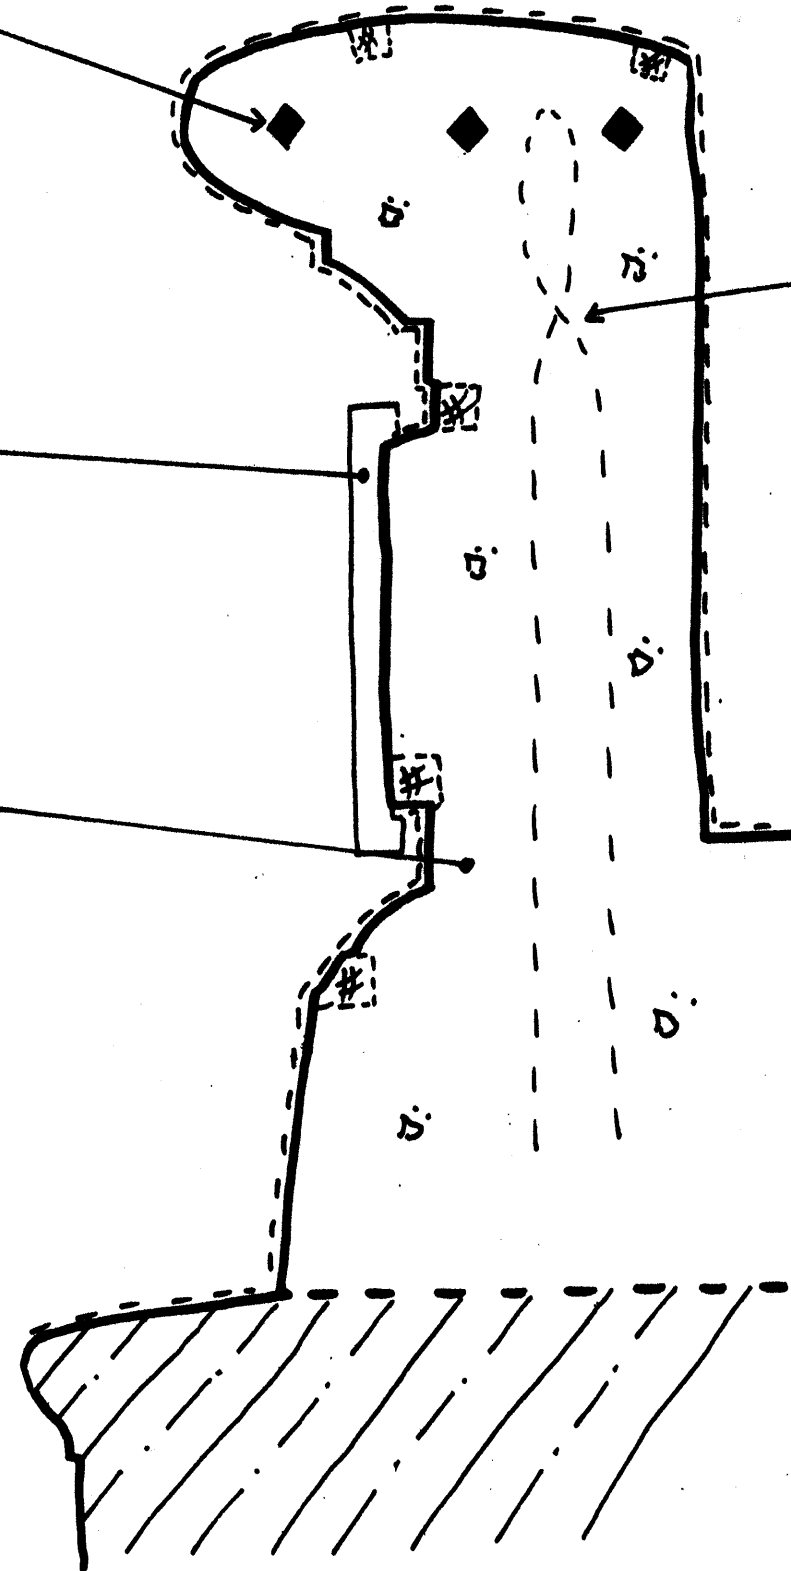
KNIFE REINFORCEMENT BARS AT TOP OF PARAPET ARE CORRODING + DELAMINATING.

FRANKS BETWEEN DECORATIVE LEADWORK AND PARAPET ARE FAILING.

CHUNKS CONCRETE IS SPALLING CAUSING LEADWORK TO CRACK AND BECOME DETACHED. [REFER TO ARCHITECTS DRAWINGS FOR DETAILS OF DEFECTS TO LEADWORK].

GENERAL REINFORCEMENT IS CORRODING.

EMBEDDED STEEL COLUMNS HAVE SURFACE CORROSION
