**Report No. 3469**

**King Edward VII Building  
British Museum**

**Details of Weathering Lead  
Alterations and  
New Stainless Steel Armatures**

**November 2009**

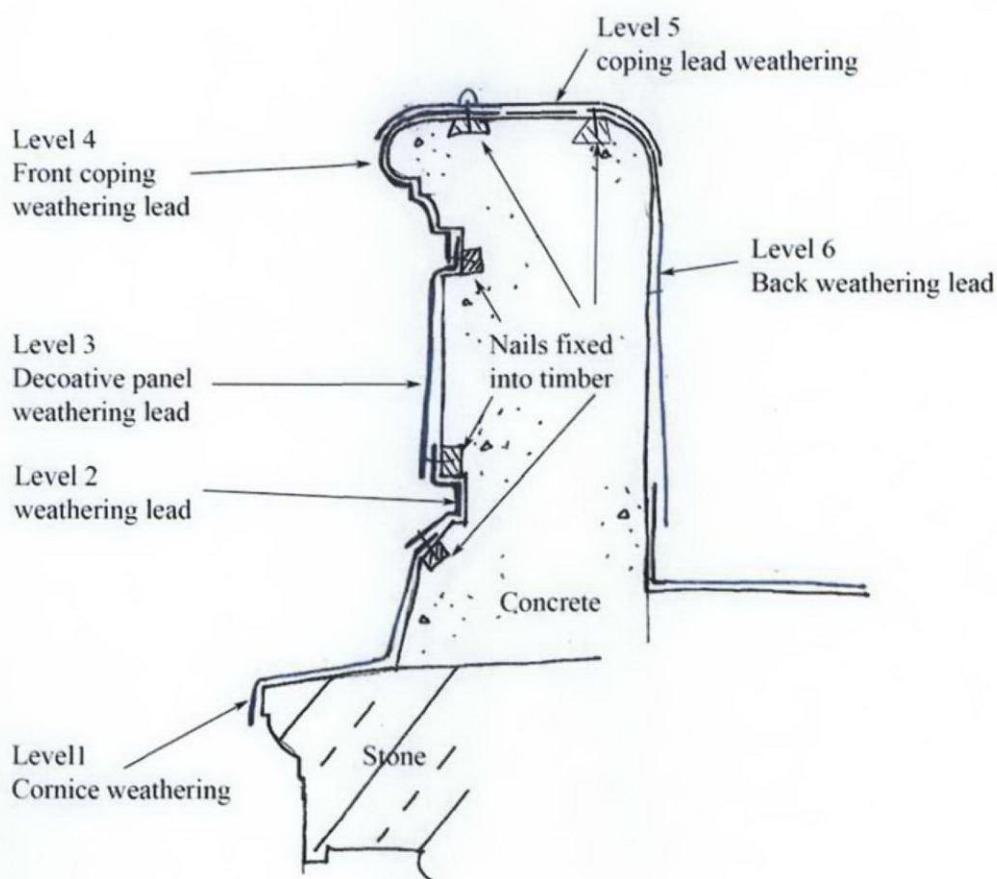
Figure 1. Section through parapet showing new lead arrangement

The alterations to the leadwork were carried out as described in Graham Abrey's report, to BSEN 12588:2006, and the current BS6915 Code of Practice.

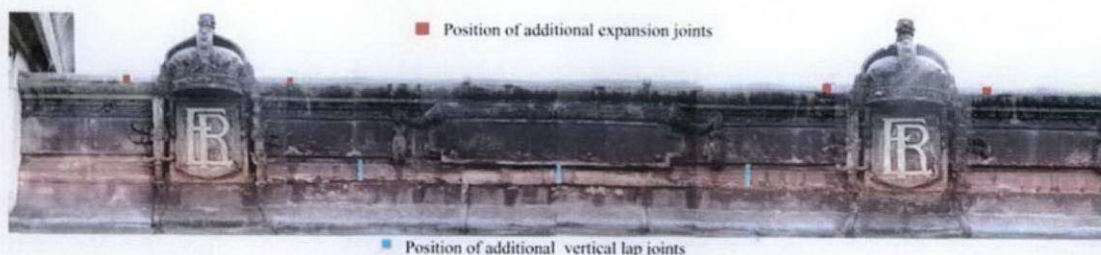
Figure 2. Position of additional welts and lap joints at front

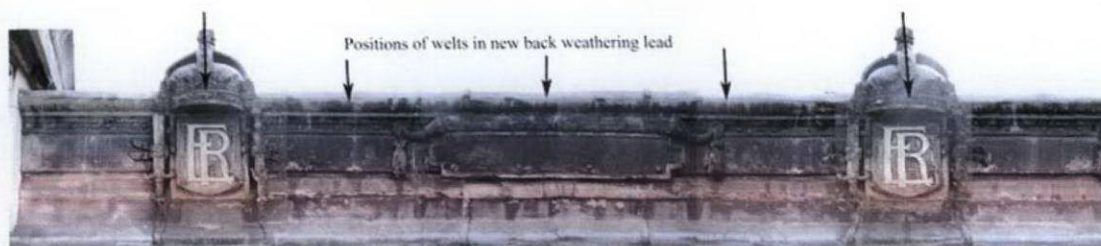
Figure 3. Position of welts in new lead at back

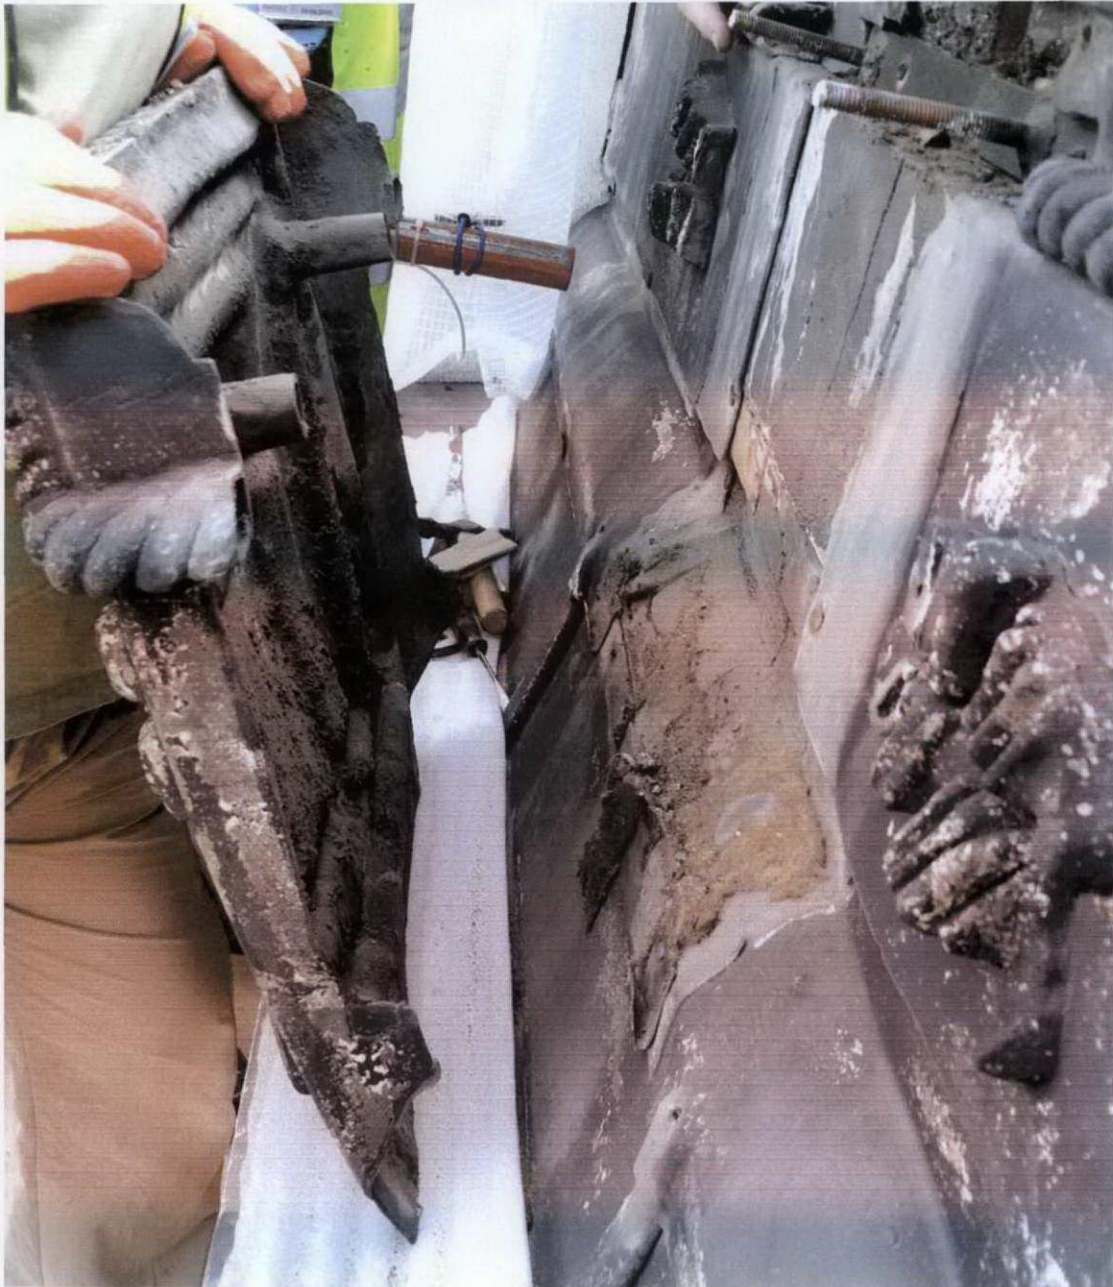
The Shield decoration was fixed to a bracket consisting of two brass studs braised to a strip of brass that is screwed to timber set into the parapet. The bracket is adequate, but all the weight hangs from the two lead tubes in the back of the shield. We have fitted a simple stainless steel armature to spread the load more evenly.

Figure 4. Shield during removal

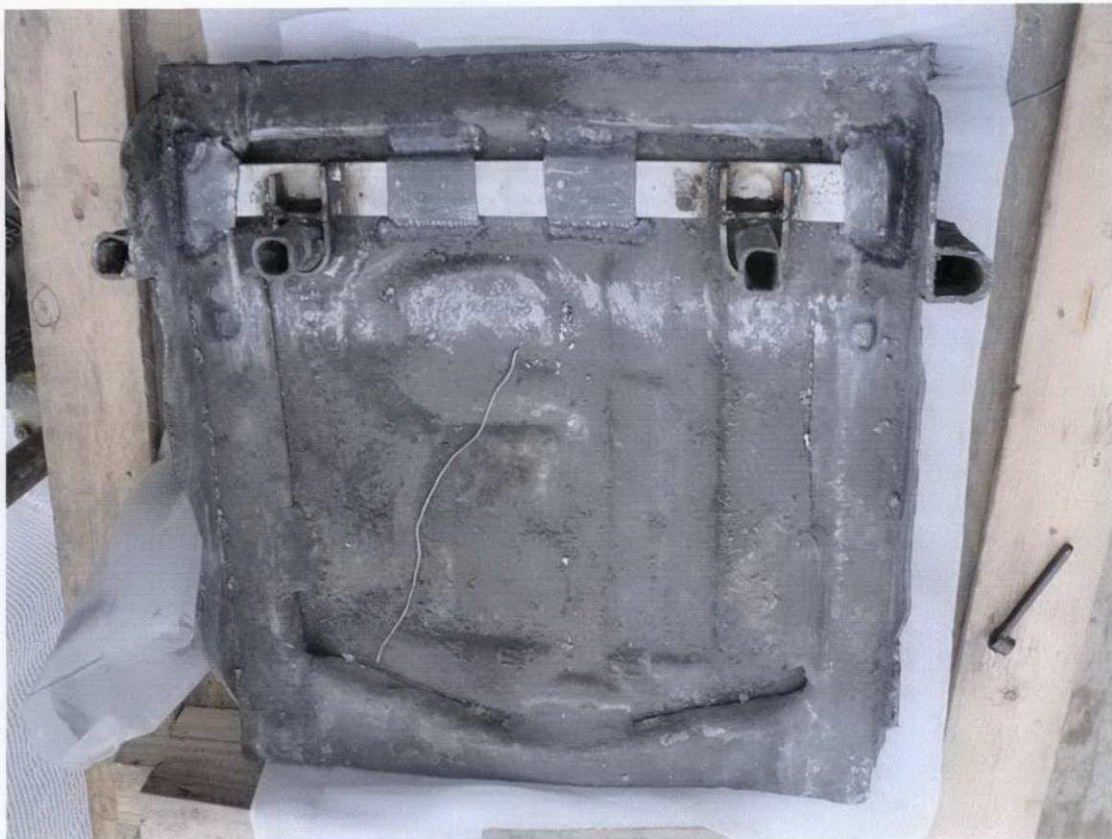
Figure 5. Shield with new armature

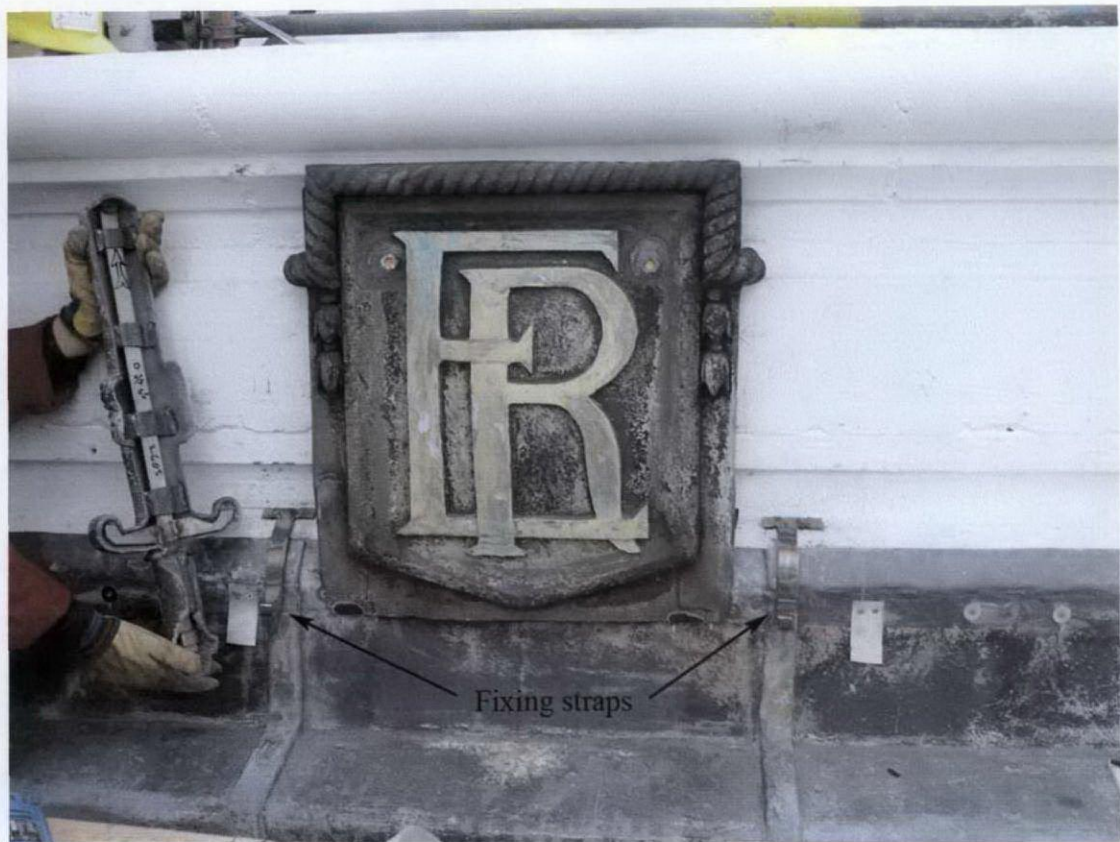
The swords and sceptres, either side of the shields were soldered to three or more separate sheets of lead, and the movement of these lead sheets has caused many of the solder joints and subsequent welded repairs to fail. Stainless steel armatures have been developed so that these decorations can be fixed to the concrete parapet independently of the lead sheet, with sliding joints allowing for movement where appropriate.

Figure 6. Sword armature and lower fixing straps

A loop in the bottom of the armature fits over a hook formed on the fixing strap. At the top, the armature is fixed to the fixing strap using stainless steel set screws, accessed through holes drilled in the lead. These holes are then filled with lead weld.

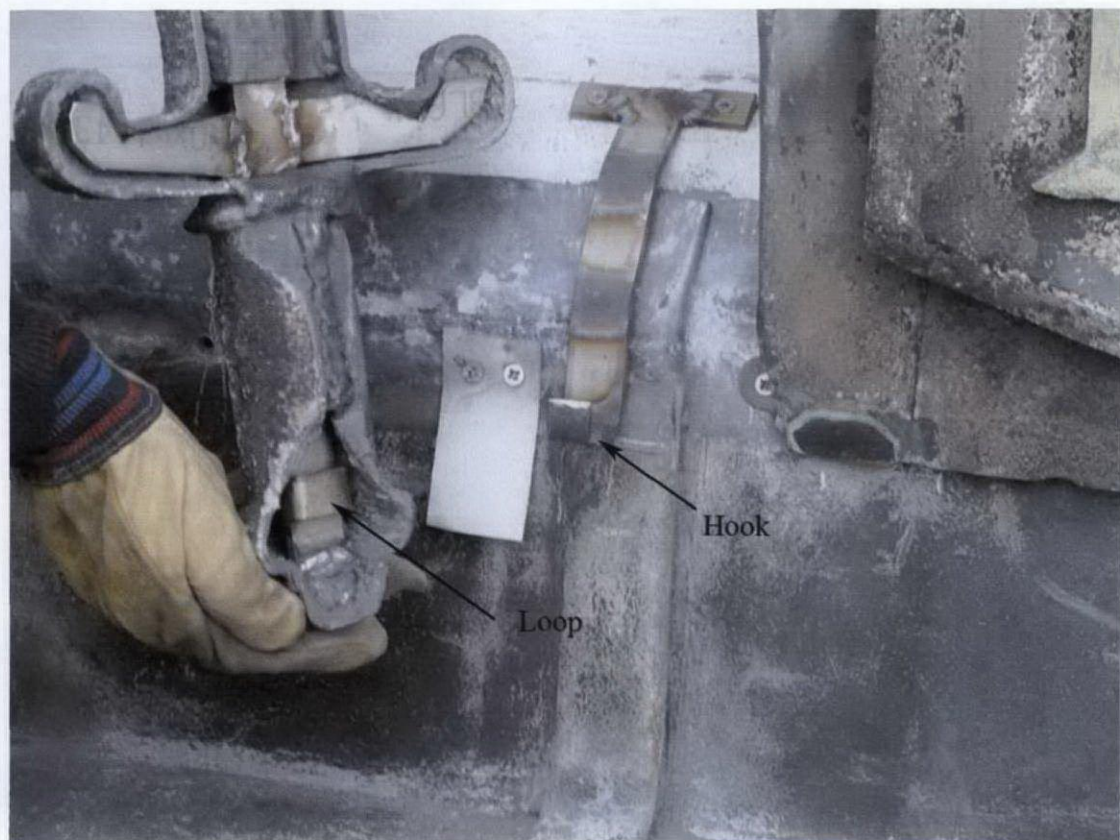
Figure 7. Close-up of bottom sword fixing

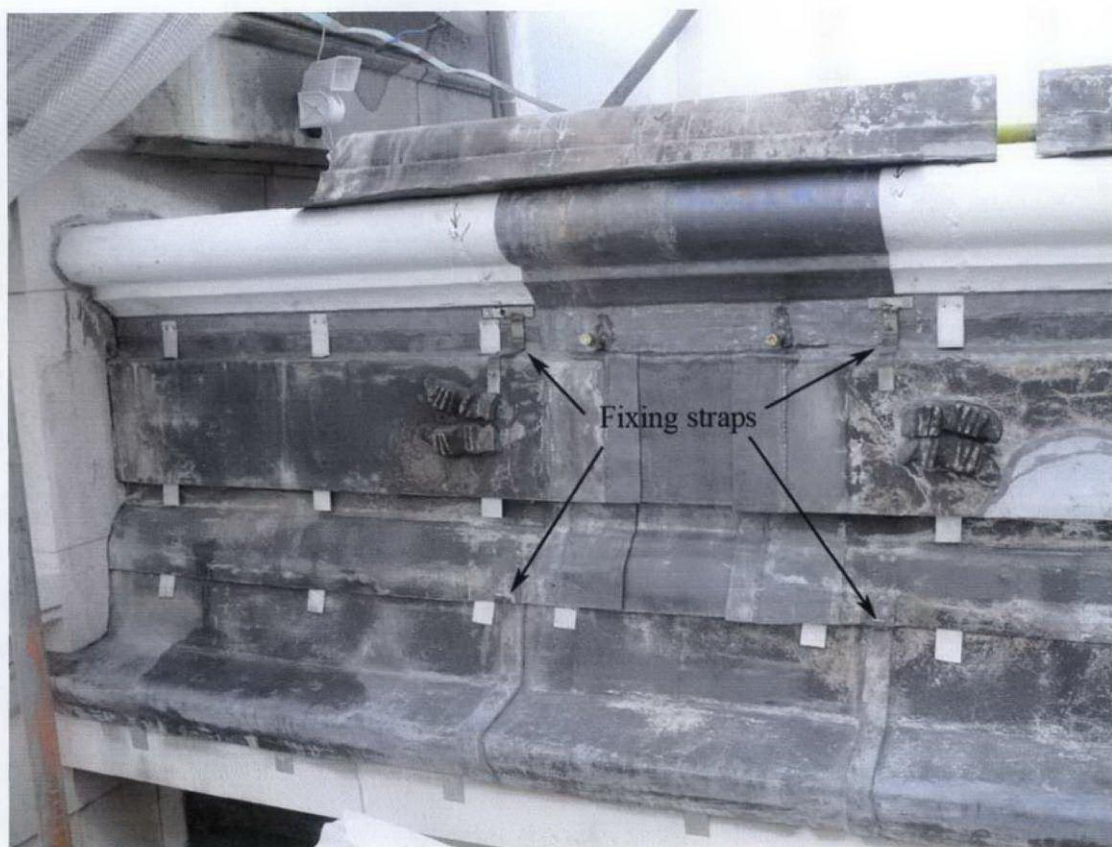
Figure 8. Fixing straps in place

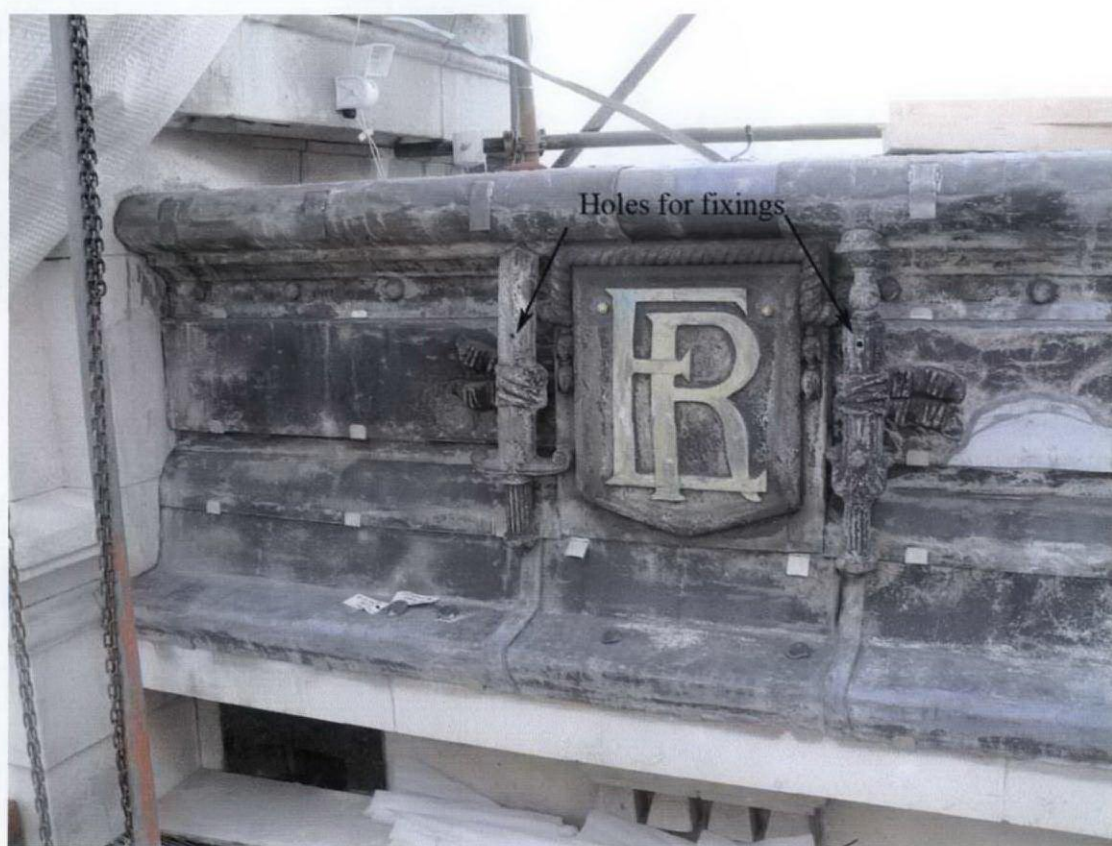
Figure 9. Sword and Sceptre in position

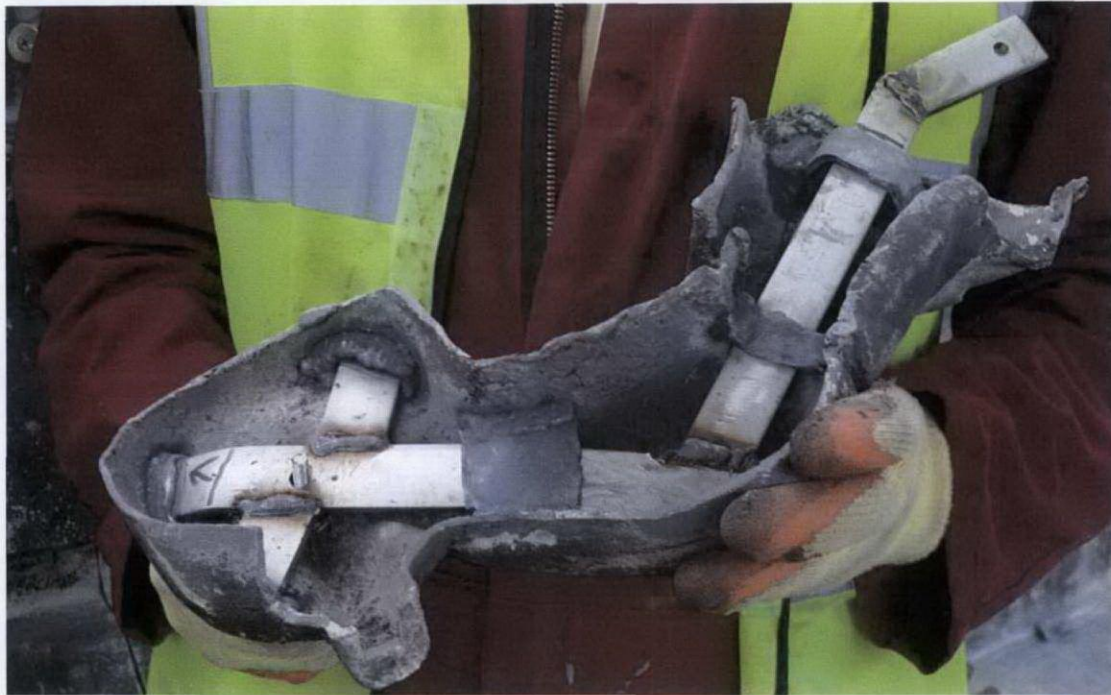
The swags over the central decorative panel also bridged several lead sheets, with results similar to those mentioned above. Again, stainless steel armatures have been developed so that the various elements can be separately attached to the parapet, without compromising the integrity of the weathering lead. These armatures allow for movement of both the weathering lead and the lead decoration.

Figure 10. Right-hand swag with armature

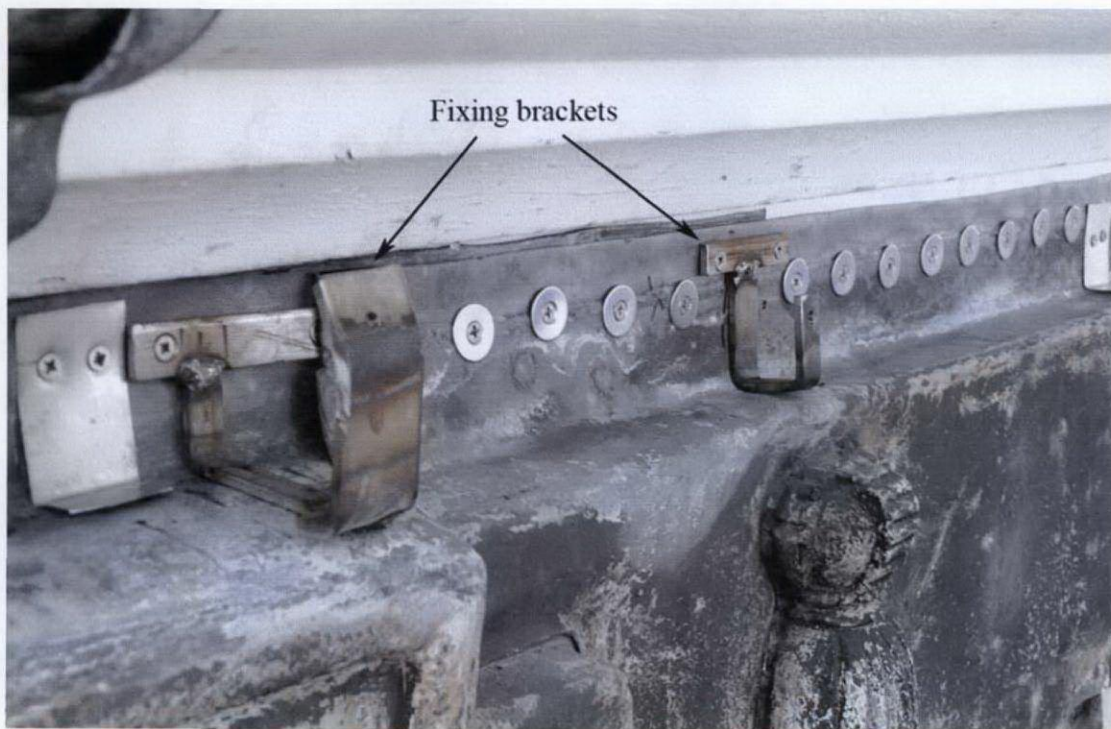
Figure 11. Right-hand swag fixing brackets

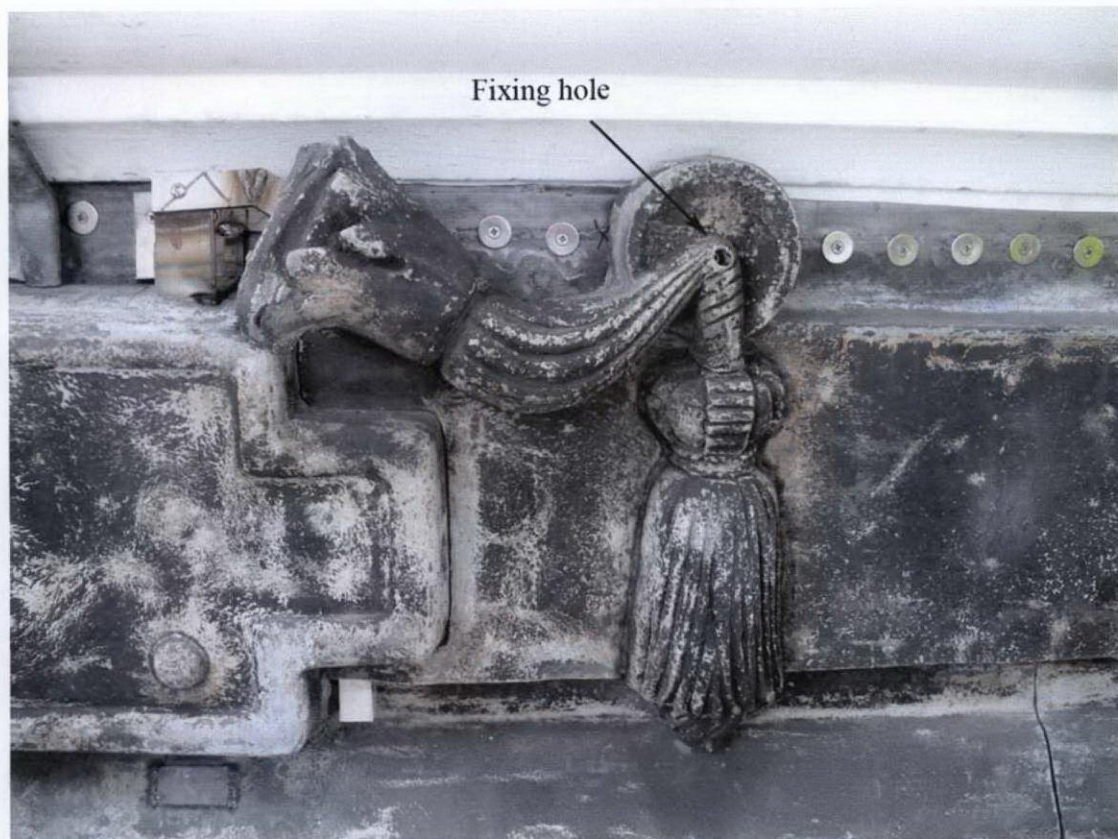
Figure 12. Right-hand swag in place

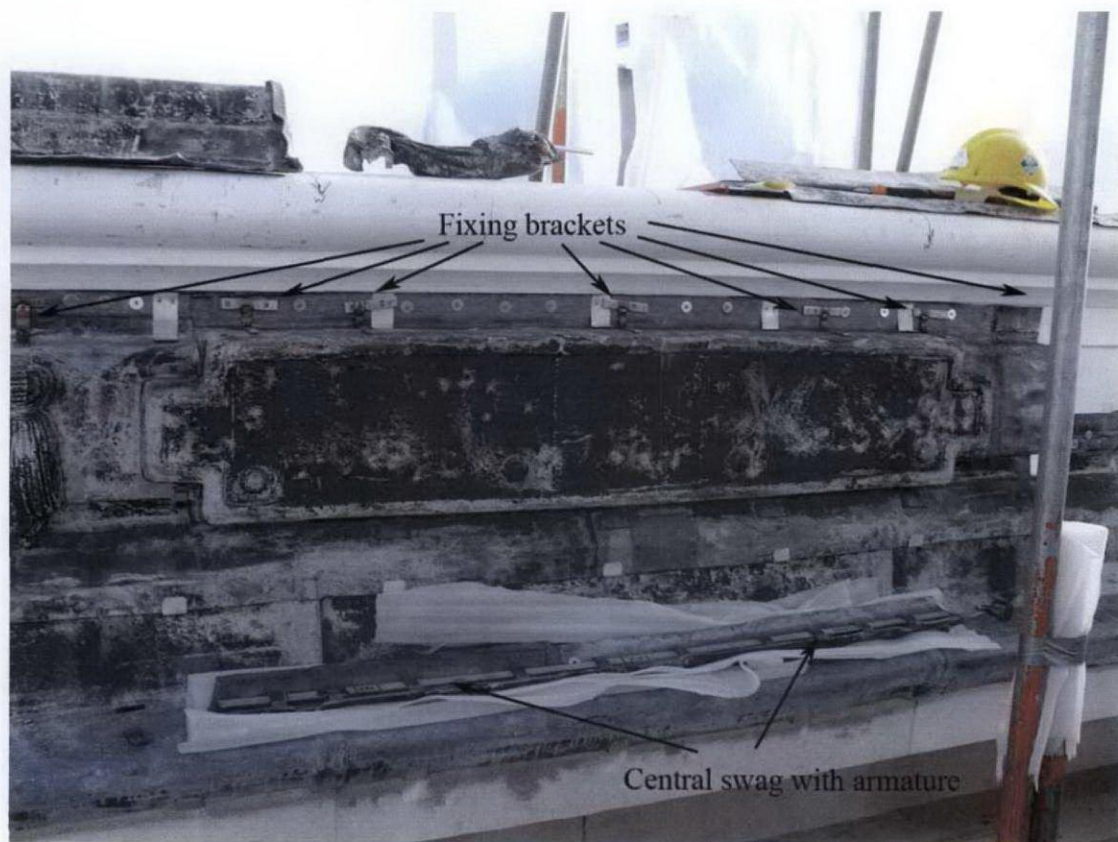
Figure 13. Central swag and fixing brackets

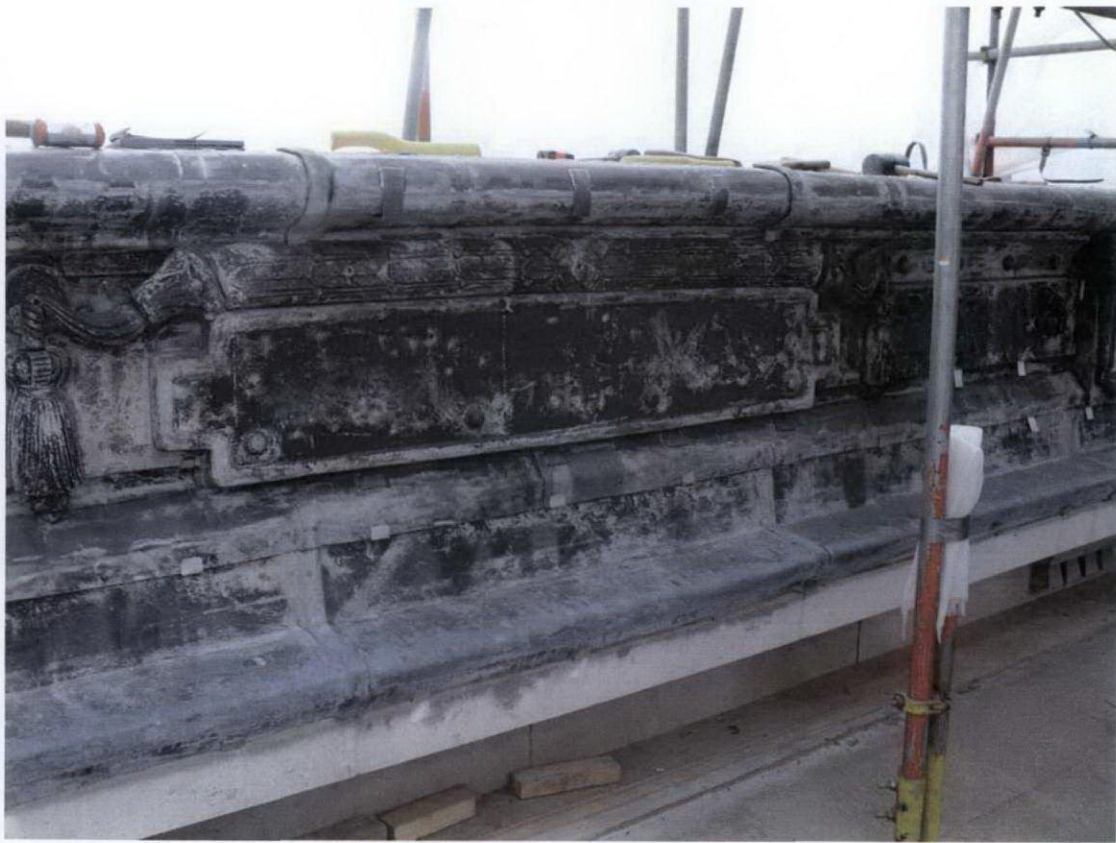
Figure 14. Swags in place

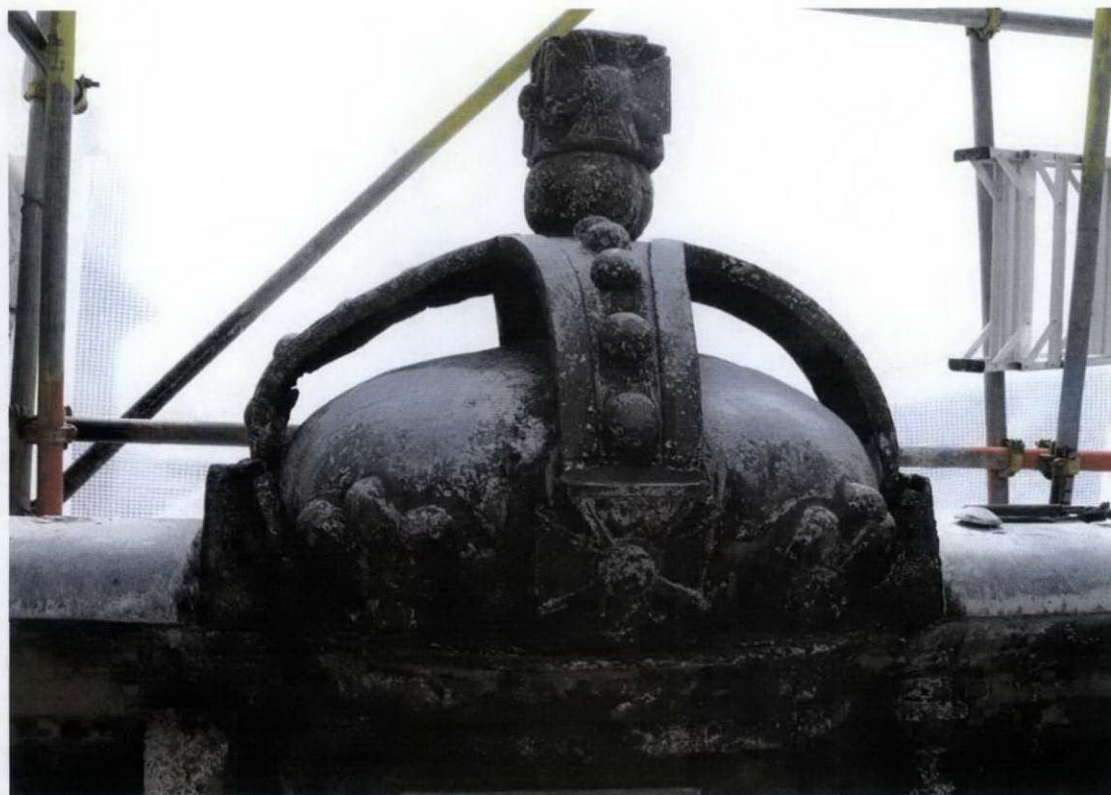
The crown decorations are not adequately supported, and many of them appear to have slumped down at the front as a result. A new stainless steel armature has been designed to overcome this problem.

Figure 15. Crown. Front view

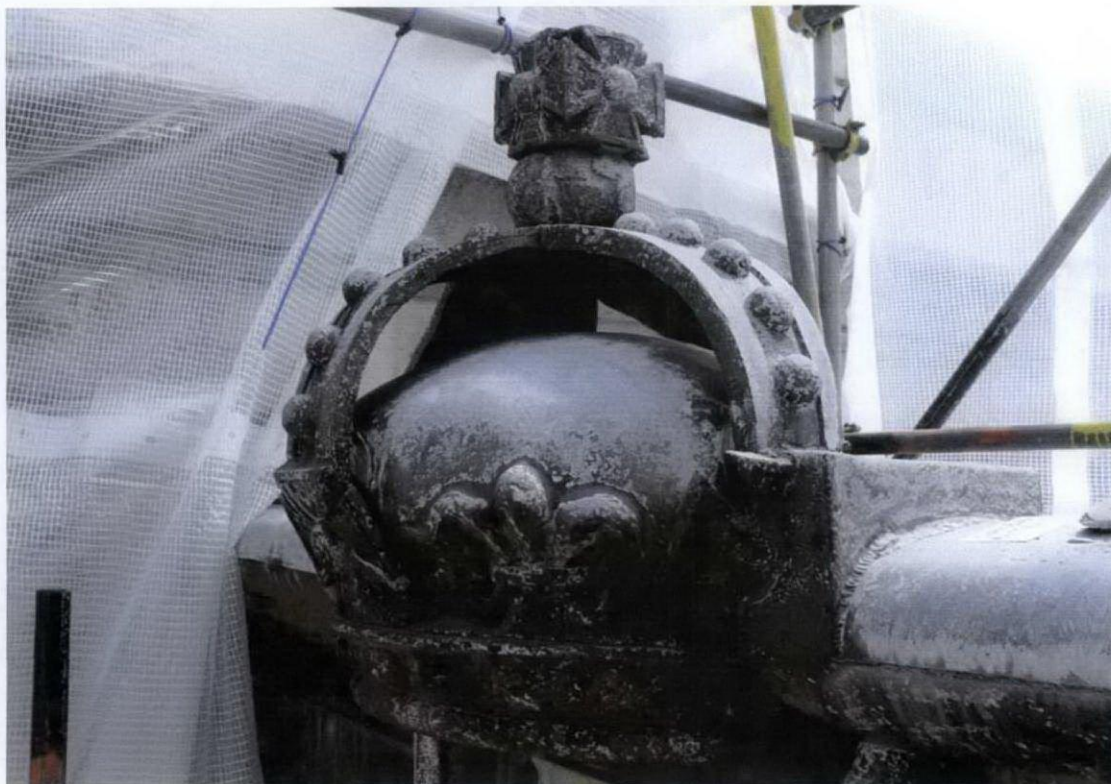
Figure 16. Crown. Right-hand side

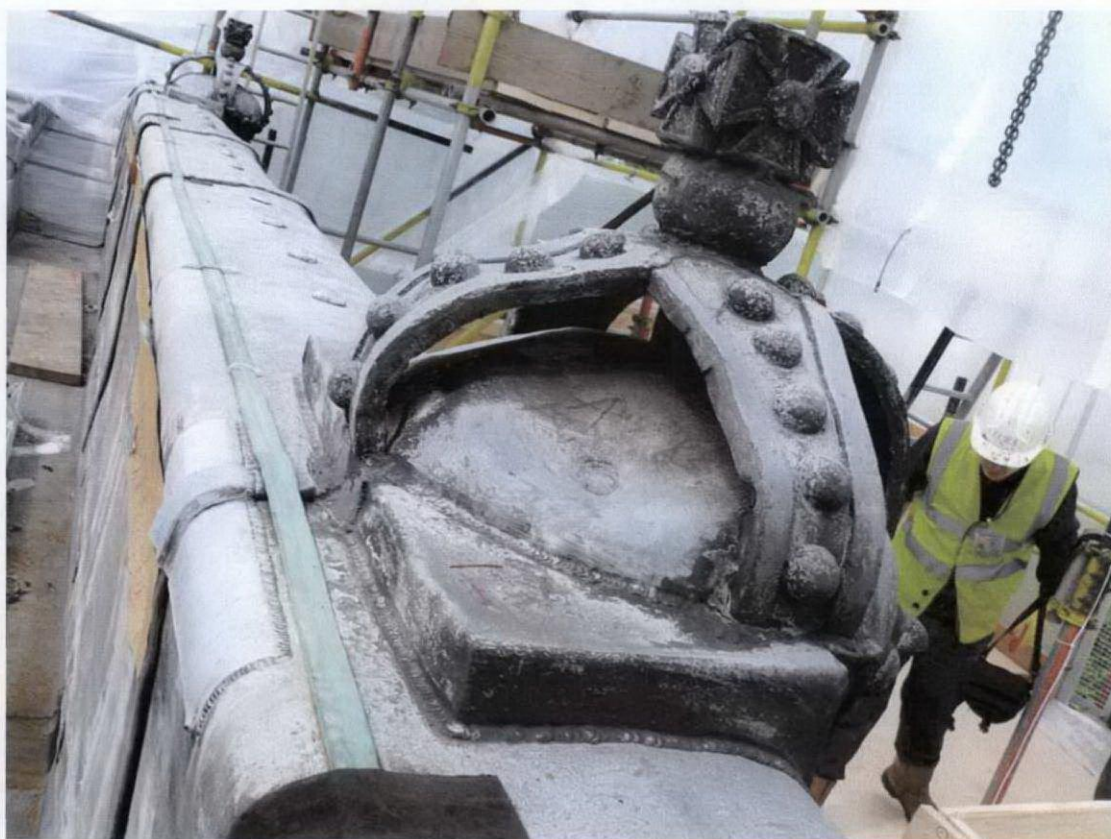
Figure 17. Crown. Back left

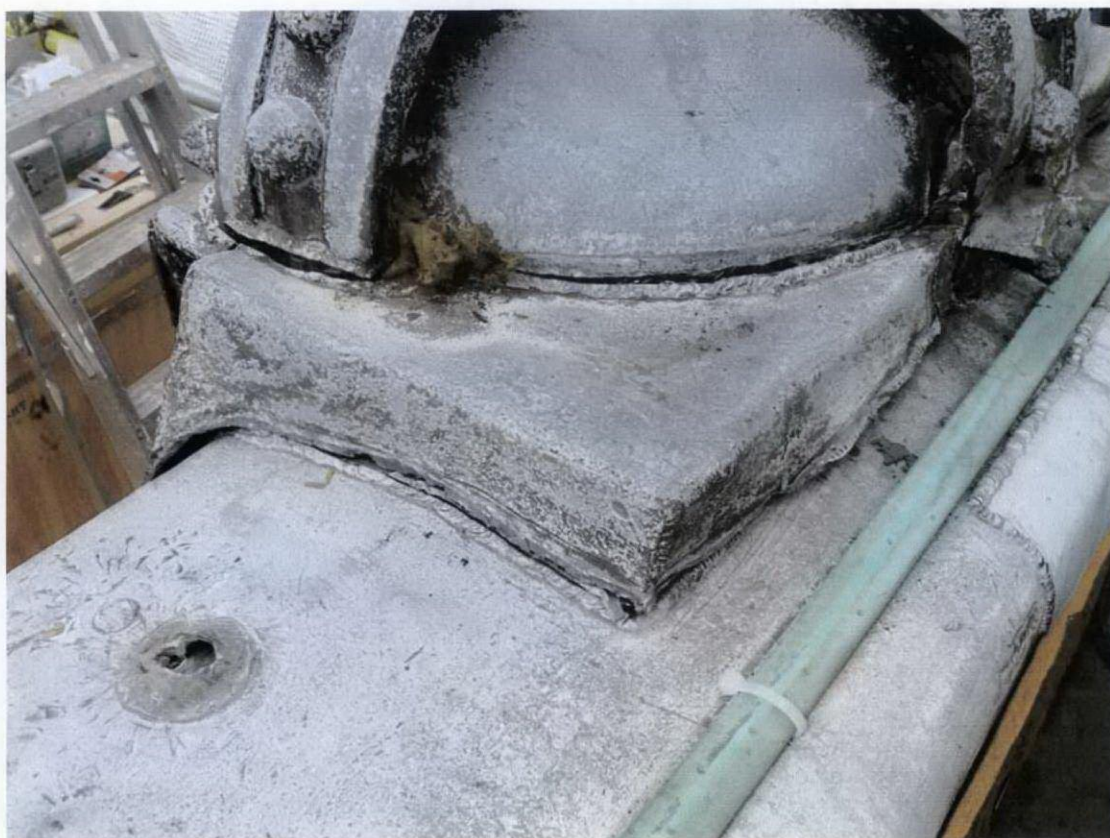
Figure 18. Cushion, back right

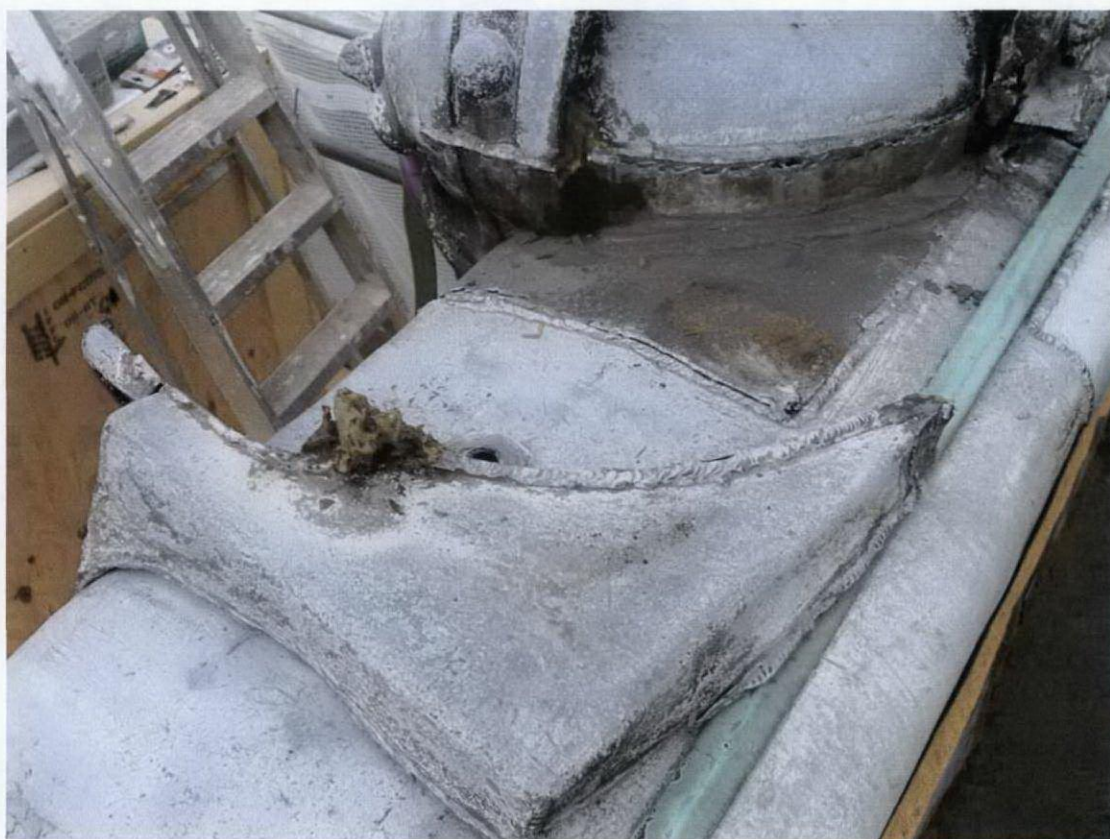
Figure 19. Removal of cushion

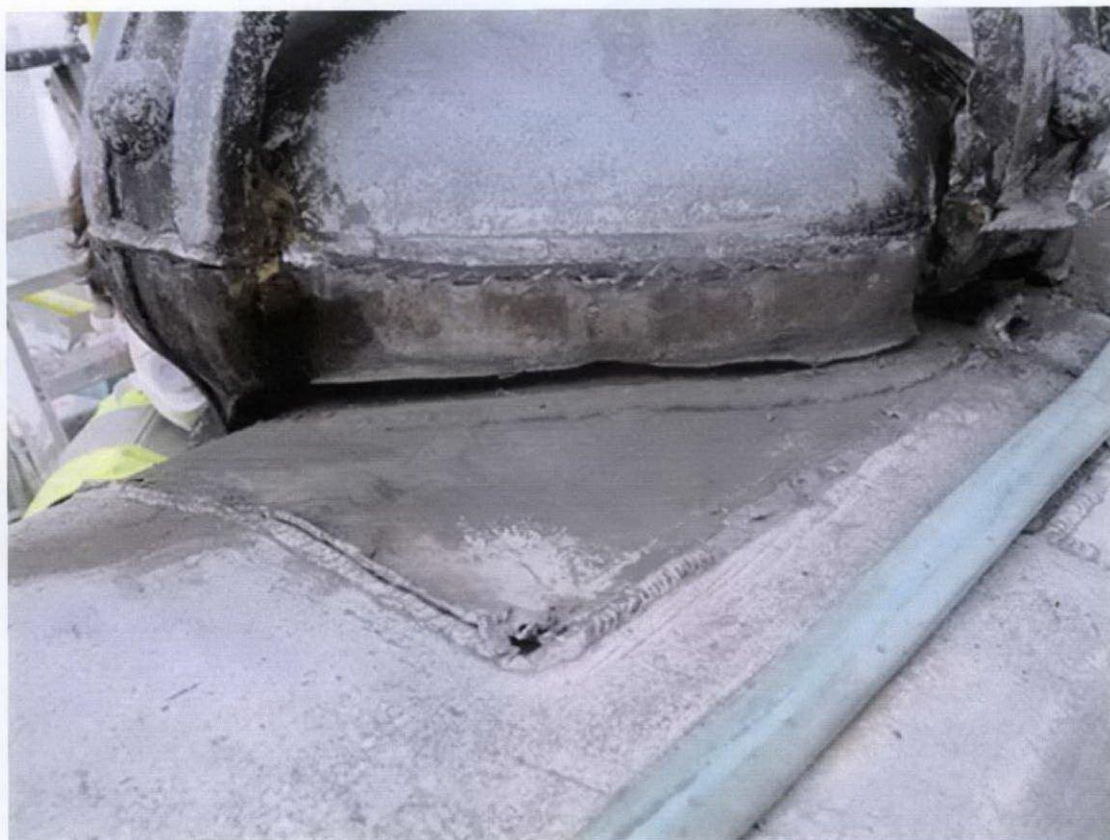
Figure 20. Removal of Crown

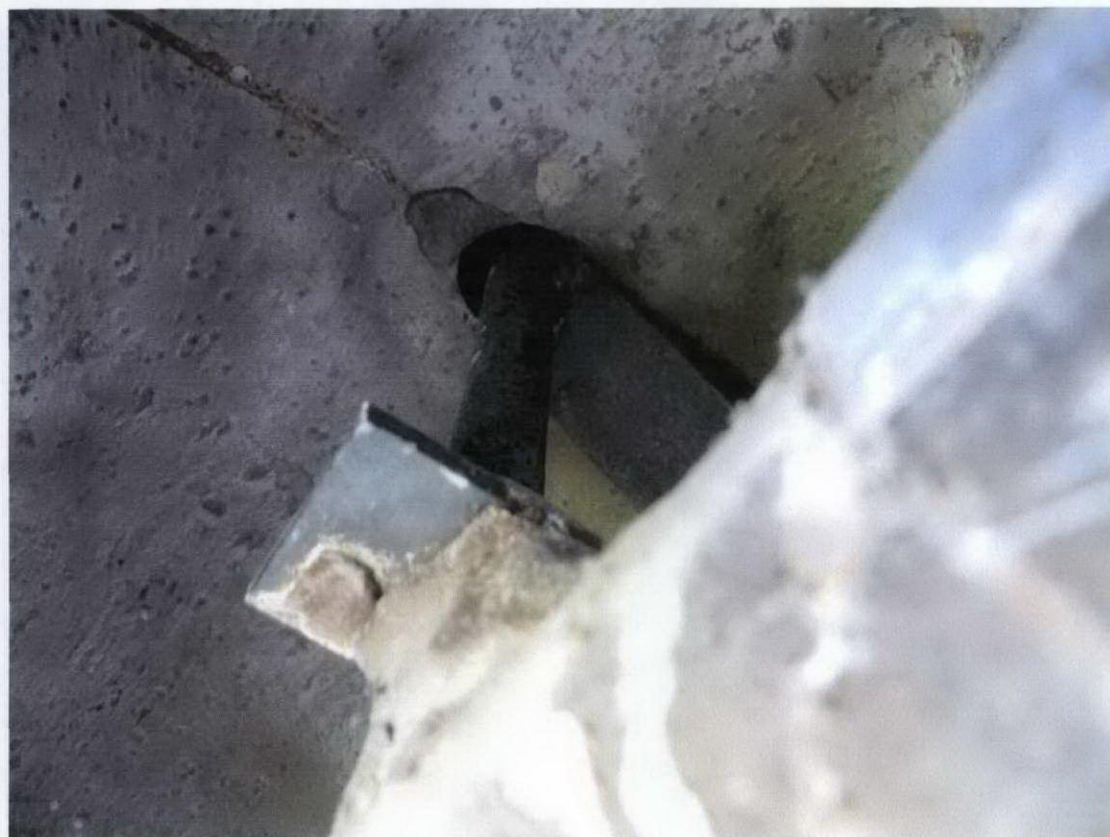
The crown decoration had formed part of the weathering of the parapet, and had let in water as soldered joints failed. Many of these soldered joints had been welded up, these repairs have often failed. In several locations, where welding was difficult or impossible, mastic has been used with varying success.

Figure 21. Underneath Crown in situ

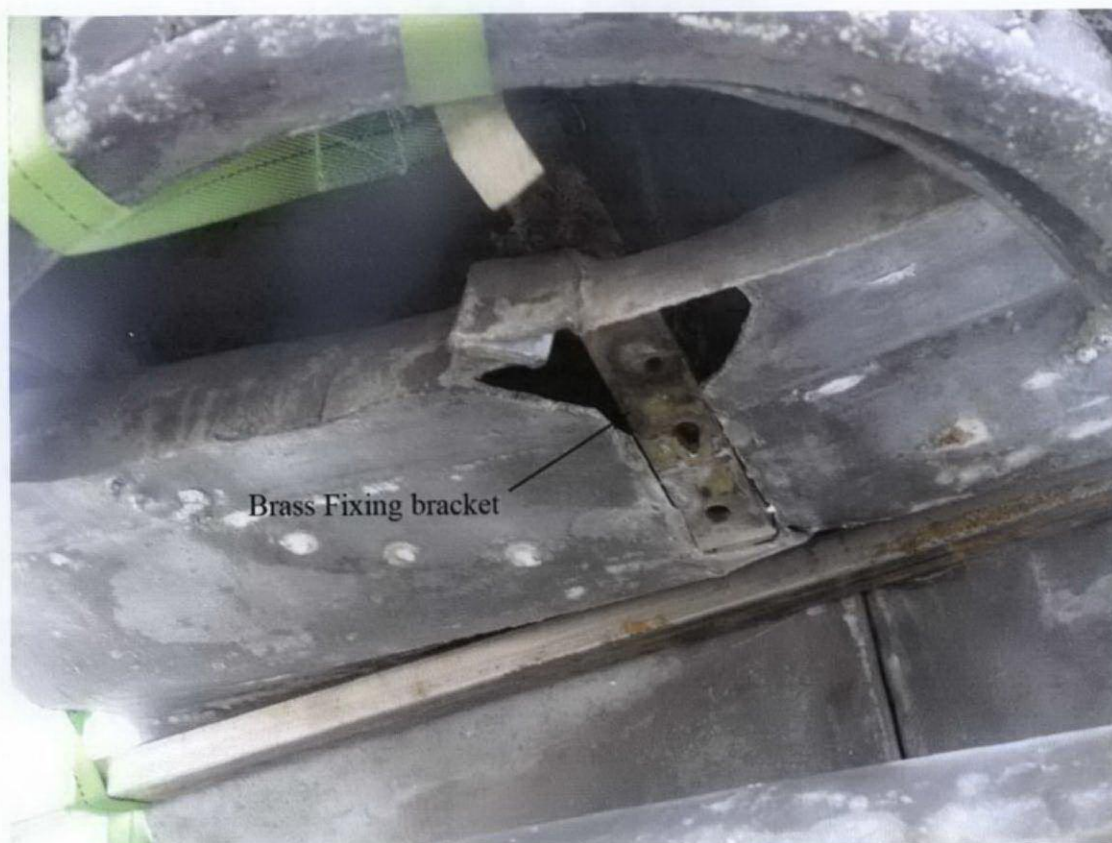
Figure 22. Underneath removed Crown

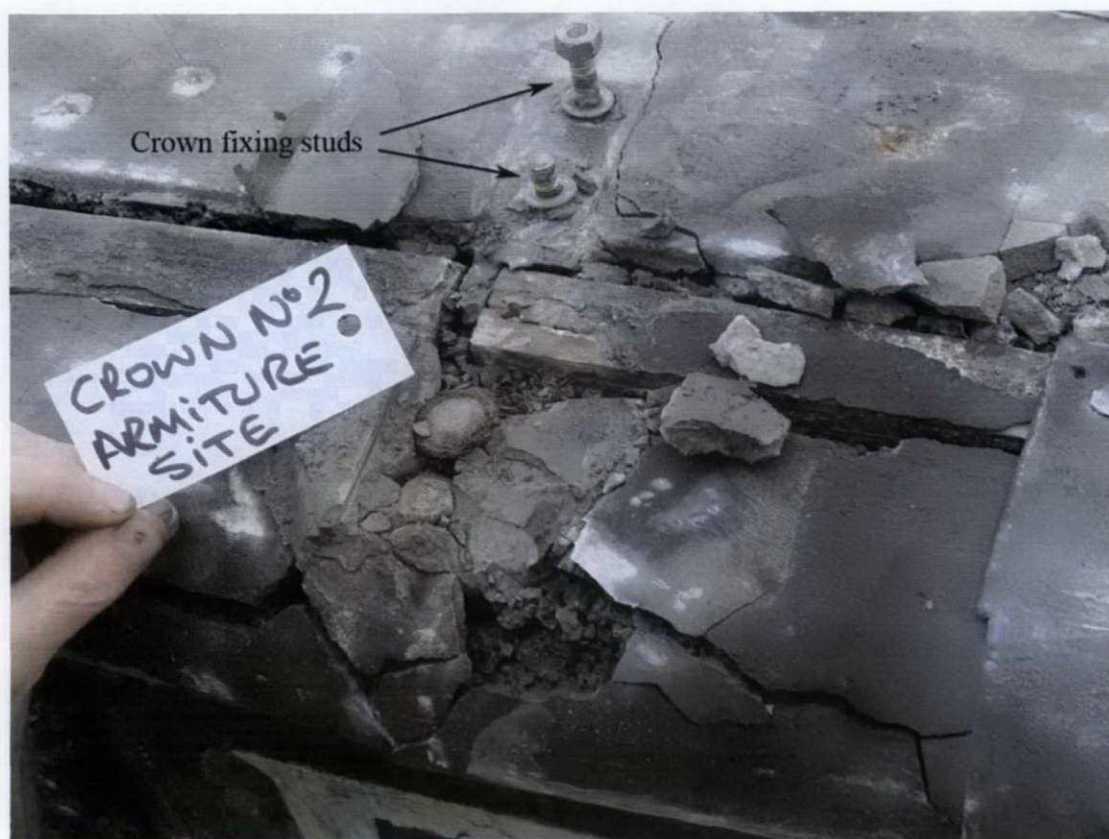
Figure 23. Top of parapet after removal

It was decided to weather the parapet independently of the crowns, and fix the crowns over the weathering lead. Lead taken from the back of the parapet was used to cover the top of the parapet, under the Crowns. This was introduced between the new welts added either side of each Crown.

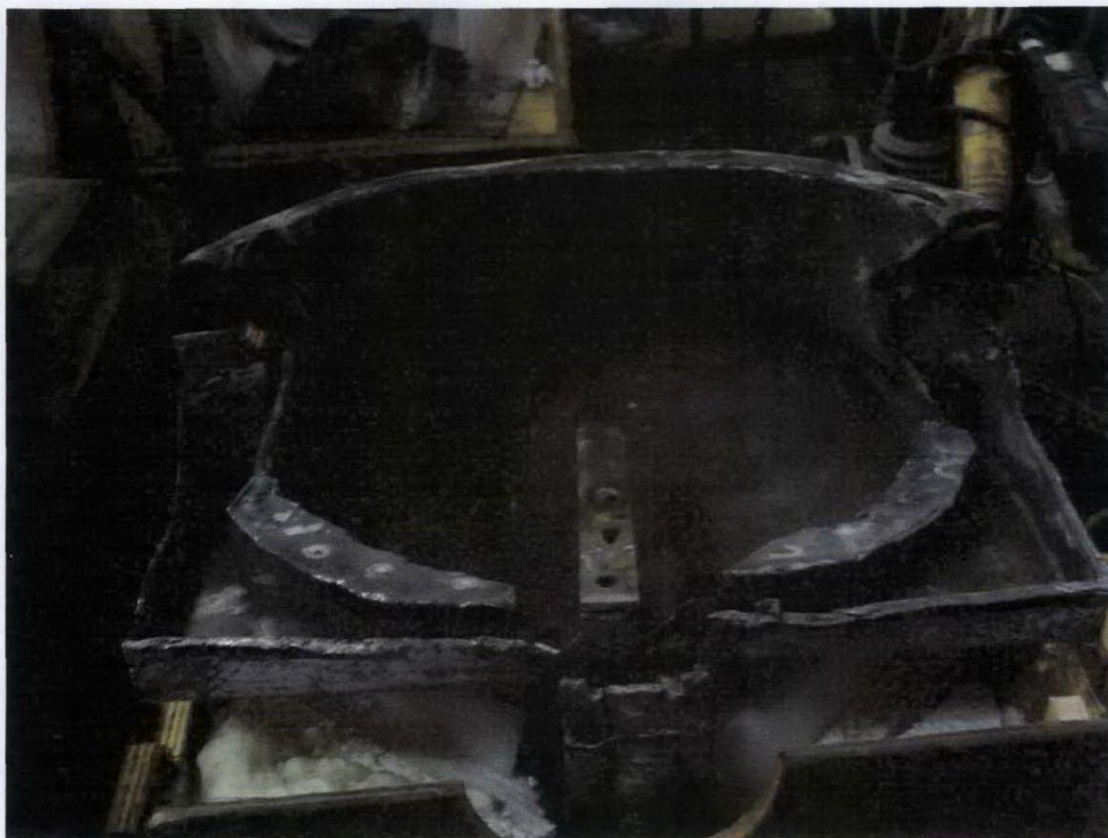
Figure 24. Crown inverted for removal of fixing bracket

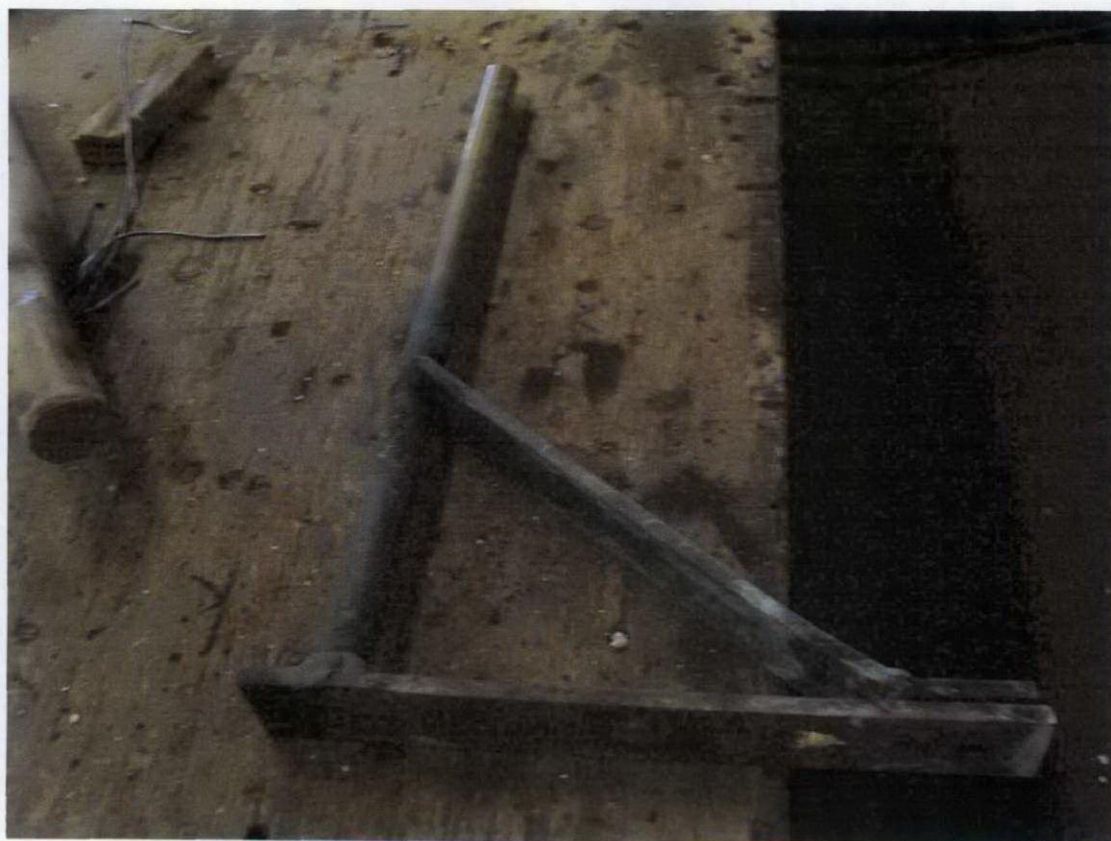
Figure 25. Crown fixing bracket removed
