**Report No. 3469**

**King Edward VII Building  
British Museum**

**Details of Weathering Lead  
Alterations and  
New Stainless Steel Armatures**

**November 2009**

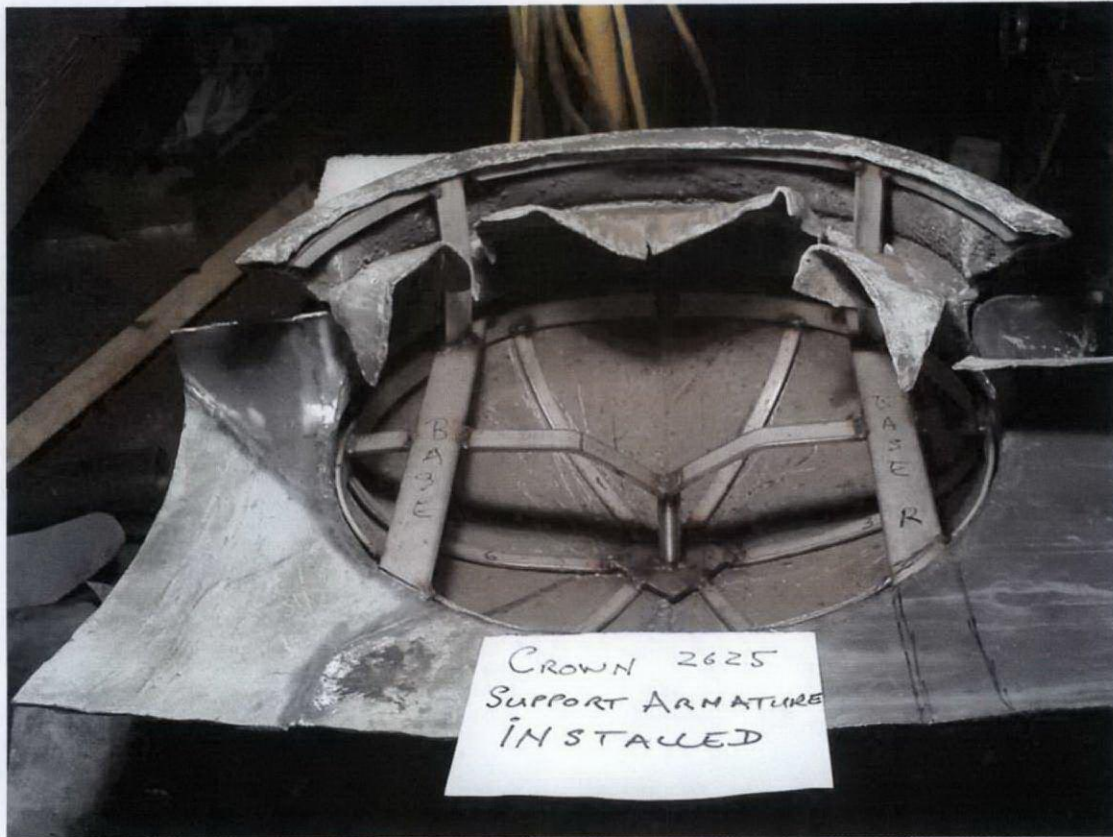
Figure 26. Installation of new support armature

The armatures have been made to fit the shape of the nosing at the front of the parapet. They are fixed to the parapet by 12 X 250 mm long stainless steel studs, resin fixed through two straps extending from the armature at the back of the Crowns. Lead packers are welded beneath the straps to keep the entry holes above the level of the parapet lead, and they are weather with welded sheet lead covers.

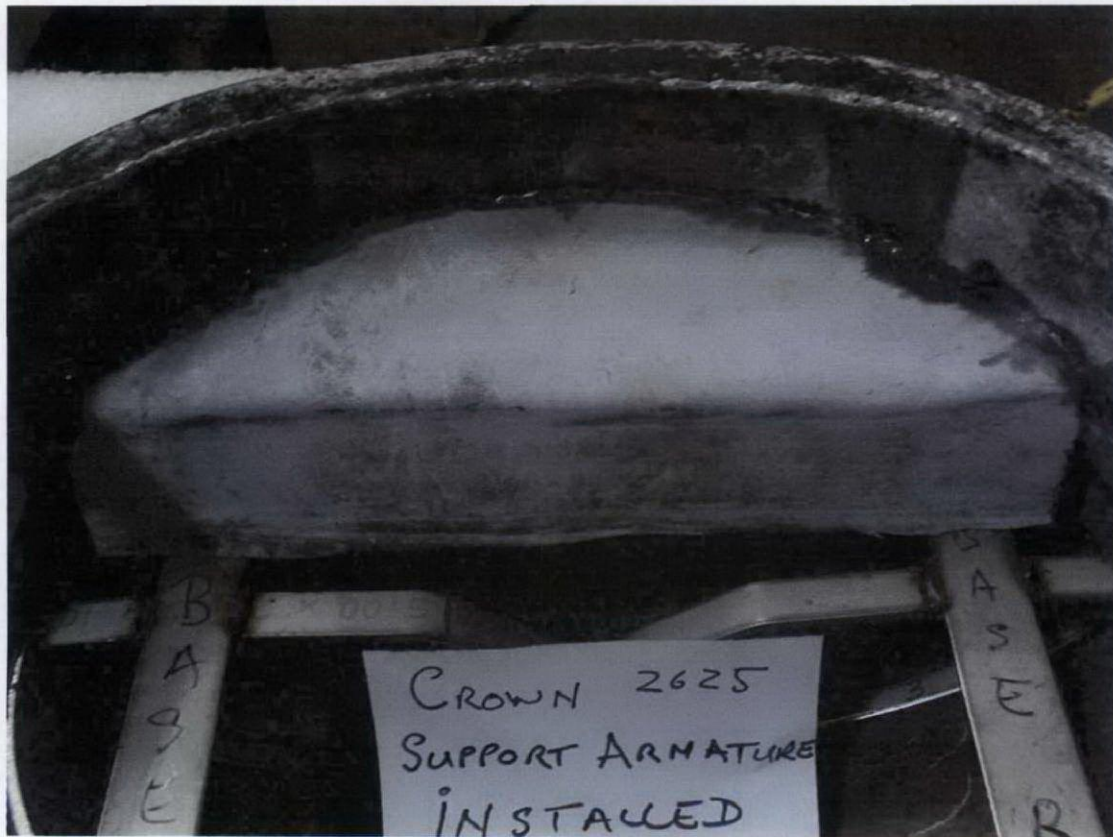
Figure 27. Armature complete

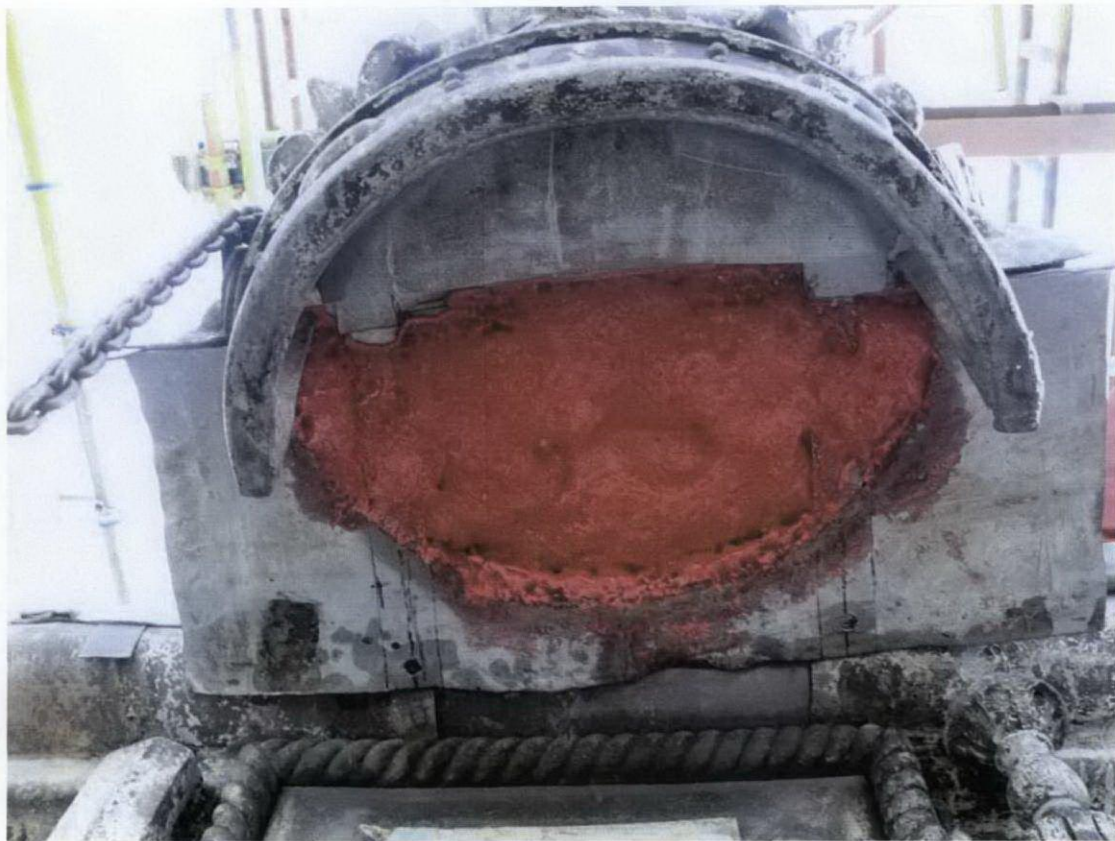
Figure 28. Crown filled with high density polyurethane foam

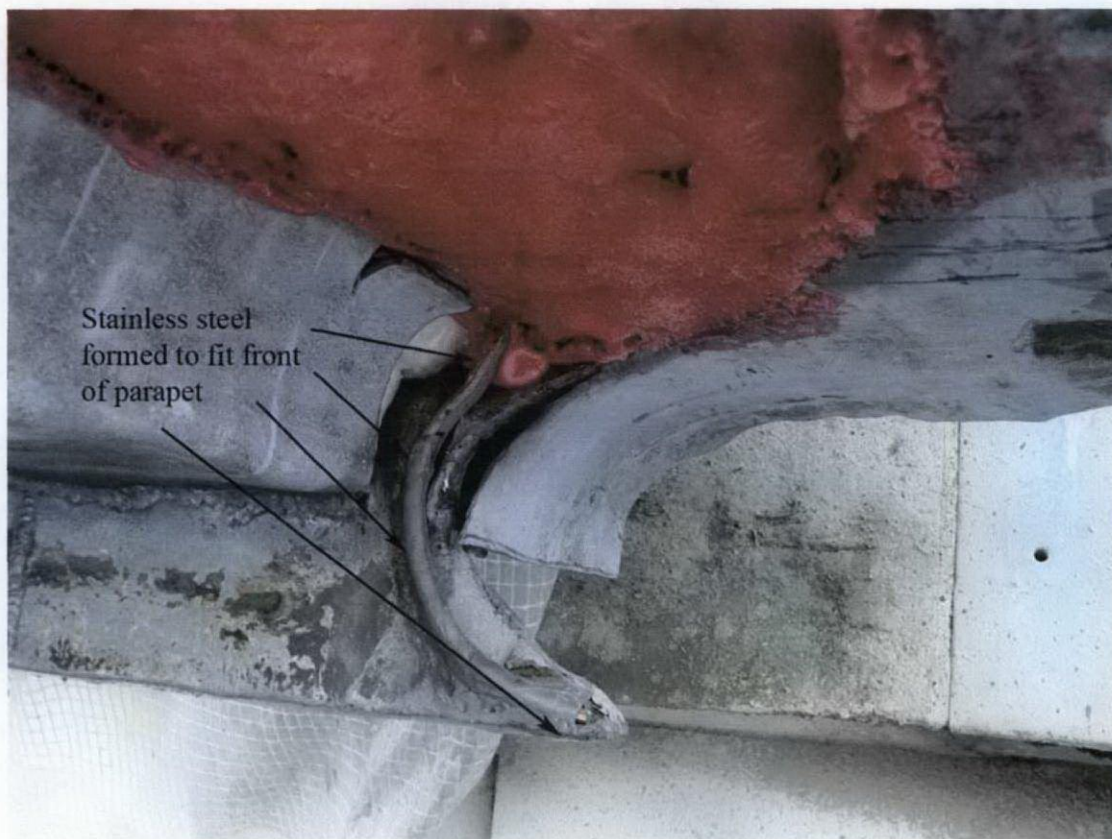
Figure 29. Underneath front of Crown, showing armature detail

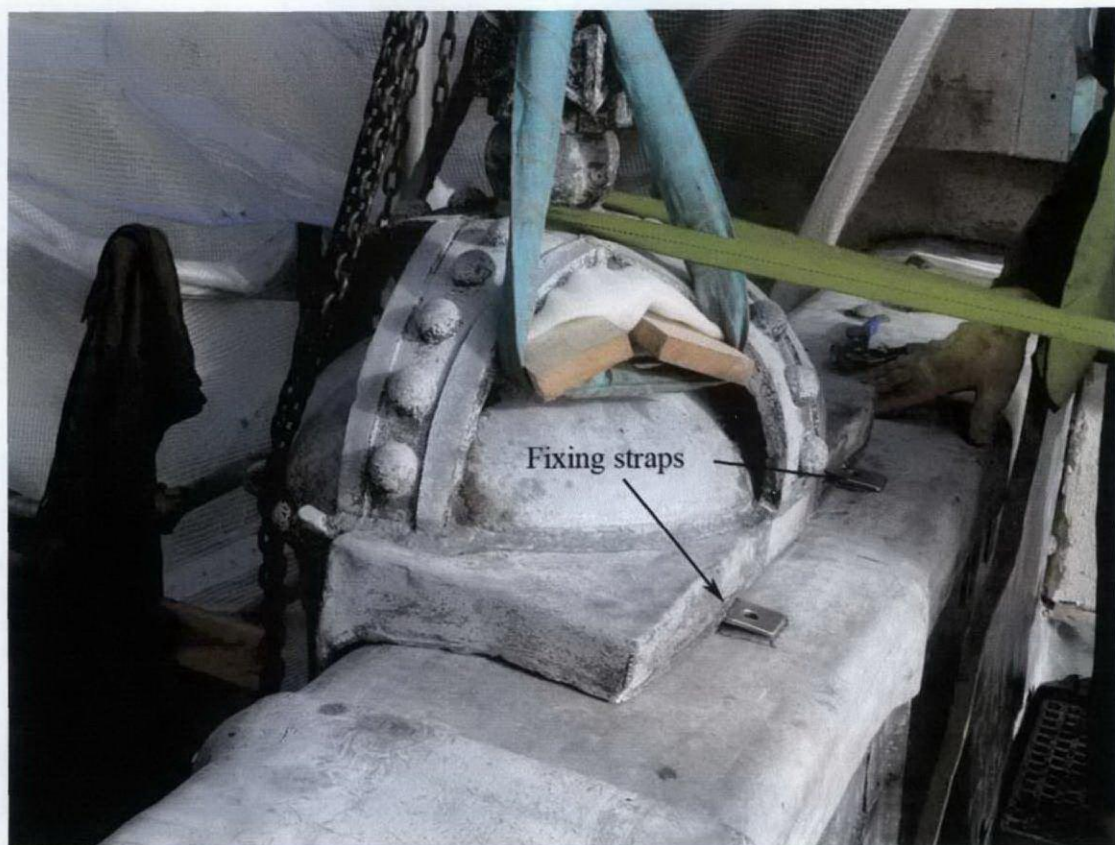
Figure 30. Crown ready for fixing

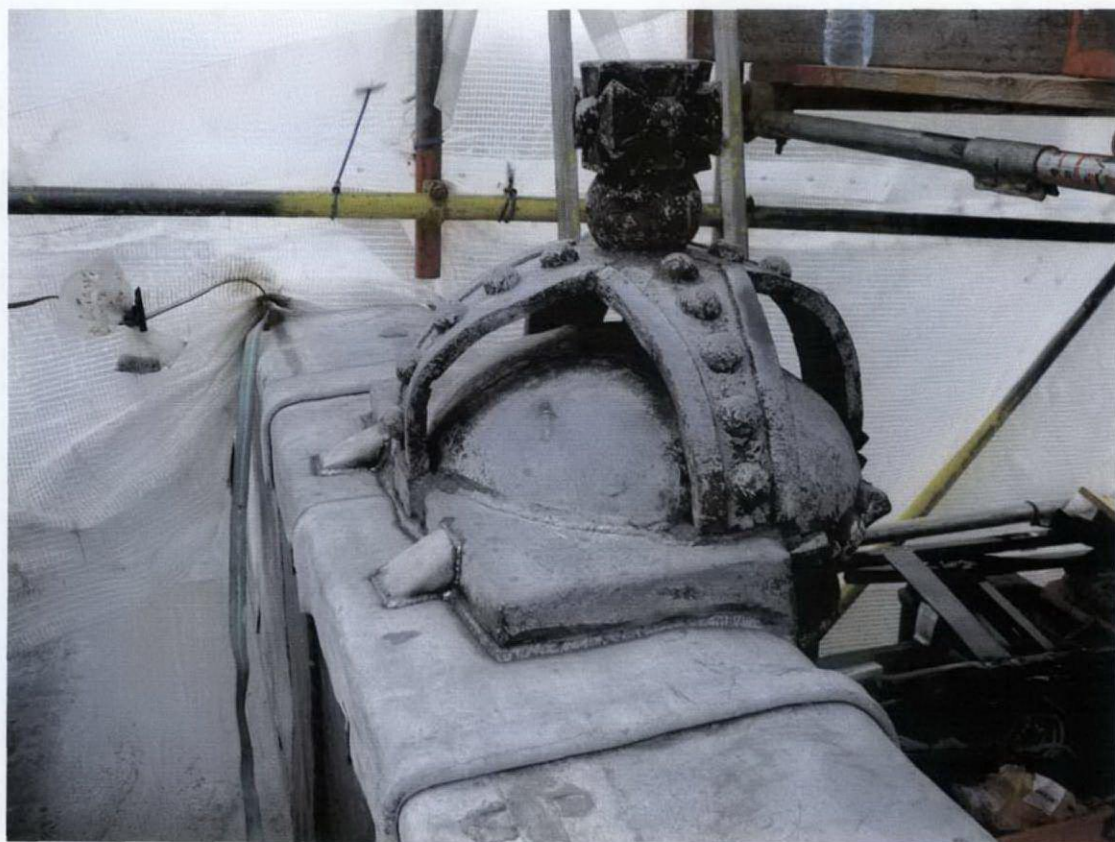
Figure 31. Completed Crown
