# 12 Bedford Square WC1

# Windows

# Design and conservation assessment for The Bedford Estates

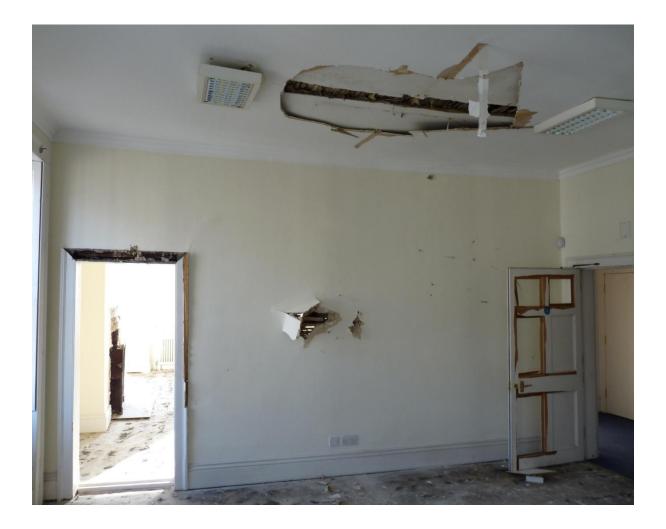
# APPENDIX A

- 2.1 The building is currently empty despite attempts to let it and has suffered significant vandalism. It is understood that the difficult in letting is at least in part due to the high noise levels in Gower Street which affect the rooms on both faces. There is no secondary or double glazing. **APPENDIX A**

Current building condition due to vandalism

- 2.2 Consent has already been granted for the installation of air handling units to improve the internal conditions and it is planned to carry out reinstatement of the damage caused to the building. Applications 2010/5036/P and 2010/5050/L

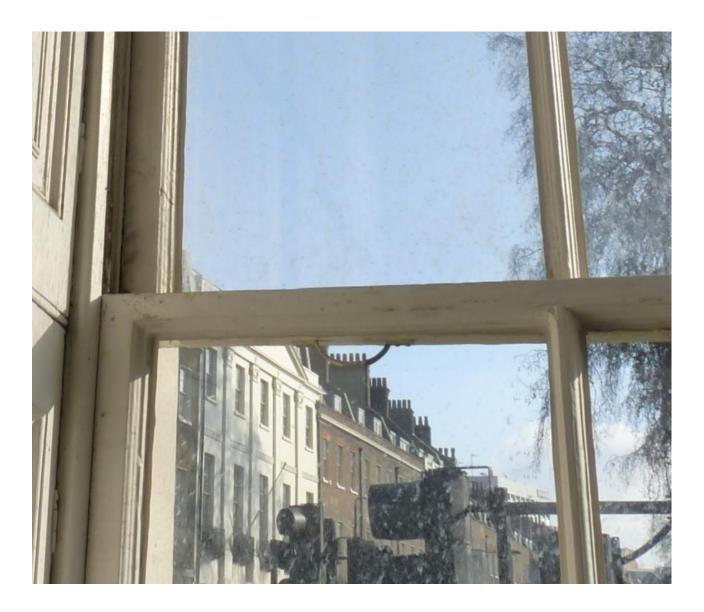
Bedford Square elevation. Later sashes with 24mm wide, ovolo glazing bars of poor quality. No evidence of hand made glass. **APPENDIX B**

# **APPENDIX B** Ground floor Bedford Square – probable later sashes, 24mm ovolo glazing bars.

2 x large six over six box sash windows. The original Georgian frames have been replaced with poor quality Victorian sash frames with 24mm glazing bars with Ovelo mouldings. There is no evidence of any original hand blown glass.

Replace complete sash frames with detailing in the Georgian style and incorporate the 6.8mm Pilkington Optiphon<sup>1</sup> (sound reduction approx.7 decibels). Full draught stripping (sound reduction approx. 4 decibels).

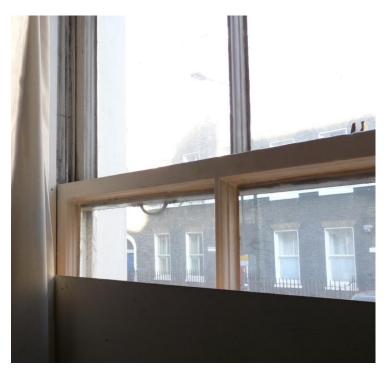
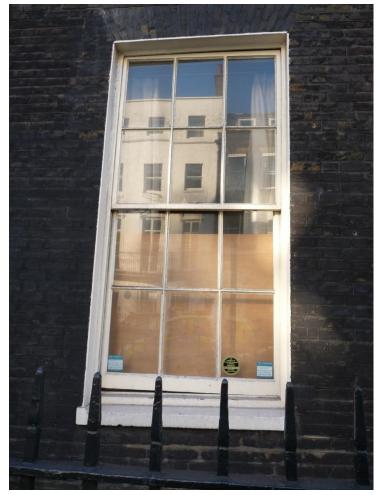
# APPENDIX C

Gower Street elevation. Glazing bars 20mm wide, mixed ovolo and cavetto with bead glazing bars which appear to have been inserted in earlier frames. No hand made glass. **APPENDIX C**

Ground floor Gower Street – simple ovolo glazing bars with square nose. External view shows sashes are a bad fit.

2 x six over six box sash windows. These windows have 20mm glazing bars (these particular bars (reed & hollow moulding) seem to be replacements within the original Georgian sash frames). There is no evidence of any original hand blown glass.

1 x six over six box sash window. This window looks like an original Victorian addition. It has 22mm glazing bars with a typical Victorian Ovelo moulding. There is no evidence of any original hand blown glass.

Replace all glass with 6.8mm Pilkington Optiphon<sup>1</sup> (sound reduction approx.7 decibels). Full draught stripping (sound reduction approx. 4 decibels).

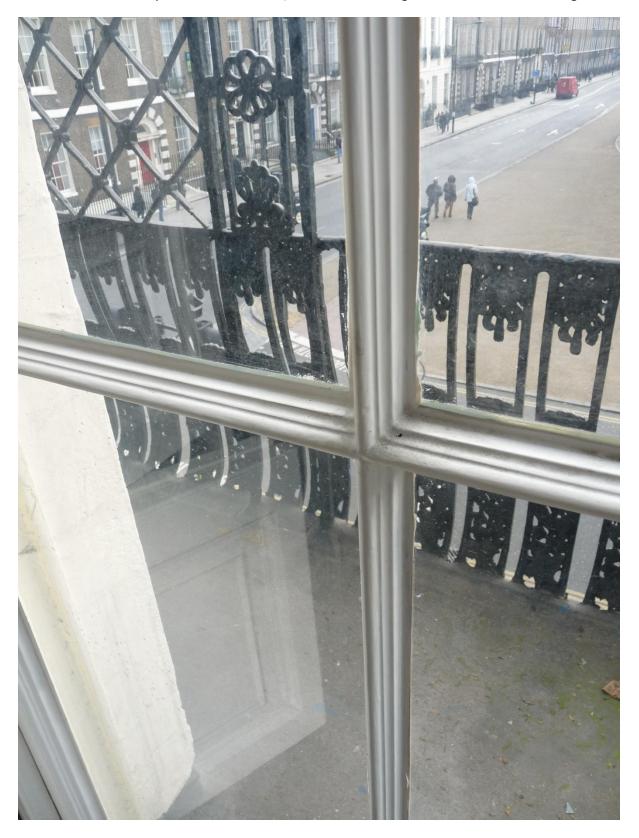
# APPENDIX D

Bedford Square elevation. Glazing bars 24mm wide, ovolo glazing bars. Sash mouldings do not match box mouldings. One or two panes of hand made glass and some industrial glass.

First floor Bedford Square – 20mm bars, cavetto mouldings with round bead nosing

3 x large six over six box sash windows. These windows have 20mm glazing bars (these particular bars (reed & hollow moulding) seem to be replacements within the original Georgian sash frames). There is some evidence of original hand blown glass.

Replace all glass with 6.8mm Pilkington Optiphon<sup>1</sup> (sound reduction approx.7 decibels). Full draught stripping (sound reduction approx. 4 decibels).

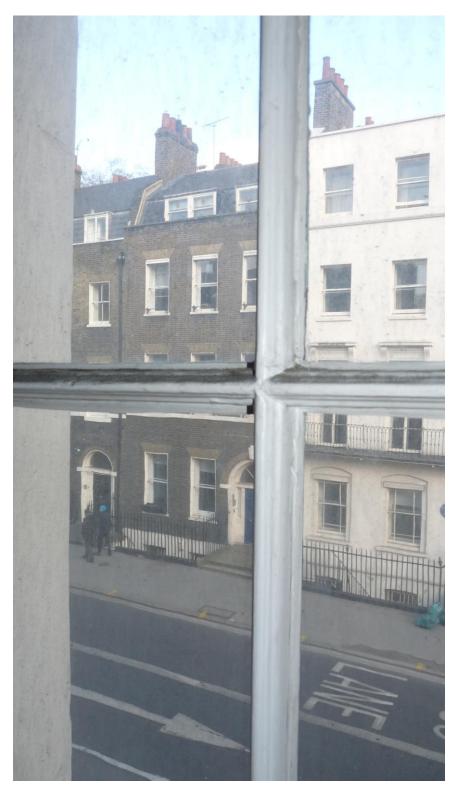
# APPENDIX E

Gower Street elevation. Glazing bars 20mm wide, ovolo glazing bars. Some hand made glass.

First floor Gower Street – 20mm cavetto glazing bar with round nosing.

3 x large six over six box sash windows. These windows have 20mm glazing bars (these particular bars (reed & hollow moulding) seem to be replacements within the original Georgian sash frames). There is some evidence of original hand blown glass.

Replace all glass with 6.8mm Pilkington Optiphon<sup>1</sup> (sound reduction approx.7 decibels). Full draught stripping (sound reduction approx. 4 decibels).

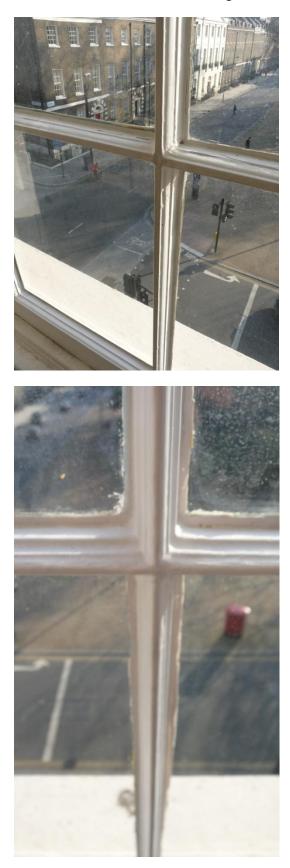
# **APPENDIX F**

Bedford Square elevation. Glazing bars to one window 17mm wide, cavetto with bead glazing bars, some hand made glass. Two windows are later replacements with 24mm ovolo glazing bars of lower quality.

Second floor Bedford Square – varied glazing bars some ovolo bars with square nosing others cavetto with round nosing. Paint blurrs the appearance of the glazing bar.

1x original Georgian six over six box sash window. These frames have 17mm glazing bars with reed & hollow moulding. There is some evidence of original hand blown glass.

2 x six over six box sash windows. The original Georgian frames have been replaced with poor quality Victorian sash frames with 24mm glazing bars with Ovelo mouldings. There is no evidence of any original hand blown glass.

Replace all glass with 6.8mm Pilkington Optiphon<sup>1</sup> (sound reduction approx.7 decibels). Full draught stripping (sound reduction approx. 4 decibels).

Replace complete sash frames with detailing in the Georgian style and incorporate the 6.8mm Pilkington Optiphon<sup>1</sup> (sound reduction approx.7 decibels). Full draught stripping (sound reduction approx. 4 decibels).

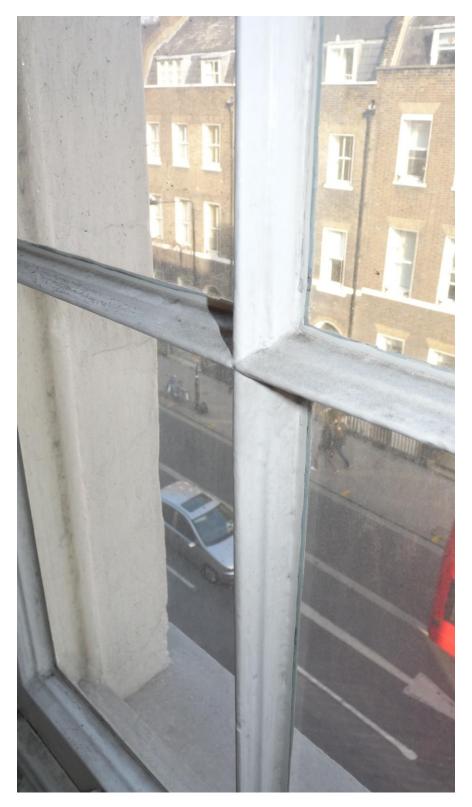
# APPENDIX G

Gower Street elevation. Glazing bars 17mm wide, cavetto with bead glazing bars with some panes of hand made glass. **APPENDIX G**

Second floor Gower Street – 17mm cavetto glazing bar with the detail obscured by paint.

3 x original Georgian six over six box sash windows. These frames have 17mm glazing bars with reed & hollow moulding. There is some evidence of original hand blown glass.

Replace all glass with 6.8mm Pilkington Optiphon<sup>1</sup> (sound reduction approx.7 decibels). Full draught stripping (sound reduction approx. 4 decibels).

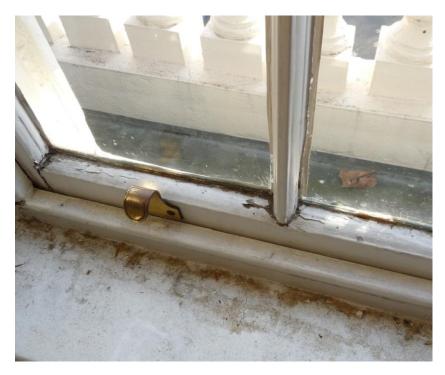
# APPENDIX H

Bedford Square elevation. Later sashes with 24mm wide, ovolo glazing bars very poor quality and evidence of previous repairs. No hand made glass. **APPENDIX H**

Third floor Bedford Square – windows in poor condition with ovolo bars and square nosing. Some frames are modern replacements.

Both are in very poor condition and appear to be Victorian replacement sash frames with 24mm glazing bars with Ovelo mouldings which have already undergone considerable poor quality repairs. There is no evidence of any original hand blown glass.

Replacement double glazed box sash windows in the Georgian style.

Replace complete sash frames with detailing in the Georgian style and incorporate the 6.8mm Pilkington Optiphon<sup>1</sup> (sound reduction approx.7 decibels). Full draught stripping (sound reduction approx. 4 decibels).

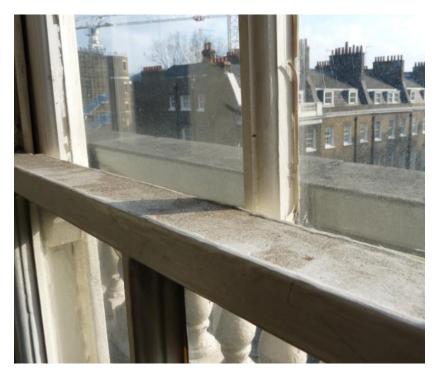
Replacement sashes with crude horns to top frame.

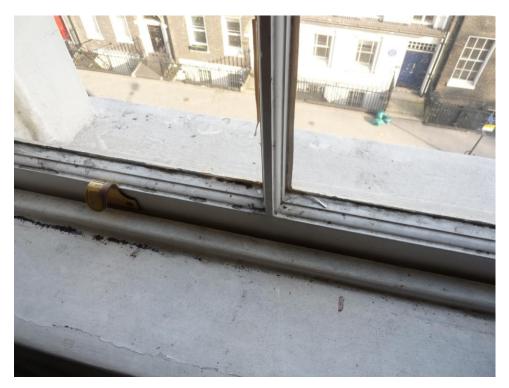
# APPENDIX I

Gower Street elevation. Later sashes with 24mm wide, ovolo glazing bars, poor quality. No hand made glass. **APPENDIX I**

Third floor Gower Street – modern window with standard ovolo glazing bar

3 x three over three box sash windows. The original Georgian frames have been replaced with poor quality Victorian sash frames with 24mm glazing bars with Ovelo mouldings. There is no evidence of any original hand blown glass.

Replace complete sash frames with detailing in the Georgian style and incorporate the 6.8mm Pilkington Optiphon<sup>1</sup> (sound reduction approx.7 decibels). Full draught stripping (sound reduction approx. 4 decibels).

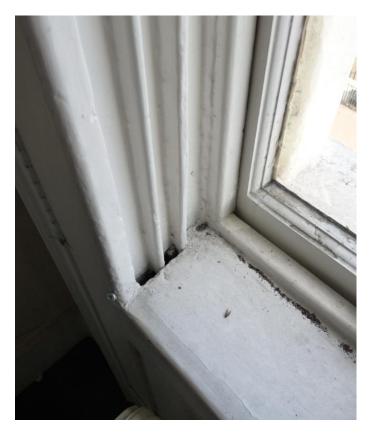
Windows to Gower Street showing original vertical sliding shutters now removed and modern sash replacement window.

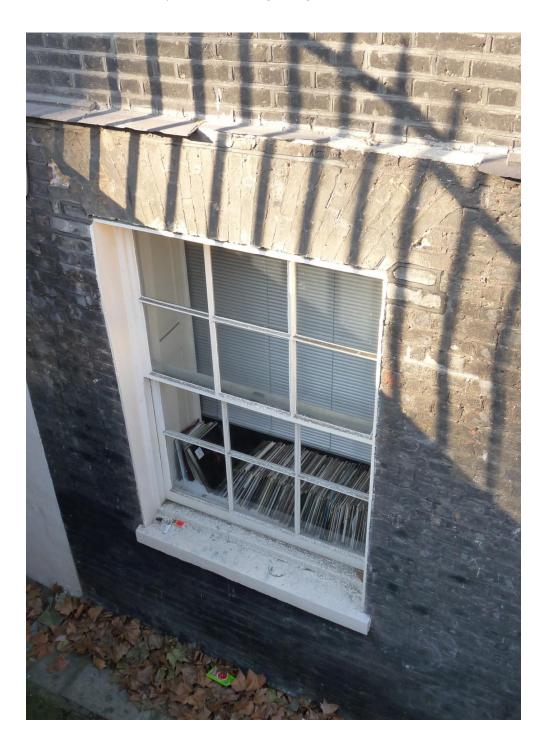
Bedford Square elevation. Glazing bars 20mm wide, ovolo glazing bars **APPENDIX J**

# **APPENDIX J** Basement Bedford Square – 20mm glazing bars.

2 x six over six box sash windows. These windows have 20mm glazing bars (these particular bars seem to be replacements within the original Georgian sash frames). There is no evidence of any original hand blown glass.

Replace all glass with 6.8mm Pilkington Optiphon<sup>1</sup> (sound reduction approx.7 decibels). Full draught stripping (sound reduction approx. 4 decibels).

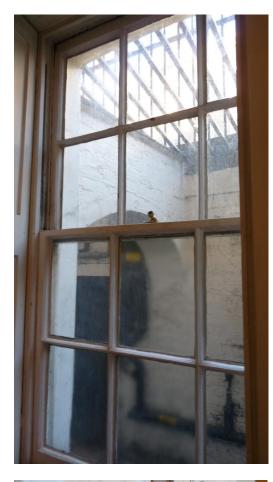
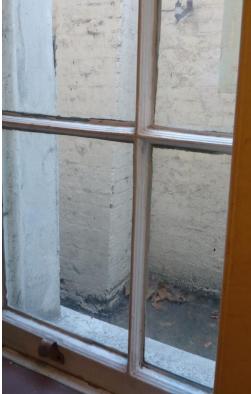
Gower Street elevation. Glazing bars 20mm wide, ogee glazing bars **APPENDIX K**

**APPENDIX K** Basement Gower Street- 15mm glazing bars with slight moulding.

3 x six over six original box sash windows. These windows have 15mm original glazing bars with a small ogee moulding. There is no evidence of any original hand blown glass.

Replace all glass with 6.8mm Pilkington Optiphon<sup>1</sup> (sound reduction approx.7 decibels). Full draught stripping (sound reduction approx. 4 decibels).
