VATS WINE BAR

FRONT ELEVATION 1:50

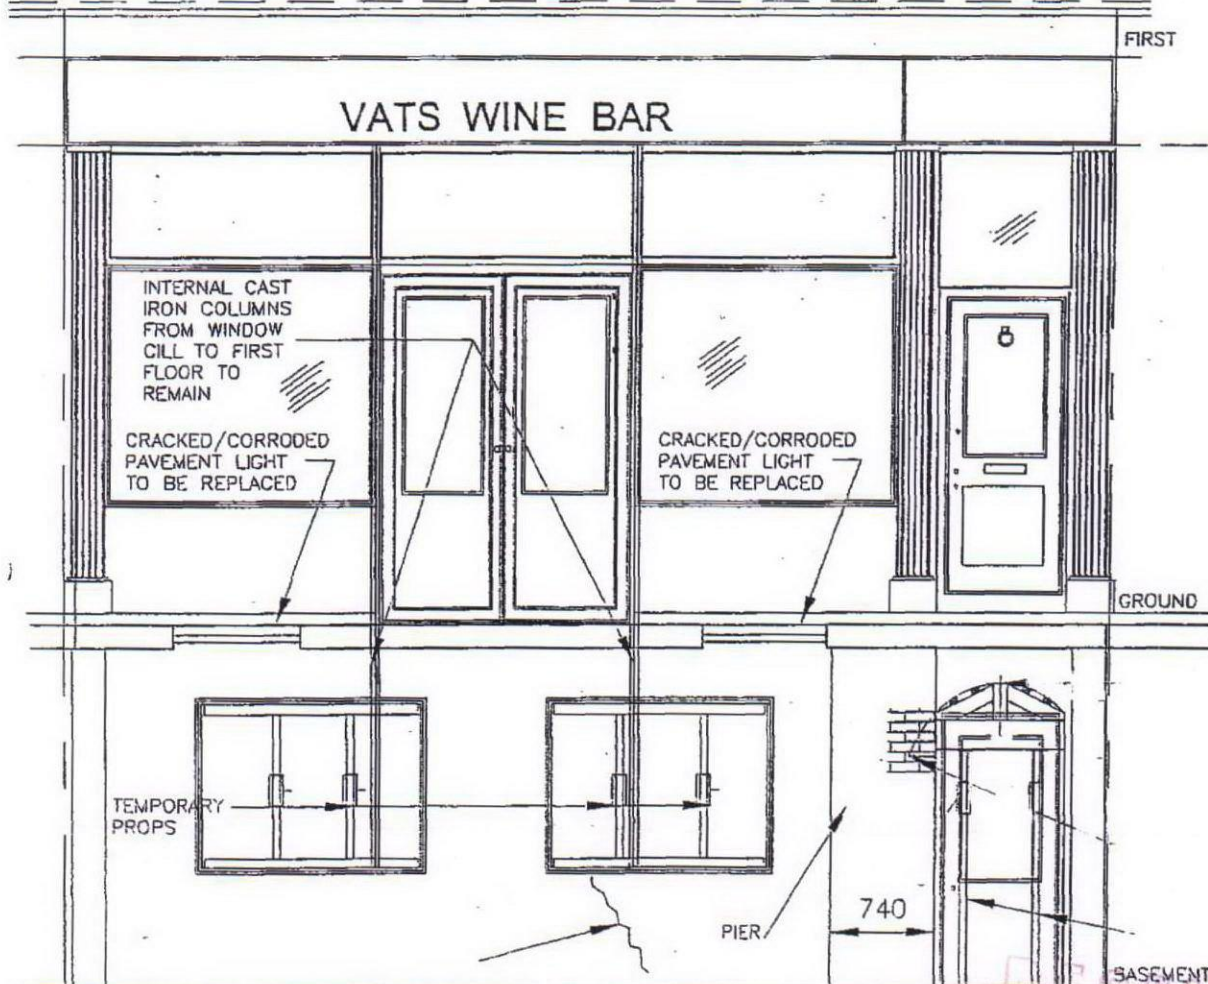
CRACKED/CORRODED  
PAVEMENT LIGHT  
TO BE REPLACED
