Arboricultural implications assessment  
for development at  
17 Templewood Avenue NW3 7UY

20 01 12  
AIA 7101

Mr T Henry

Report date: 20 01 12

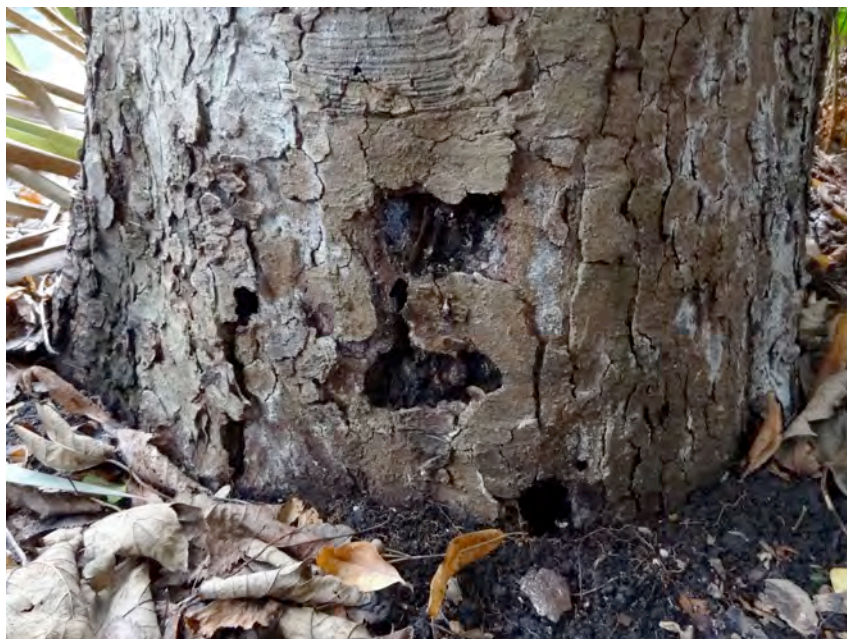
- 4.2 The sycamore T3 (TPO T60) has scattered areas of lifted or absent bark from the trunk base to about 1m above ground level on the north, east and south-east of the trunk. (See example in photograph 1 in Appendix B.) Where the underlying wood is exposed, it is either stained or soft and decaying, so that a probe penetrates up to 100mm when minimal pressure is applied. There are also other small patches of dead, dark bark around the trunk to about 1.5m from ground level. Close to the trunk base on the eastern (road-facing) side is an area approximately 550mm wide and about 400mm high from ground level which sounds hollow when tapped with a rubber mallet. If the tree were to remain, its structural safety would need to be monitored, especially as it has deteriorated over the past six months. The existence of the dysfunctional wood may be linked to the tree's thin, small crown (see photographs 2 and 3 in Appendix B). In combination, they suggest that the tree is in decline and has a safe useful life of only a few years at most. I therefore graded this tree as category R (for removal) and recommended its removal and replacement *irrespective* of the future use of the site. The proposed development does not, therefore, create pressure to remove this tree. Replanting would help to maintain the screening from the road and to ensure the long-term visual amenity of the planting at the front of the garden.

Photograph 1, of the east trunk base of the sycamore T3 (January 2012).

- 5.4 One sycamore (T3) is recommended for removal regardless of the future use of the site. A replacement tree could be placed in the gardens.
- 5.5 The proposed development is mostly within the footprint of the existing building. The proposed basement intrudes into the root protection area of the sycamore T3, but this tree is recommended for removal and replacement for sound arboricultural reasons, regardless of the future use of the site, so should not be a constraint on development.

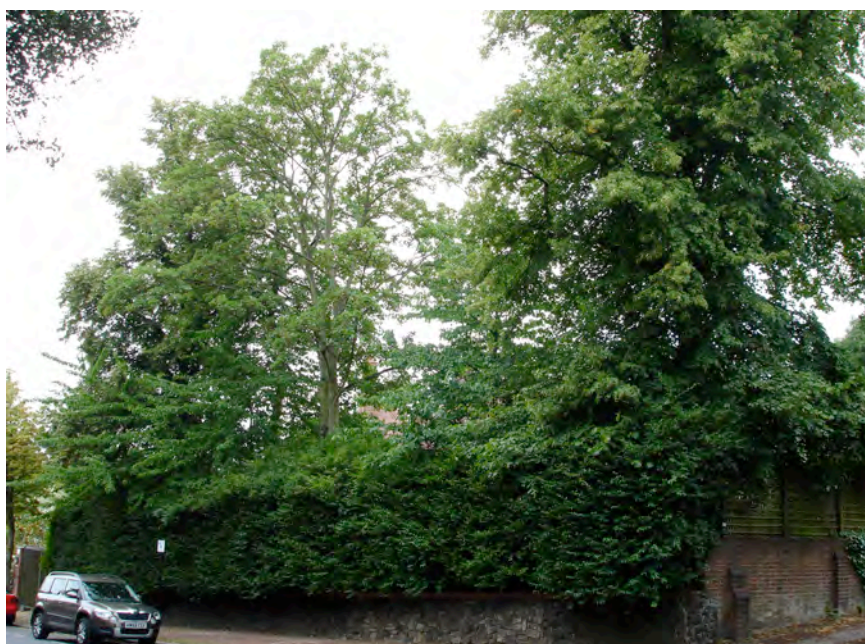
Photograph 2, taken from Templewood Avenue, showing the sparse crown of the sycamore T3 (June 2011).

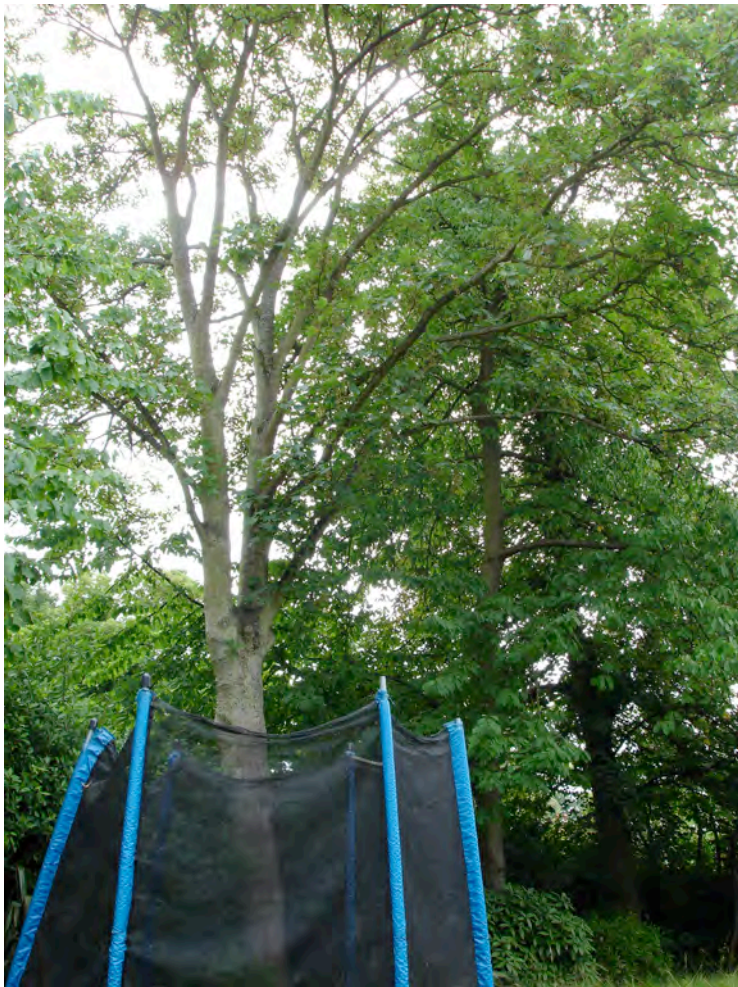
Photograph 3, taken from the front garden of 17 Templewood Avenue, showing the sparse crown of the sycamore T3 (June 2011).

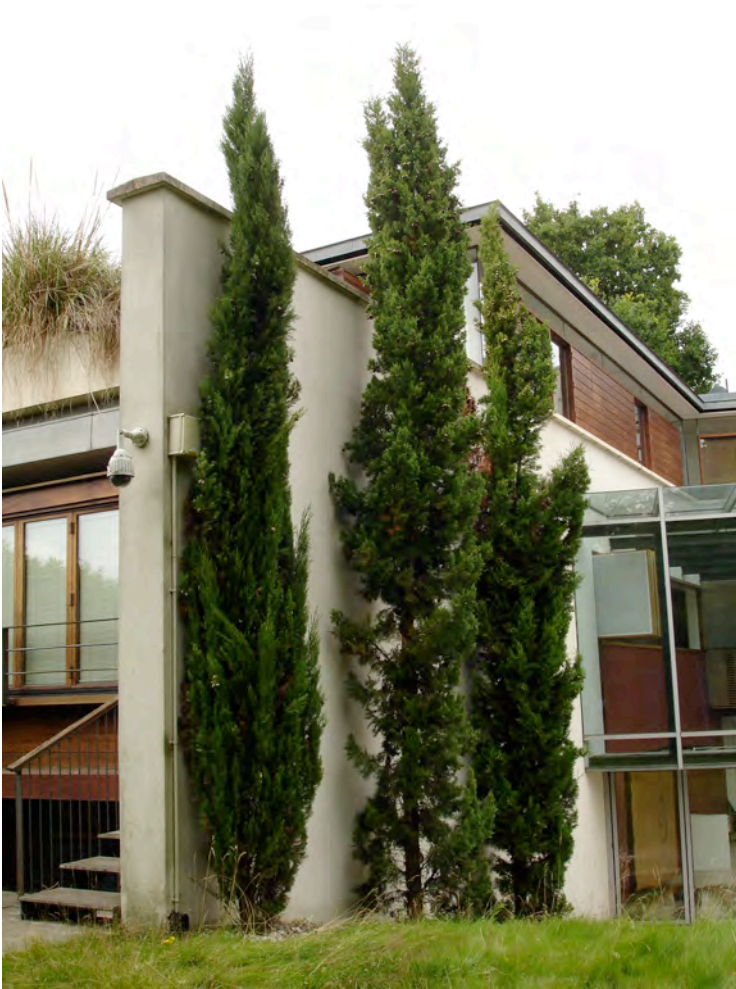
- 4.3 I graded the italian cypresses T10, T11 and T12 (see photograph 4 in Appendix B) as category C trees because of their uneven shape (T11 and T12), loss of lower foliage (T11), dead or diseased branches (especially T12) and lack of space to grow, even though this species grows as a narrow column. These trees would need to be removed to allow the proposed development to go ahead. They are not visible from outside the site, so their loss would not be detrimental to local amenity, and the British Standard BS5837:2005 notes that category C trees should not be a constraint on development. Replacement trees of better aesthetic value could be planted within the garden.

Photograph 4, taken from the front garden of 17 Templewood Avenue, showing the poor condition and form of the italian cypresses T10, T11 and T12 (June 2011).

- 5.3 Three young italian cypresses would need to be removed to allow the development to go ahead. These are category C trees that are not visible from outside the site, so should not be a constraint on development. The trees could be replaced in the gardens.

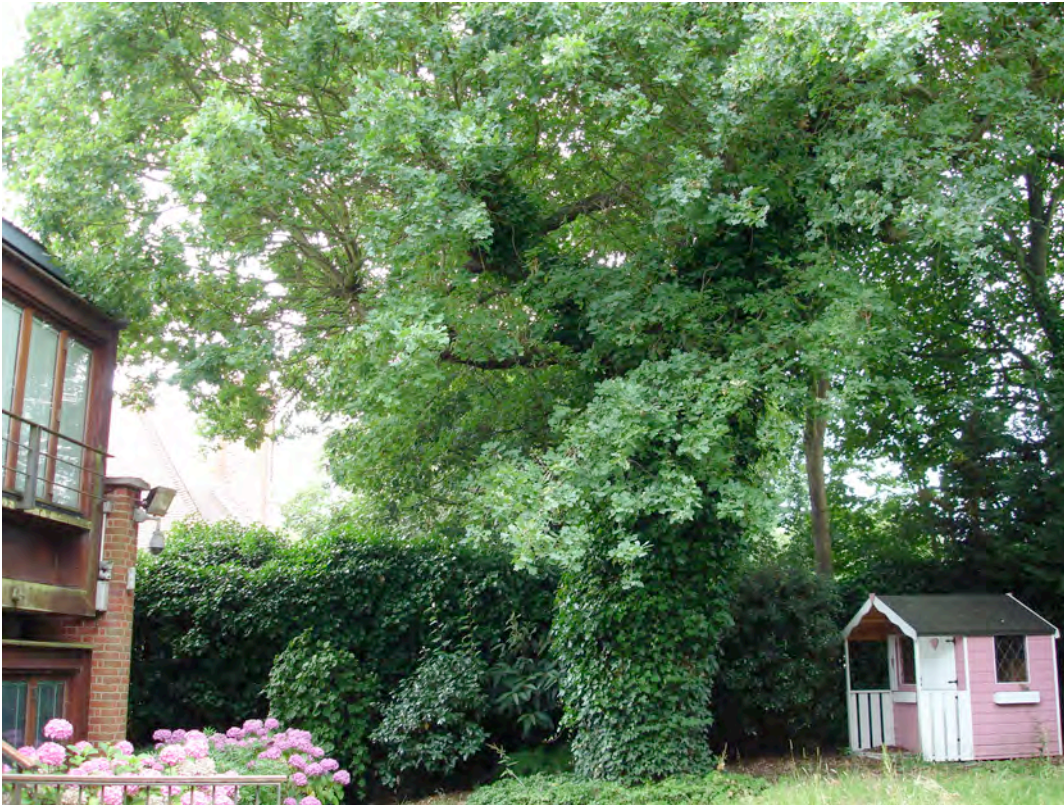
- 4.8 Irrespective of the planning proposal, the oak T13 will need to be crown lifted and cut back from the existing building (see photograph 5 in Appendix B) to prevent damage to the tree or building from branch movement. (This work would be subject to a statutory TPO application if the proposed development did not go ahead.) In addition, regardless of any planning proposal, tree work to branches near the house would be needed periodically for the foreseeable future to manage their weight and levering effect on their potentially weak attachment points adjacent to large historic pruning wounds. The proposed development would not therefore increase requests to prune the tree because the tree already needs to be pruned periodically to accommodate the existing building.

Photograph 5, taken from back garden of 17 Templewood Avenue, showing the branch growth of the oak T13 that would need to be pruned if the existing building were to remain. The first and second floors of the proposed new building would be set farther back than the ground and first floors visible here (June 2011).

- 5.7 If the existing house were to remain, the oak T13 would need to be pruned periodically to prevent branch and building damage from branch movement. The proposed development would be unlikely to increase the pressure to prune this tree. No additional pruning would be likely to be required to enable construction.
