SIMON JONES ASSOCIATES Ltd.

9th December, 2011

Ref.: Town & Country Planning Act: Section 198(6)(a) Notice.
2 Fitzroy Close, Highgate, N6 6JT.

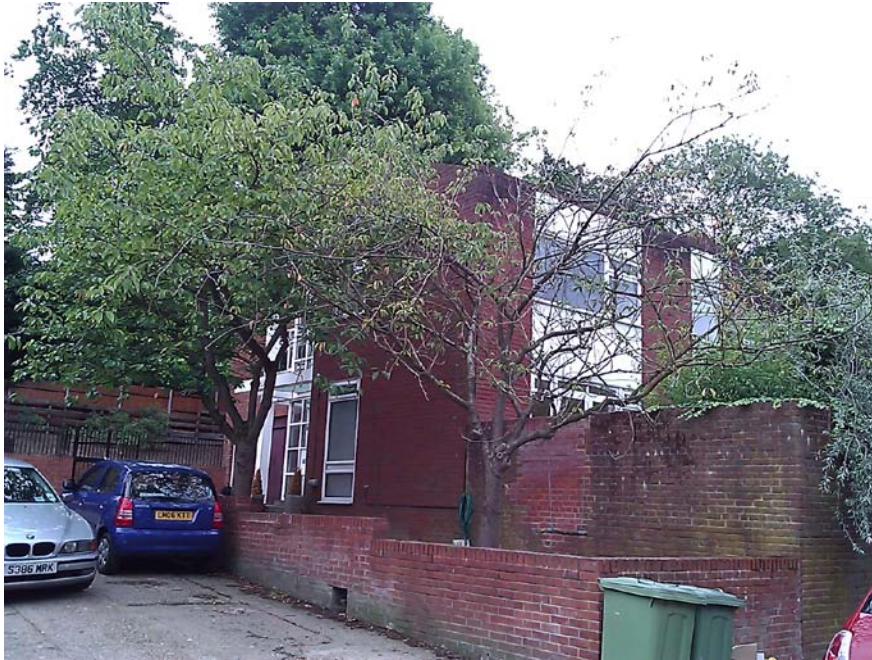
When inspected during the summer of 2011 it was extremely sparsely foliated (see **Photos #1** and **#2** below). Many twigs and sub-branches contained no leaves at all, others contained only a few and these were markedly of a smaller size than those on the adjacent tree to the north and much yellower in colour. The extent of die-back and sparsity of foliage is such that the tree is most unlikely to be able to recover and is therefore moribund. There is simply not enough photosynthesising material within the tree to provide the starch it will need to survive.

No clear reason for the demise of this tree can be seen. However, I noted that the ground levels around the bases of both trees appears to have been covered with a geotextile membrane with pea shingle above. No buttress roots are visible at the bases of either tree and it is quite probable therefore, that the positioning of this membrane has restricted the amount of water and oxygen available to the roots of the tree, and is also preventing the replenishment of any organic matter within the soil through leaf fall etc. However, ornamental cherries tend to be both short-lived and prone to disease; so the decline of this specimen is neither uncommon nor unexpected.

Photo #1: View of cherry tree (from the west) on 13th July 2011. Note sparseness of foliage of subject tree in foreground compared to other cheery behind.

I write to notify you formally of our clients' intention to fell one cherry tree subject to a Tree Preservation Order at the above address.

Accordingly, I regard this tree to now be exempt from the TPO regulations in that it is dying.

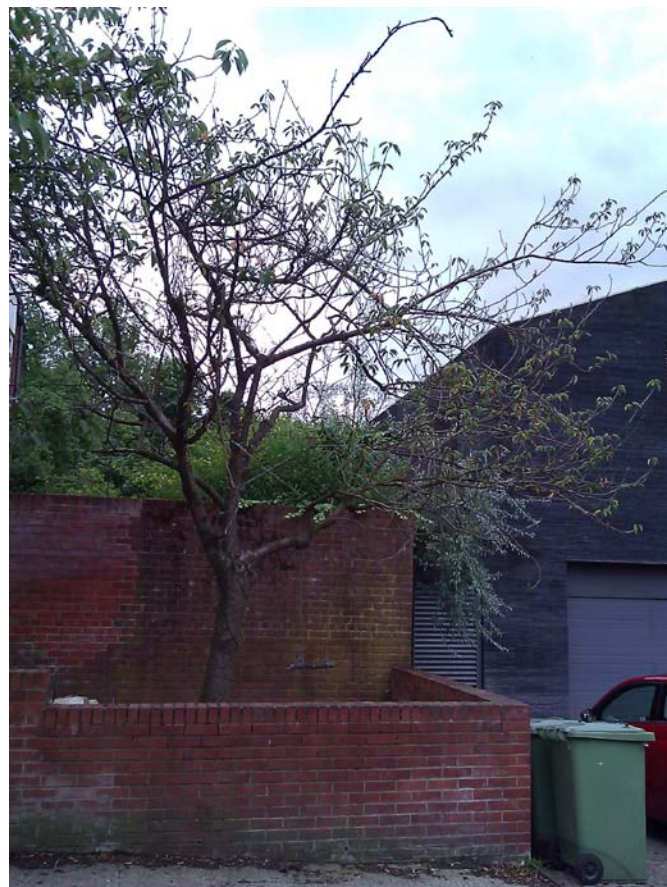
Photo #2: View of cherry tree (from the north) on 13th July 2011. Sparseness of foliage readily apparent. Healthy foliage in upper left of picture is from the other cherry to the east.
