Easter Goods Yard, King's Cross  
2007/5228/P

**Appendix 3:** Feasibility Study into the Restoration of Turntable B. (Rev. B)

## RESTORTION OF TURNTABLE B

DATE: 18<sup>th</sup> November 2011

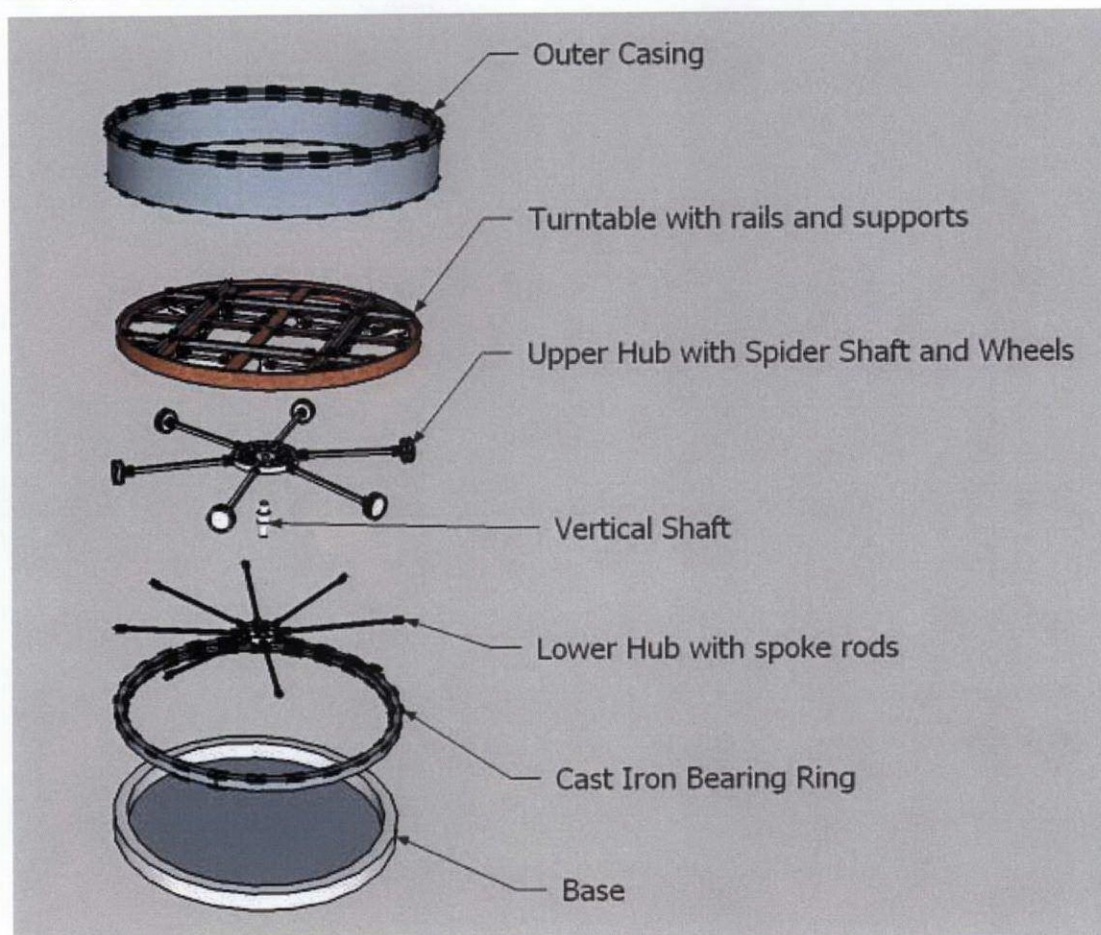
- 2.2. **Turntable Components.** The exploded view of the turntable below gives an indication of the primary components that make up the turntable. These components act similar to a roller bearing. The lower cast iron bearing ring would be supported on a brickwork ring and would act as the base to the bearing. The lower hub and spoke rods would maintain the circular shape of the cast iron bearing ring whilst providing a central base to the main vertical shaft around which all components rotate. The upper hub with the spider shafts and wheels act as the balls to the bearing and allow the turntable to rotate relative to the bearing ring. When the turntable was operated, the turntable with rails and supports would rotate at twice the rate of the upper hub with spider shafts, whilst the lower hub and bearing ring would remain stationary. All of these components are then housed within, and rotate within the outer casting. The outer casting remains stationary throughout.

- 2.3. **Outer Casing.** The outer casing is constructed from cast iron plate formed into a circular ring. Corrosion of the structure since its last use, combined with external forces applied to the structure whilst it has been buried has had an effect on the geometry of the ring and it is no longer circular. A detailed survey of the ring has taken place which suggests that the plate itself is out of line by up to 25mm from its likely original position.

- 2.4. **Turntable .** Similar to the outer casting, the turntable itself has been affected by corrosion and the application of load and is no longer truly circular in plan. The detailed survey information suggests that the outer ring of the turntable may be out of line by up to 25mm.

- 2.5. **Upper Hub and Wheels.** All components are showing signs of corrosion, however this is generally limited to surface corrosion. The existing wheels **appear to be "rusted" onto the existing shafts** and it is unlikely that these could be rotated or removed due to the corrosion locking the wheels onto the shaft.

- 2.6. **Vertical Shaft.** The shaft is showing signs of vertical corrosion and it appears as though the corrosion has locked the shaft into the upper and lower hubs and any rotational capability is considered unlikely.
- 2.7. **Lower Hub with spoke rods.** The wrought iron spoke rods show signs of corrosion. At their connection with the lower hub the spoke rods are threaded and are secured by nuts locking the rod to the hub. It is likely that these nuts originally provided some adjustment allowing the hub to be centred. These nuts are corroded and locked on to the spoke rods.
- 2.8. **Cast Iron Bearing Ring.** The cast iron bearing ring is showing signs of corrosion and pitting. The ring is made up of a number of individual elements bolted together. The bolts have almost completely rusted away. The upper running surface has significant pitting.

- 3.2. **Outer Casting.** It will be necessary to return the outer casting to a true circular form. This is likely to consist of cutting the casting into a series of smaller parts and then fixing these to a circular steel former around the perimeter.

- 3.3. **Turntable with supports and rails.** This element would be refurbished and any corrosion removed to allow the turntable to rotate within the outer casting. As a minimum this is likely to include grinding to the outer surface to remove any protrusions. This may however not be sufficient and it may be necessary to strip the turntable down to its component parts to allow any corrosion products to be removed and re-constructing it ensuring its circular form is reinstated and maintained. It would be necessary to machine out the centre of the hub to allow a new vertical shaft and bearing to be installed. The lower face of the turntable which is in contact with the bearing wheels would need to be machined / treated to provide a true level bearing surface.

- 3.4. **Upper Hub with Spider Shafts and Wheels.** The centre of the hub would need to be machined out to accommodate a new vertical shaft and bearing. The existing wheels would be removed and if possible refurbished for re use. It is however possible that these wheels are no longer serviceable and new replacement wheels are likely to be required. The ends of the existing spider shafts would be removed and new ends spliced in to provide support to new bearings.

- 3.5. **Vertical Shaft.** The existing vertical shaft will be redundant and would be replaced with a new shaft and bearings to facilitate the movement.

- 3.6. **Lower Hub with Spoke Rods.** The centre of the lower hub would be machined out to accept a new vertical shaft and bearing. The upper surface of the casting would be worked to provide a true level surface for the bearing wheels to run on.

- 3.7. **Base.** The existing base is now redundant and the lower hub would be supported on a new reinforced concrete base.
