Landmark Trees

ARBORICULTURAL IMPACT ASSESSMENT REPORT:

The Waterhouse,
Millfield Lane,
London
N6 6HT

Ref: SHH/WHs/AIA/01 Rev C

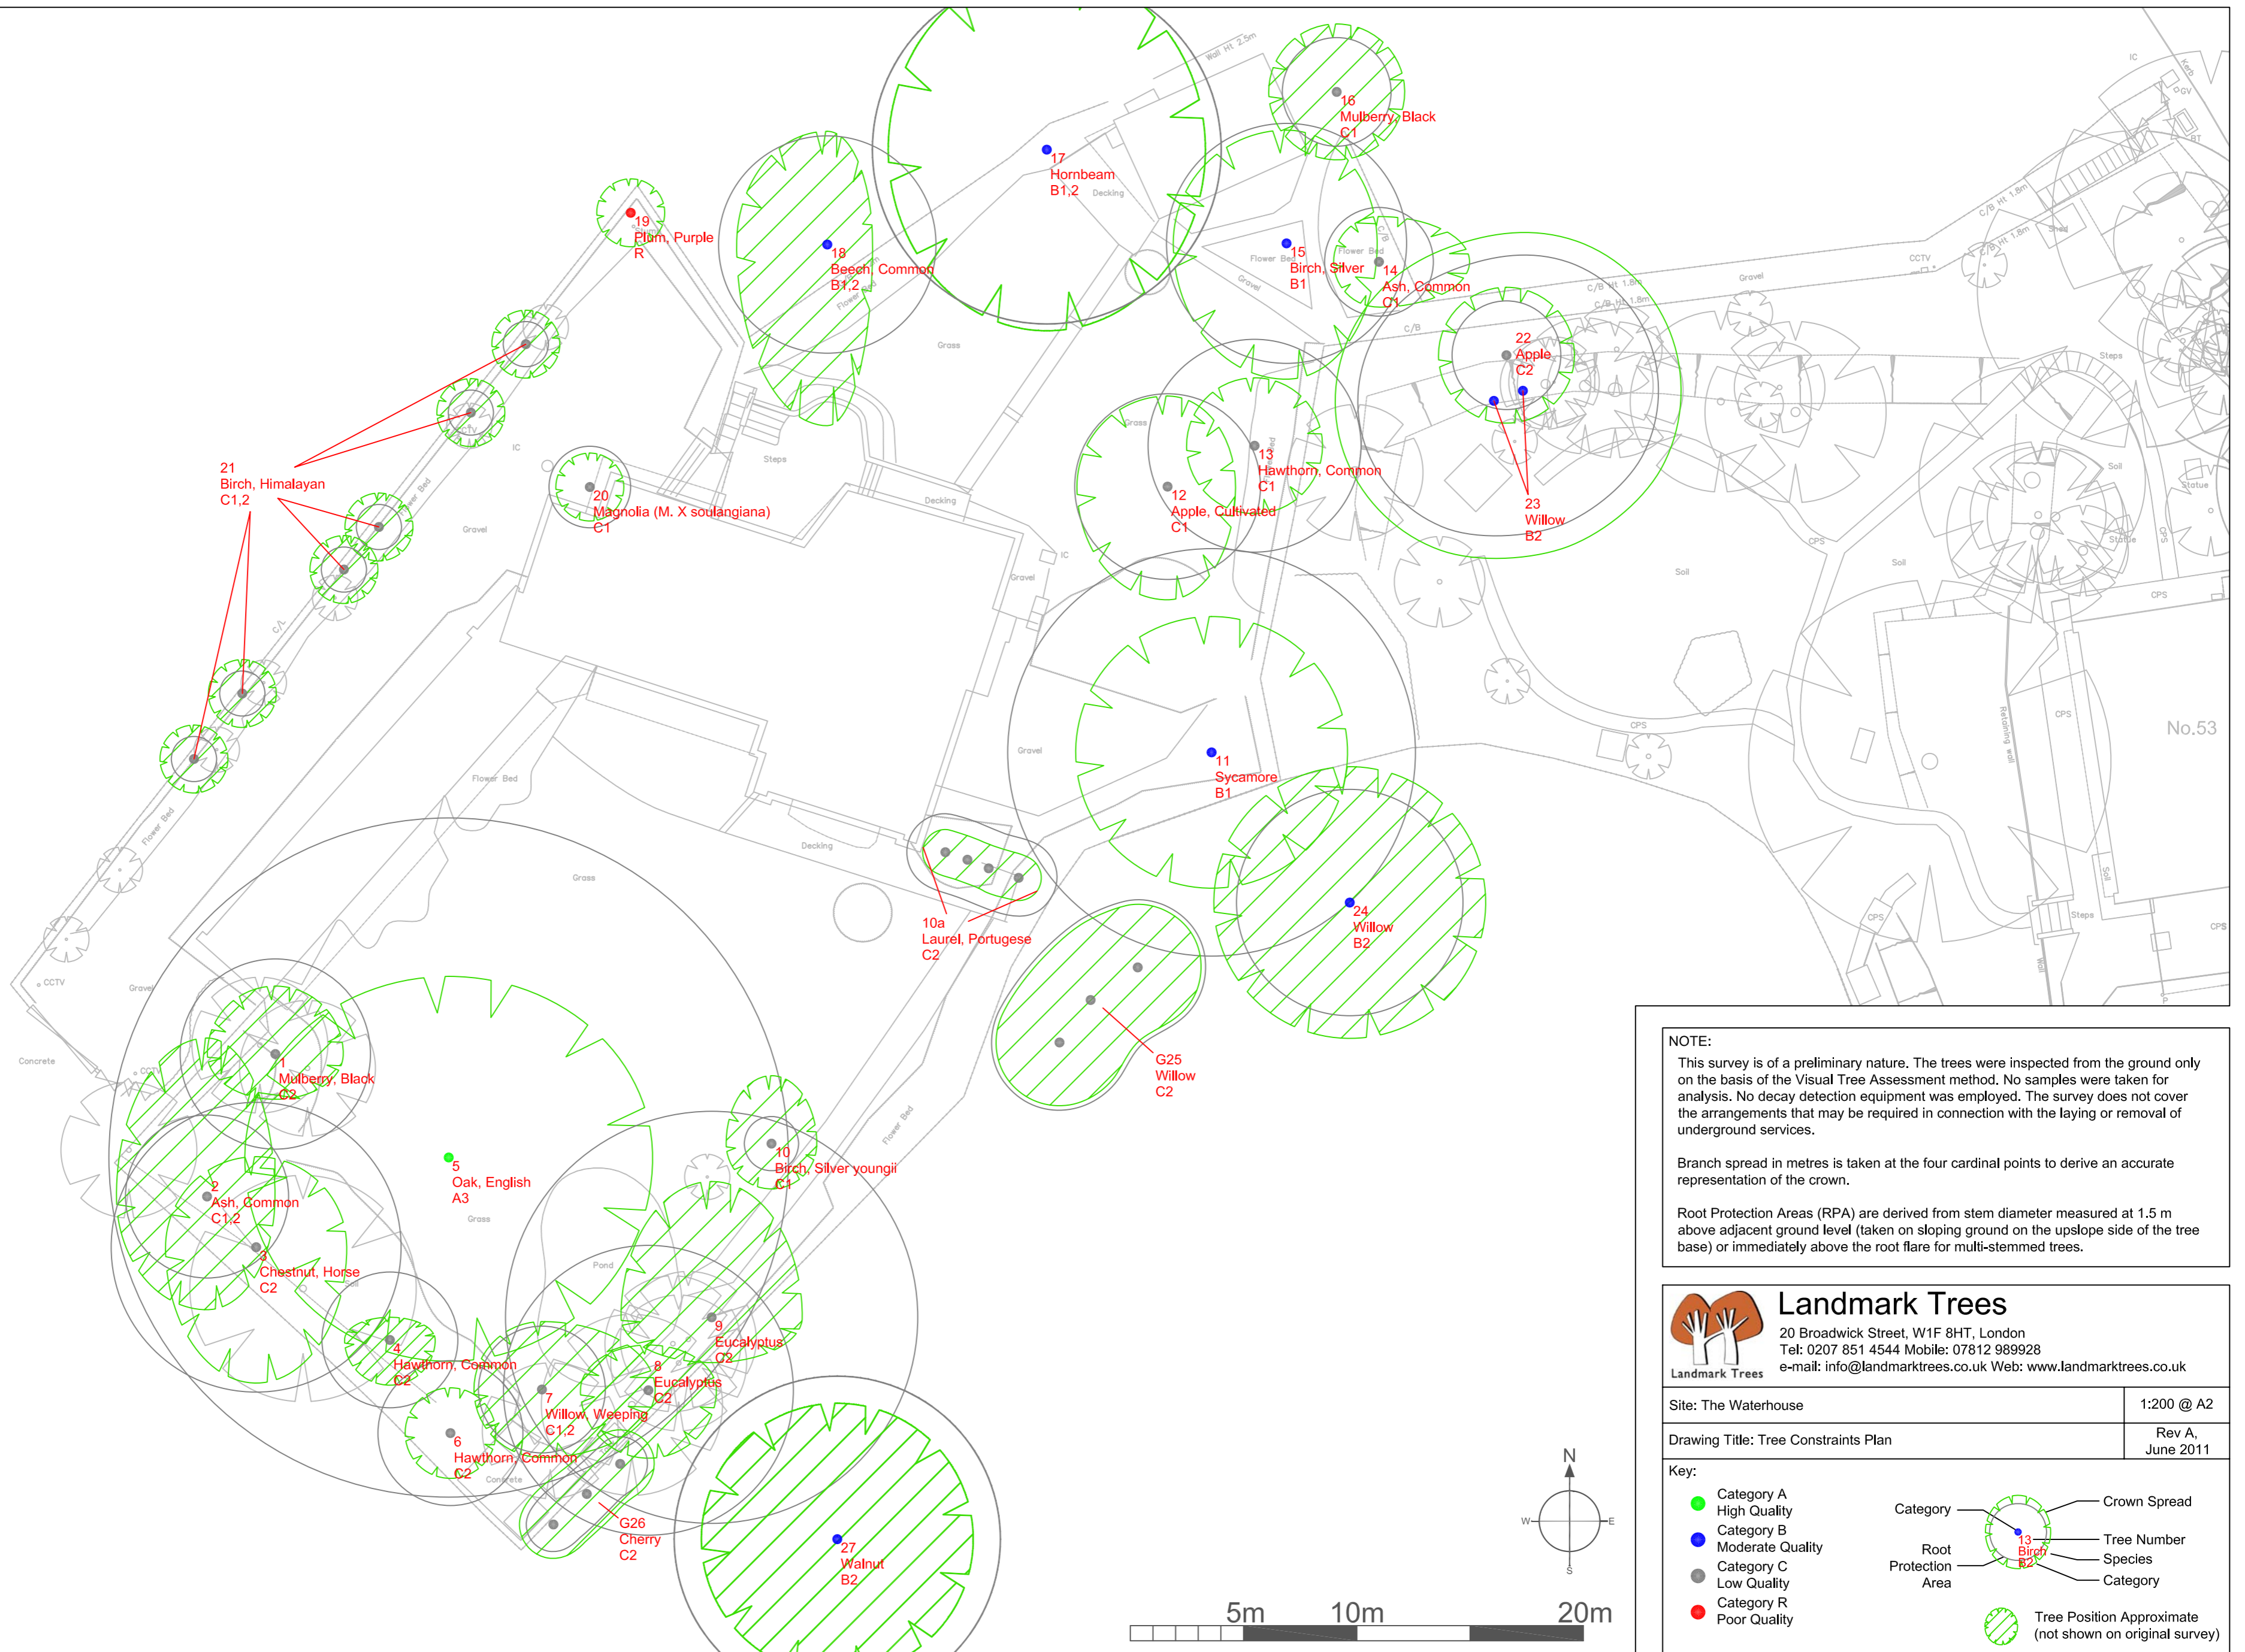
APPENDIX 4TREE CONSTRAINTS PLAN

3.2.1 Of the 28 surveyed trees on or near the site, only one, T5 is category 'A' (High Quality). There are seven 'B' category (Moderate Quality) trees: 11, 15, 17 & 18, and the remaining nineteen trees are 'C' category (Low Quality), excepting one poor quality ('R' category) tree i.e. 19.

- 3.2.7 Tree 5 is an imposing post-mature 20m tall English oak with an average crown spread of 8/9m and a stem diameter at 1.5m of 129cm. The tree has marked defects with a large cavity at the base and clear areas of decay present in the trunk. The crown of the tree is vigorous and no obvious major dieback is evident. On the basis of the noted decay, consideration should be given to the size of the crown and for a crown reduction to reduce the possibility of large crown branches failing from regions of decay in the main trunk.

- 8.1.2 It is strongly recommended that the decay within oak tree 5 is investigated further, to determine the status of the tree and its management requirements.

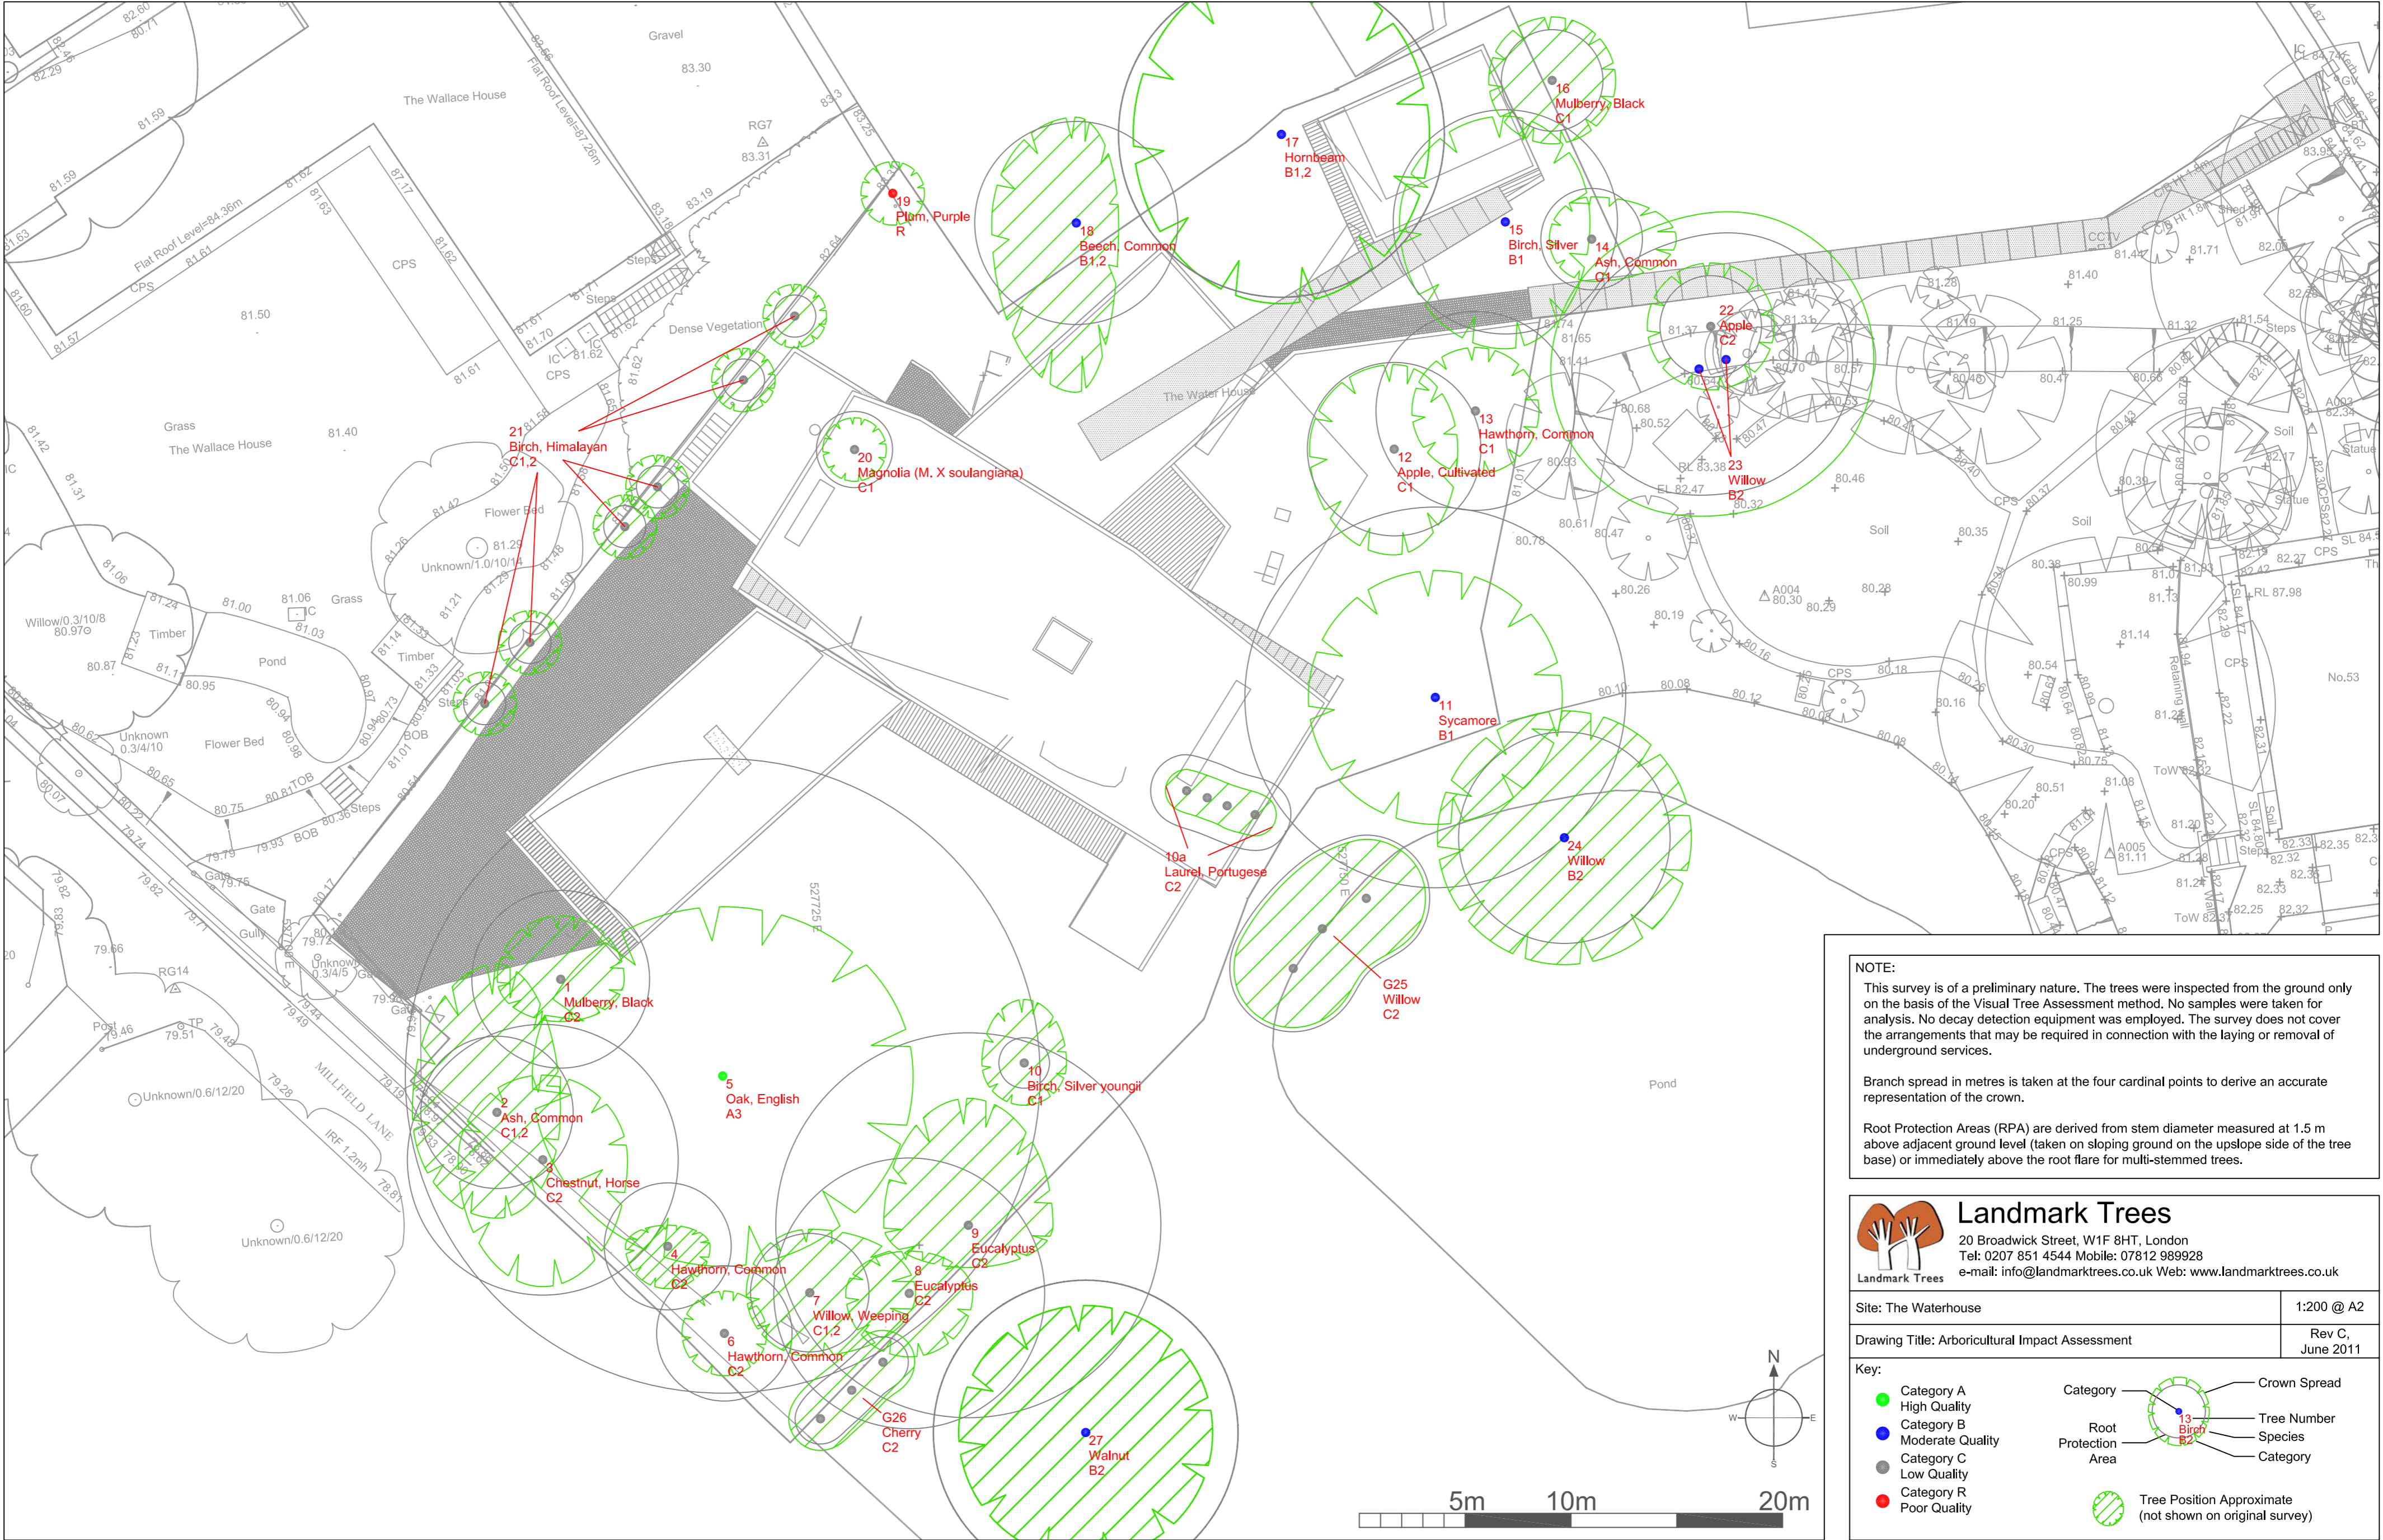
APPENDIX 5ARBORICULTURAL IMPACT ASSESSMENT PLAN

Encroachment of trees 1, 5, 11, 15, 17,18 & G21 by the proposed footprint and additional landscaping. Most impacts are <10% of RPA, excepting trees 1 & 15 at 13% & 26%, respectively. Half the impact to T15 will be no-dig construction.				
Comments				
Impacts are rated low and can be further mitigated through planting and constructional variation.				
Recommendations				
1	Proposal will mean the loss of important trees (TPO/CA)			N
2	Proposal has sufficient amelioration for tree loss			Y
3	Proposals provide adequate tree protection measures			Y
4	Proposal will mean retained trees are too close to buildings			N
5	Specialist demolition / construction techniques required			Y
6	The Proposal will result in significant root damage to retained trees			N
7	Further investigation of tree condition recommended			Y

- 1.3 The principal primary impacts in the current proposals are the removal of trees 10a, 12 and 20. The removal of all these trees is sustainable, given their low quality and value. Further impacts to retained trees comprise the encroachments of trees 1, 5, 11, 15, 17 and 18 by the proposed footprint and additional landscaping. Most are <10% of RPA and rate very low impact, excepting trees 1 & 15 at 13% & 26% RPA, respectively. Tree 13 is a C category mulberry, which could simply be removed, but is preferred for retention. T15 is a B category birch, and although the impacts exceed 20%, they are of low intensity 13% no-dig paving and 13% out-building extension.

6.3.2 The building encroachments will require the use of specialised foundation techniques, such as mini-piling or pad and raised beam (where levels permit). The foundation pits within the RPA should be trial-excavated by hand using a double-headed spade ("shove-holer") or similar to minimise breadth of hole required for inspection.

6.3.3 The paving encroachment will require a no-dig construction technique, using a cellular confinement system with no fines aggregate for the sub-base. The degree of encroachment (<20% of RPA) means that a permeable paving surface (e.g. gravel or block paving) is not required (but nonetheless, recommended here).
