Project name:
FITZROY PARK

Contract number:
5110

Inspection report

Road: FITZROY PARK	Div/Dist:	start MH: MH.1
Place: HAMPSTEAD HEATH	Drain. Area:	end MH: MAIN RUN
Location: Gardens	Standard: BS EN 13508-2:2003	Total length: 25.2 m
Purpose: Sample survey (asset condition)	Shape/Size: Circular 150	Pipe length:
Type: Gravity drain/sewer	Material: Vitrified clay (i.e. all clayware)	
Use: Combined	Lining: Lining Type:	
Comment:

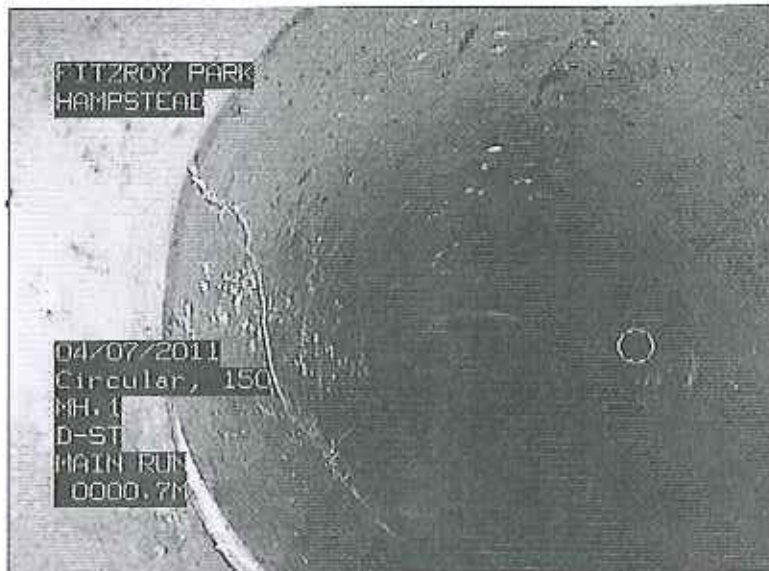
0.70	FCJ	Circumferential Fracture at joint from 08 to 09 o'clock	00:00:42	1_5a	(Struct) 3
	4.30	CCJ	Crack Circumferential at joint from 09 to 01 o'clock	00:01:28	1_6a	(Struct) 2

Photo: 1_5a, Tape No.: 5110, 00:00:42
0.7m, Circumferential Fracture at joint from 06 to 09 o'clock

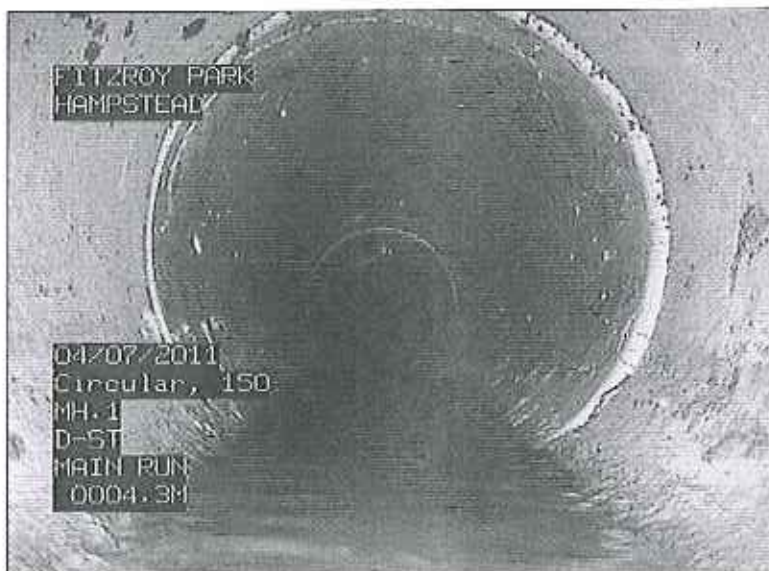
Photo: 1_6a, Tape No.: 5110, 00:01:28
4.3m, Crack Circumferential at joint from 09 to 01 o'clock

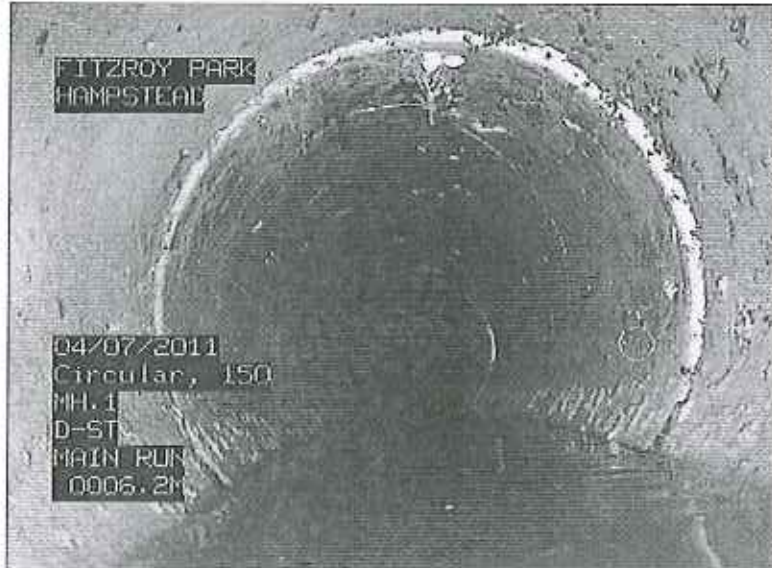
4.60	WL	Water level 10 % height/diameter	00:01:57		(Serv) 0
	6.20	FCJ	Circumferential Fracture at joint from 10 to 03 o'clock	00:02:14	1_8a	(Struct) 3
	8.40	FCJ	Circumferential Fracture at joint from 08 to 03 o'clock	00:03:00		(Struct) 3

Photo: 1_8a, Tape No.: 5110, 00:02:14
6.2m, Circumferential Fracture at joint from 10 to 03 o'clock

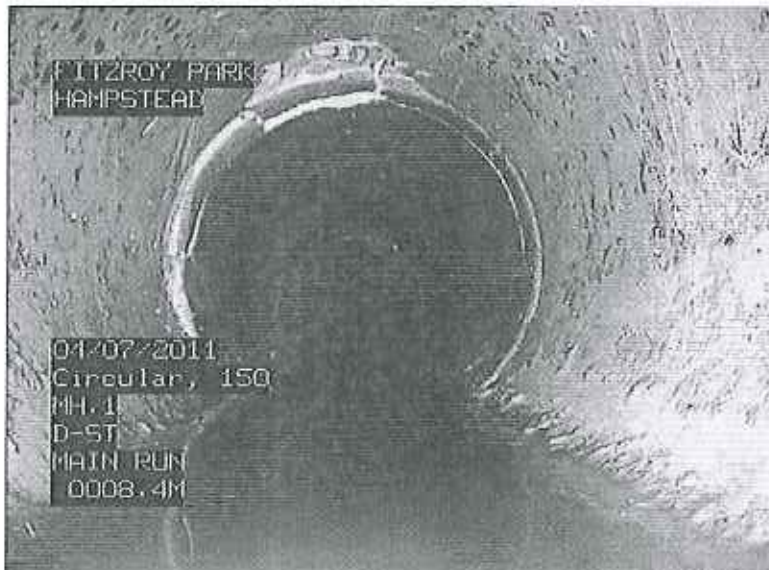
8.40	BJ	Broken Pipe at joint from 11 to 01 o'clock	00:03:07	1_10a	(Struct) 4
	9.60	WL	Water level 5 % height/diameter	00:03:27		(Serv) 0
	11.00	CCJ	Crack Circumferential at joint from 10 to 03 o'clock	00:03:47	1_12a	(Struct) 2

Photo: 1_10a, Tape No.: 5110, 00:03:07
8.4m, Broken Pipe at joint from 11 to 01 o'clock

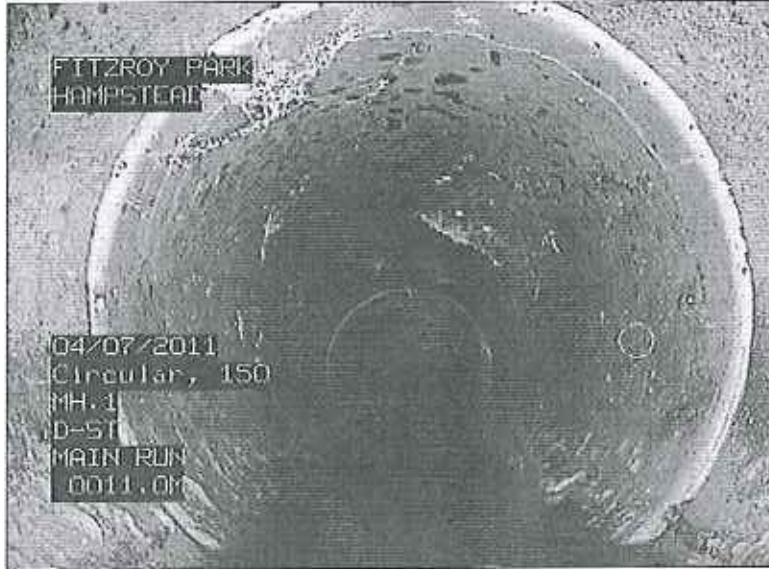
Photo: 1_12a, Tape No.: 5110, 00:03:47
11m, Crack Circumferential at joint from 10 to 03 o'clock

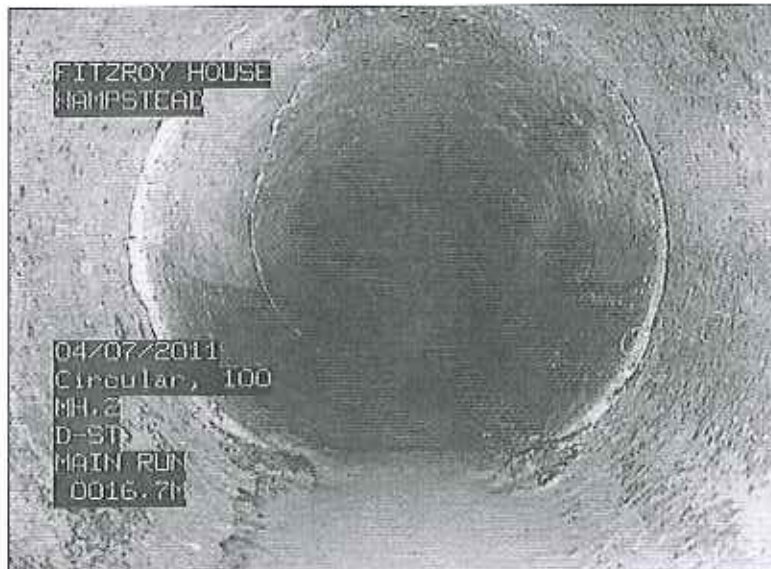
Photo: 41_11a, Tape No.: 5110, 00:05:16
16.7m, Fracture spiral from 06 to 12 o'clock

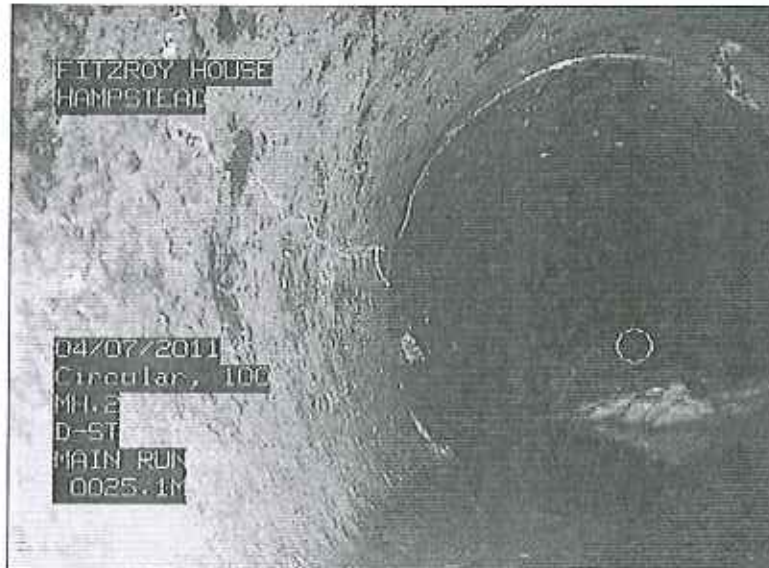
25.10	FCJ	Circumferential Fracture at joint from 12 to 12 o'clock	00:08:59	49_19a	(Struct) 3
	28.30	CC	Crack Circumferential from 12 to 12 o'clock	00:10:31		(Struct) 2

Photo: 49_19a, Tape No.: 5110, 00:08:59
25.1m, Circumferential Fracture at joint from 12 to 12 o'clock

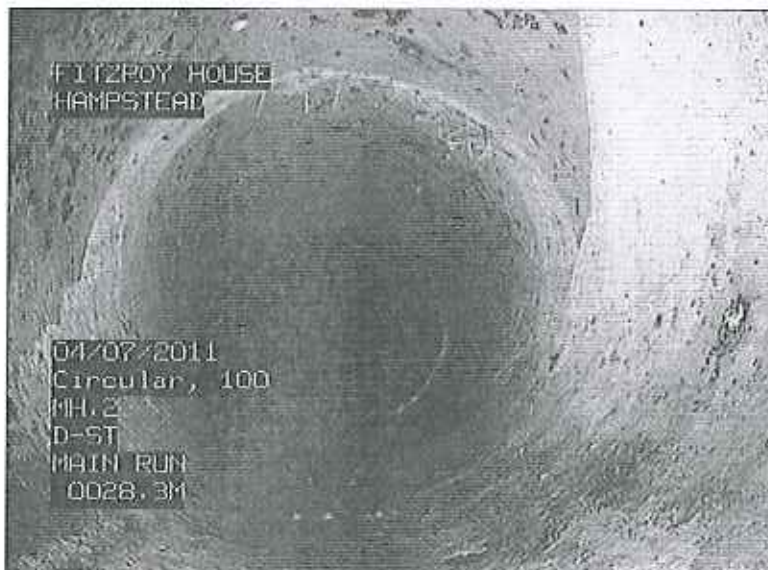
Photo: 51_21a, Tape No.: 5110, 00:10:38
28.3m, Fine Roots

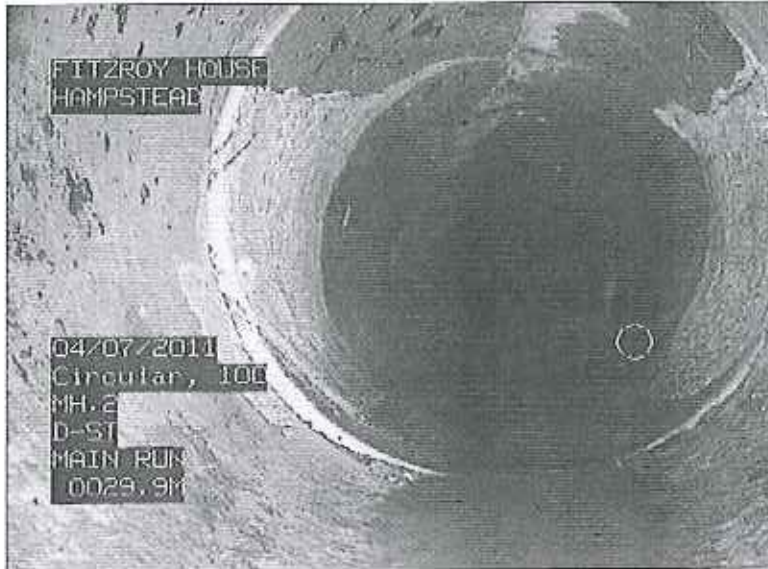
Photo: 52_22a, Tape No.: 5110, 00:11:08
29.9m, Crack Longitudinal at joint at 02 o'clock

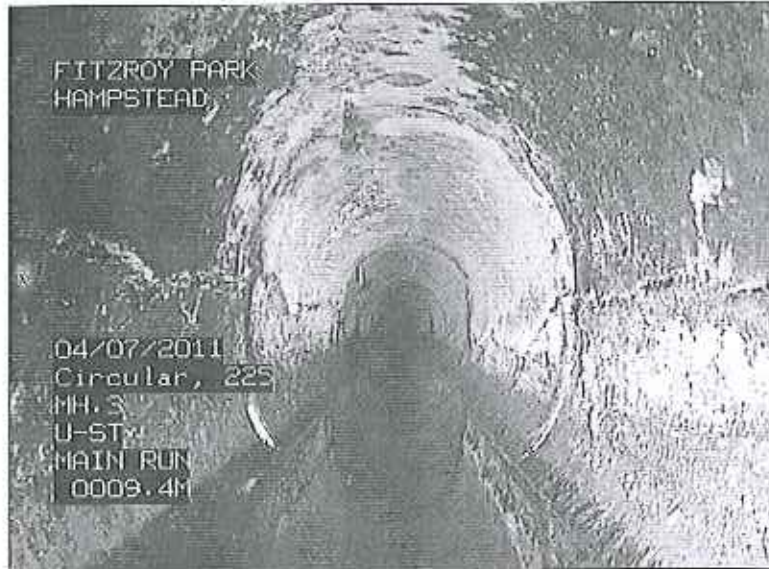
9.40	FL	Fracture longitudinal at 12 o'clock	00:01:42		(Struct) 3
	9.40	D	Deformed drain/sewer 10 %	00:01:48	4_11a	(Struct) 5
	10.50	S2	FL Fracture longitudinal at 03 o'clock, Start	00:02:28		(Struct) 3

Photo: 4_11a, Tape No.: 5110, 00:01:48
9.4m, Deformed drain/sewer 10 %

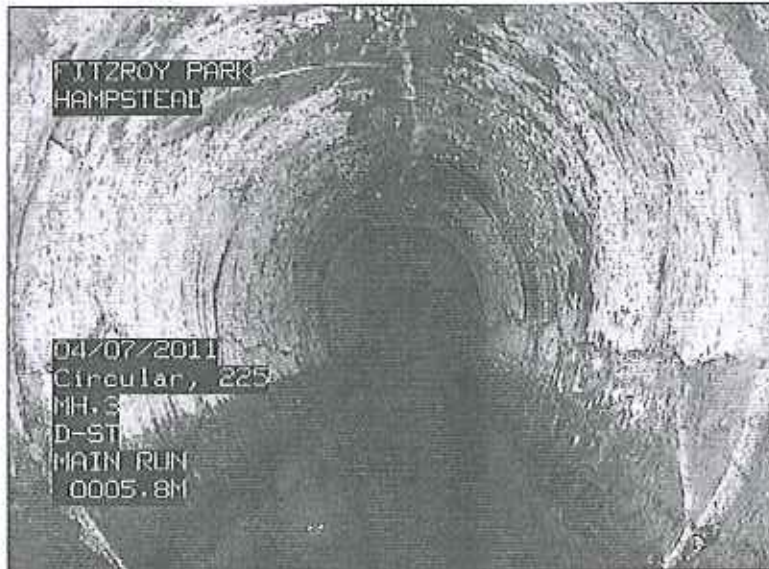
5.80	FLJ		Fracture longitudinal at joint at 03 o'clock	00:00:56		(Struct) 3
5.80	FLJ		Fracture longitudinal at joint at 09 o'clock	00:01:02		(Struct) 3
5.80	D		Deformed drain/sewer 5 %	00:01:07	90_7a	(Struct) 5

Photo: 90_7a, Tape No.: 5110, 00:01:07
5.8m, Deformed drain/sewer 5 %
