# CONDITION SURVEY

**30a Highgate Road, London NW5 1NS**

Date: 25<sup>th</sup> July 2011

**Re: 30a Highgate Road**

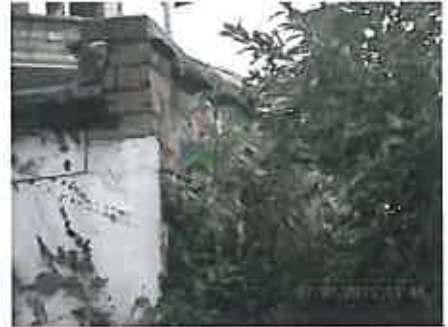
Fairly extensive cracking has occurred to the brickwork structural walls throughout. In particular, the single storey front elevation wall is leaning excessively and we consider this to be structurally unstable. Extensive rebuilding works will be required in order to rectify this, together with structural supports required to tie the front elevation brick wall to the roof structure. To other cracks noted to the brick work internally, allow for resin bond repairs.

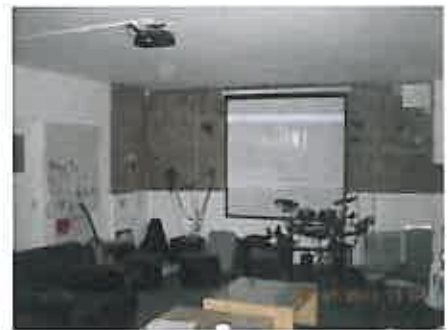
There is evidence of remedial works following rising damp in the form of a waterproof render being applied approximately 1 metre above ground level. This generally appears to be in tact although minor surface cracking is evident.

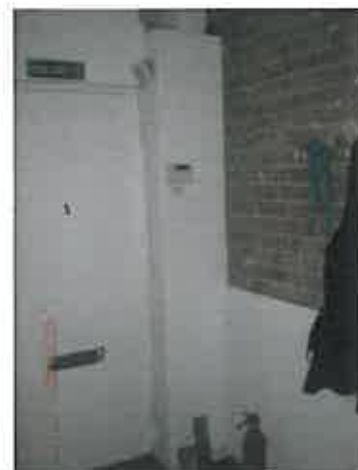
We suspect the presence of asbestos containing material in the form of duct lining panels adjacent to the front entrance door. Allow for an Asbestos Survey to be undertaken and these materials to be removed.

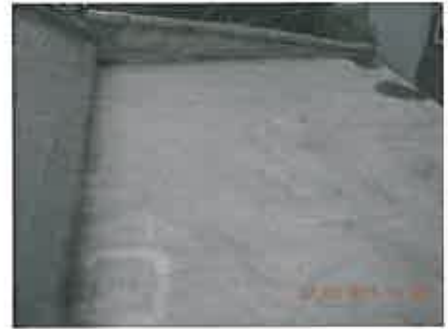
There is a leaking rain water down pipe internally causing damp staining at roof level. Rain water gutters and down pipes elsewhere are leaking in places and extensive remedial works to the rainwater goods is required.

General roof repairs are required including replacement, reinstatement or redressing of lead covered flashings and asphalt repairs.

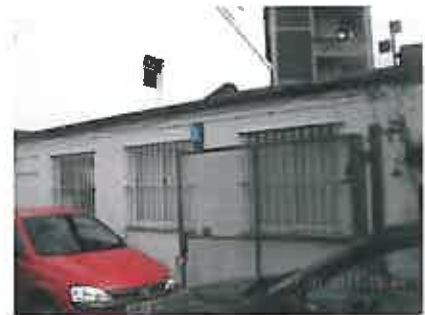
There is fairly extensive buddleia growth from within the external brickwork walls. Allow for cutting these out and making good the brickwork.

The external painted render is extensively cracked and requires hacking off and renewal to the entire left hand side elevation.

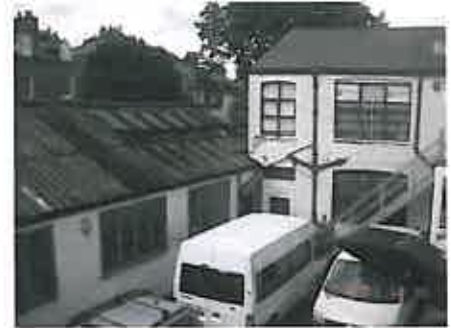
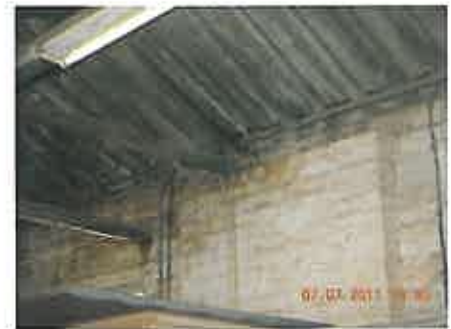
The roof coverings comprise asbestos cement corrugated sheets incorporating 10 No raised sky lights. The roof sheets have been repaired over the years. There are currently a number of defective sheets evident and the coverings are at the end of their useful life with extensive water ingress internally. Allow for complete replacement with new composite insulated profile metal roof system.

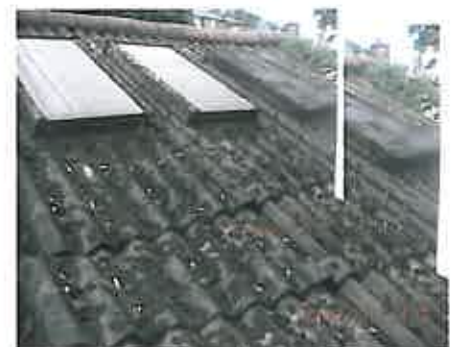
The sky lights are old and in a poor condition and require replacement.

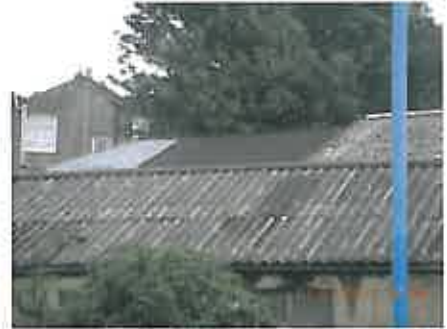
External rain water gutters look to be serviceable but there are a number of leaks and defective sections requiring repair or replacement.

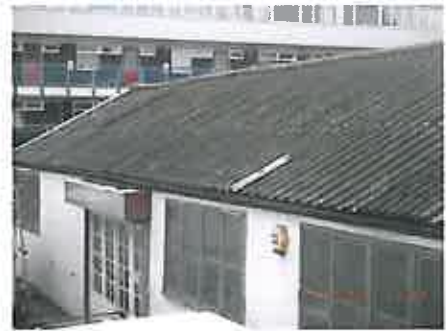
The external elevations generally comprise facing brick work with a paint covering. These appear to be poorly maintained with failed coverings and defective pointing and isolated cracks through the brick work. The paint coverings should be completely removed; the cracks should be filled in as necessary and the brick work joints repointed. Render to the left hand side and front elevations requires isolated repairs where visible.

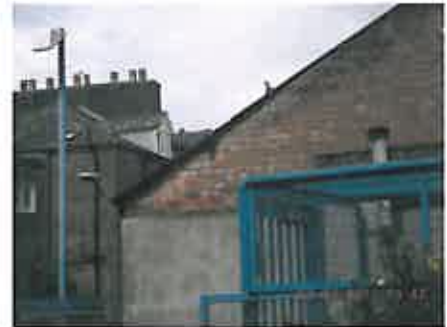
The front wall of the workshop comprises of exposed brick work at roof level with an exposed smooth render finish beneath. Brick work repairs are required together with hacking off and replacement of the defective render.

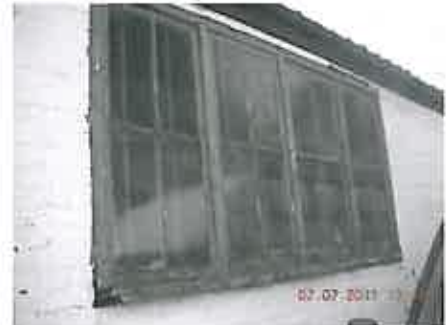
The main right hand side elevation comprises of 4 No Georgian wired timber framed windows, a high level timber ledged and braced door to the tank housing and large double opening entrance doors to the centre of the workshop. With the exception of the central timber doors, all joinery is in a very poor condition and beyond repair. Allow for replacement.

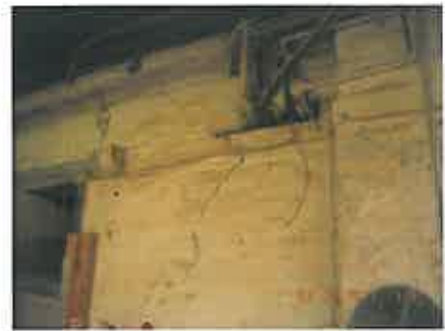
There is evidence of distortion of the metal roof trusses and localised structural repairs are required where the trusses are supported on the brick columns.

To the internal exposed brick walls, there is evidence of structural cracking. Allow for localised resin bond repairs and repointing.

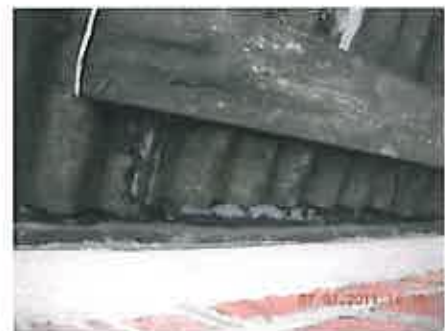
The valley gutter has failed where the workshop pitched roof abuts the rear two storey left hand side elevation wall. This requires renewing.

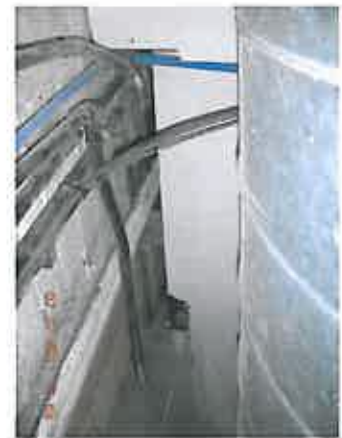
The fire stopping between the ground and first floors is insufficient with large gaps evident. Allow for upgrading fire protection.

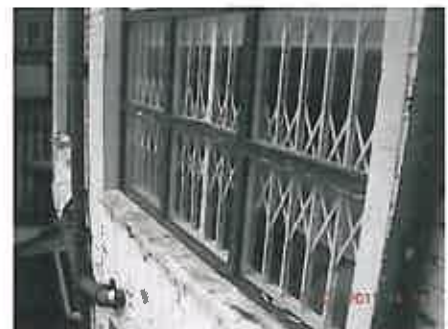
4 No windows to the rear elevation are in a poor condition and require renewal.

2 No windows to the front elevation at ground floor level are in poor condition and require renewal.

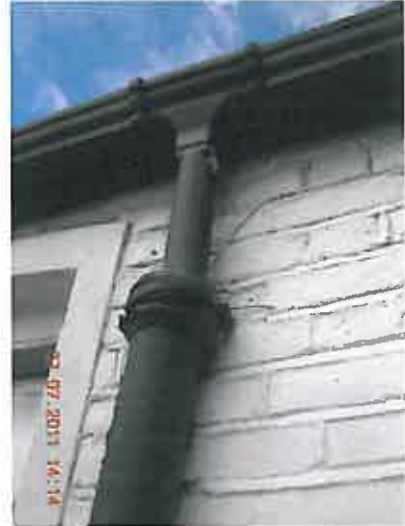
The front elevation comprises of painted exposed brick work. This has been poorly maintained with numerous cracks evident and

historic making good. The brick work requires stripping back, repointing, repairing and redecorating.

The cast iron rain water down pipes are old and require remedial repairs prior to repainting.

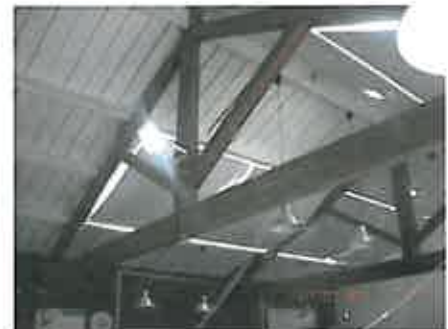
The front elevation fascia board is rotten and requires replacement.

Internally in the premises, there is minor evidence of damp ingress on the rear roof slope adjacent to eaves level. This section of the roof was not visible at the time of survey. Allow for localised repair.

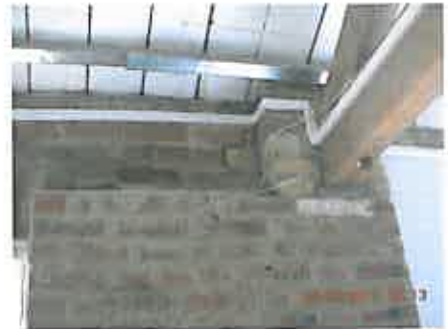
There are isolated areas of cracked brick work visible internally to the exposed structural brick walls requiring resin bond repairs.

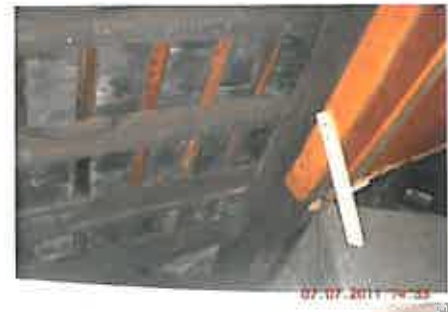
The rear part of the roof comprises original slate coverings; no roof sarking felt is provided to the underside.

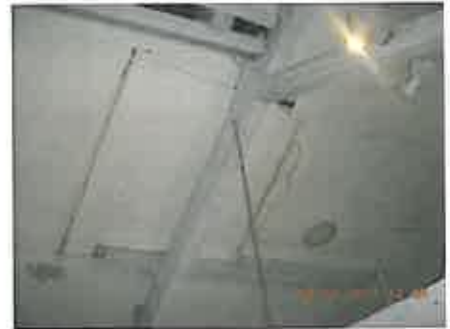
Various skylights are cracked (7 Nos) and these should be replaced in conjunction with the roof coverings.

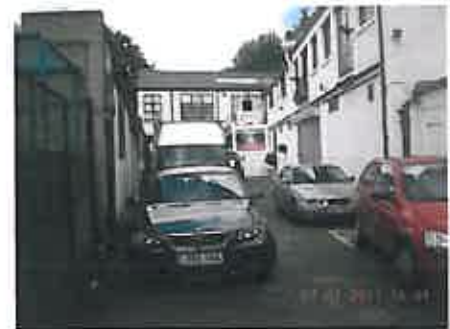
The main left and front elevations comprise facing brick work with a paint finish. This looks to be generally in a reasonable condition.

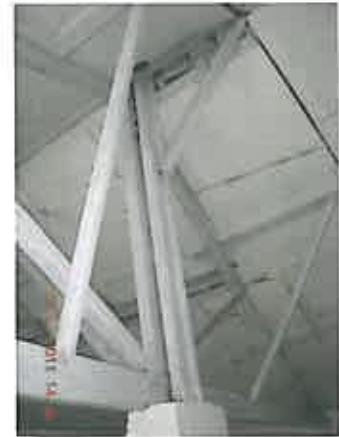
The roof structure is a combination of steel and timber. There is evidence of structural failure with structural repairs being required.

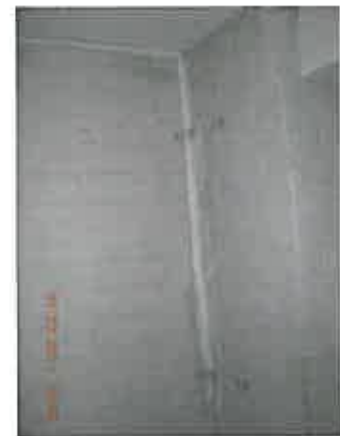
The rear elevation wall appears to be moving and the structure has failed with the rear elevation wall moving away from the brick columns. Monitoring appears to be in progress, evident by tell-tales. Allow for structural repairs to be carried out.
