**87 AVENUE ROAD,
LONDON, NW8**

Tree Survey

October 2011

Tom La Dell
Chartered Landscape Architects

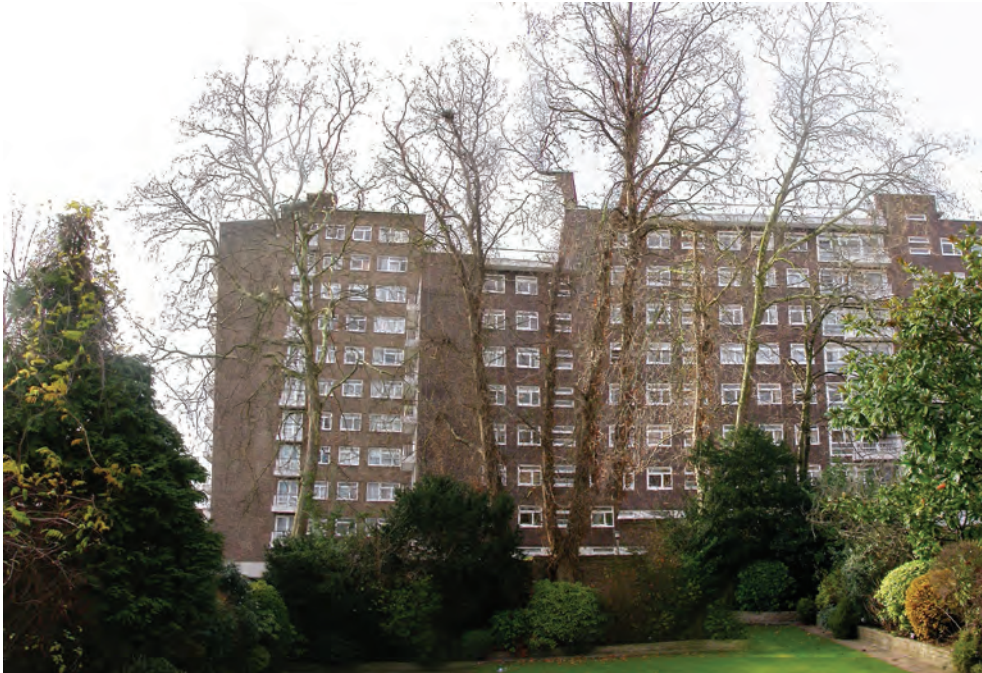
Figure 1

The rear garden boundary is dominated by four very tall plane trees, a poor lime and some small yew trees (Figure 1). The plane trees are rather drawn up by being close together and have certain condition and structure issues that are apparent from an inspection from ground level. To ascertain their long term health and safety a climbing inspection of the trees by a qualified arboricultural consultant is recommended. Tree 5 should be pruned as recommended to ensure its stability. The trees and mature shrubs on the western and eastern boundaries are of very local amenity significance (Figures 2 and 3).

No.	Species	Height	Trunk dia at 1.5 m	Branch spread	Height to crown	Age class	Condition	Structure	Safe lifespan	Category	RPA m2	RRPA	Notes and Management
1	Plane	27m	800mm	N 5 S c.7 E 3 W c.7	8m	m	p	fair	?	B	189.6	9.6	Decay at the base on the southern side because of compost heap. Cut off at 3 m and regrown as a single trunk with lean to west. Decay wound at 3 m at point of regrowth with small elder growing in it. Needs safety inspection. Burrs on northern side and decaying logs at base of tree on northern side. Compost heap should be removed as soon as possible.
2	Plane Stump	0.5m	500mm				d				113.1	6	
3	Plane	28m	900mm	N 3 S 4 E 3 W c.5	8m	m	f	good	40+	A	366.5	10.8	Burrs on east side at 0.5 to 1.5m. Lean to the west.
4	Plane	30m	900mm	N 5 S 1 E 6 W c.6	4m	m	f	fair	?	B	366.5	10.8	2 trunks at 4m. Dead ivy on fork. Needs crown inspection.
5	Plane	28m	900mm	N c.8 S c.3 E 3 W c.8	4m	m	f	poor	?	B	366.5	10.8	2 trunks at 4m. Strong lean to west. Needs crown inspection. Some branches on western side should be removed to balance the tree.

6	Lime	15m	450mm	N 3 S 2 E 3 W c.3	2m	om	p	poor	20-40	C	91.62	5.4	Severe branch loss and wound at 2.5m. Needs crown inspection. Overshadowed by plane, no.5.
7	Yew	4m		N 2 S 2 E 2 W 2		y	g	good	40+	A	-	-	Bushy to the ground.

Trees 1 to 9 on the rear boundary

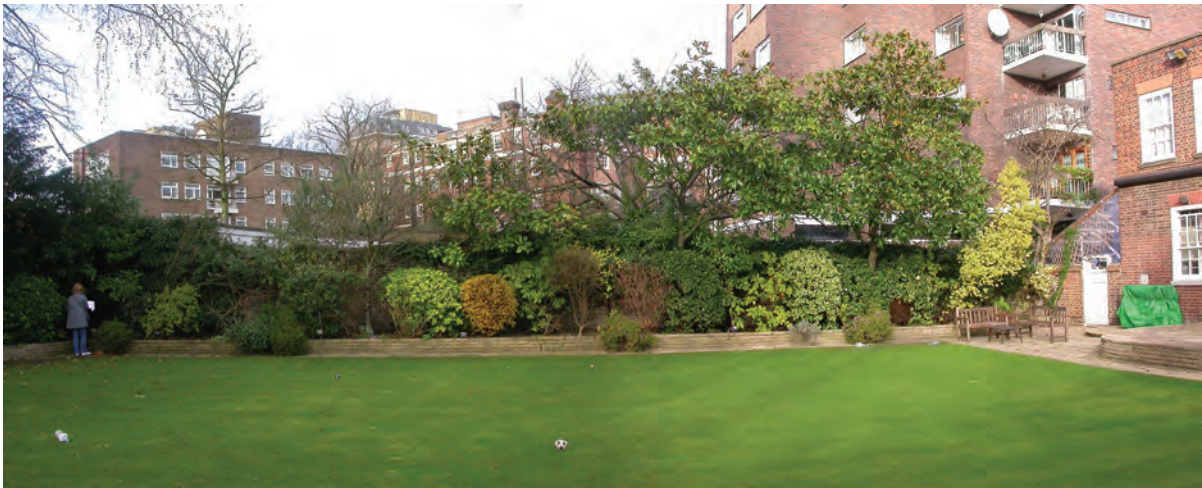
Figure 2

No.	Species	Height	Trunk dia at 1.5 m	Branch spread	Height to crown	Age class	Condition	Structure	Safe lifespan	Category	RPA m2	RRPA	Notes and Management
8	Yew	6m		N 2 S 2 E 2 W 2		y	g	good	40+	A	-	-	Bushy to the ground.
9	Yew	6m		N 2 S 2 E 2 W 2		y	g	good	40+	A	-	-	Bushy to the ground.
10	Hazel	7m	—	N 2 S 1.5 E 1.5 W 2	—	om	f	poor	20-40	C	-	-	Branching from base
11	Magnolia	8m	150mm	N 3 S 3 E 3 W 3	1.8m	y	g	good	40+	A	10.18	1.8	
12	Magnolia	7m	125mm	N 2 S 3.5 E 3.5 W 3.5	1.5m	y	g	good	40+	A	7.07	1.5	
13	Magnolia	5m	100mm	N 1 S 3 E 3 W 1	1m	y	g	good	40+	A	4.524	1.2	
14	Crab Apple	5m	100mm	N 3 S 3 E 3 W 3	1.5m	m	f	good	20-40	B	4.524	1.2

Trees 10 to 14 on the north western rear boundary

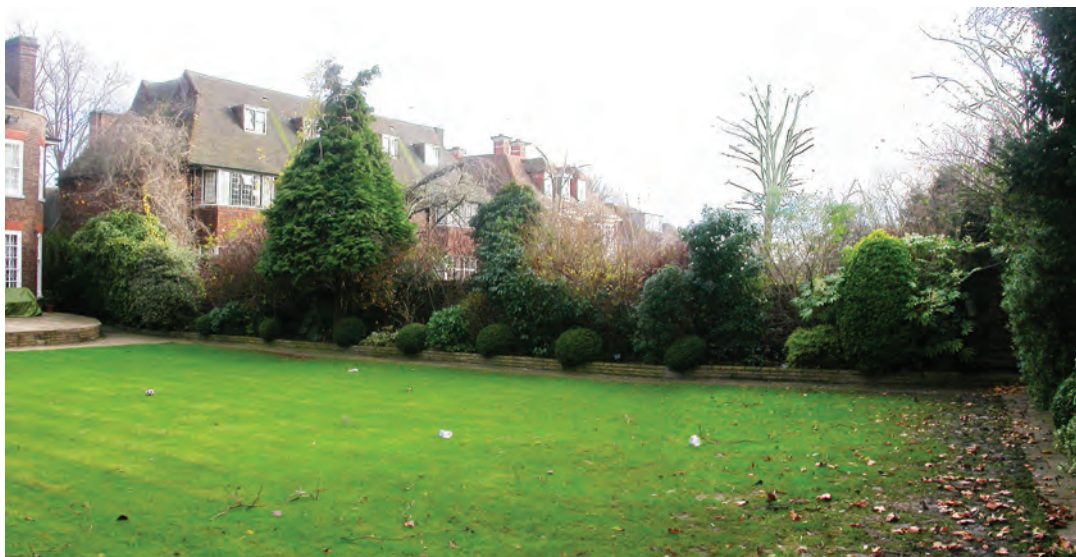
Figure 3

No.	Species	Height	Trunk dia at 1.5 m	Branch spread	Height to crown	Age class	Condition	Structure	Safe lifespan	Category	RPA m2	RRPA	Notes and Management
15	Lawson Cypress	6m	175mm	N 2 S 2 E 2 W 2	—	y	g	good	40+	B	13.86	2.1	Branching from base
16	Hazel	7m	—	N 1.5 S 1 E 1.5 W 2	—	om	f	poor	20-40	C	-	-	Branching from base
17	Beech	7m	900mm	N c.6 S 7 E 6 W 6	5m	m to om	f	reasonable	20-40	A	366.5	10.8	Tight fork but fused together. Roots above ground adjacent to wall and under tarmac near the trunk. Ground 200mm higher north of brick wall. Needs inspection.
18	Lawson Cypress	8m	—	N 2.5 S 2.5 E 2.5 W 2.5	—	ma	g	good	40+	B	-	-	Branching from base.
19	Lawson Cypress	8m	—	N 1.5 S 1.5 E 1.5 W 1.5	—	ma	g	good	40+	B	-	-	Branching from base. Grey foliated cultivar.
20	Lawson Cypress	8m	—	N 2.5 S 2.5 E 2.5 W 2.5	—	ma	g	good	40+	B	-	-	Branching from base.

Trees 15 and 16 on the south eastern rear boundary

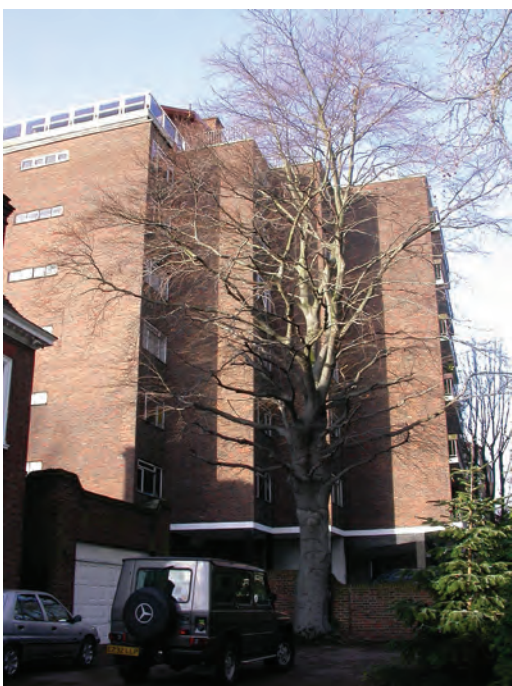
Figure 4

4. The beech on the front northern boundary (Figure 4) appears to be in reasonable condition. This is surprising as it is next to the boundary wall and the land to the north is some 200mm higher than the front garden of no.87. Beech have unusually shallow and wide spreading root systems so it can be assumed that its roots are mainly in the garden of no.87. This has tarmac paving up to the tree but there are clear signs of unevenness in the paving that shows that the roots survive under it. There is exceptional, compensatory root growth in the narrow gap between the tarmac and the boundary wall.
5. The large planes in the pavement of Avenue Road need not be considered further provided that the two existing drive entrances are re-used, without widening or excavation below the existing formation levels.

The Beech, Tree17
on the north western
front boundary

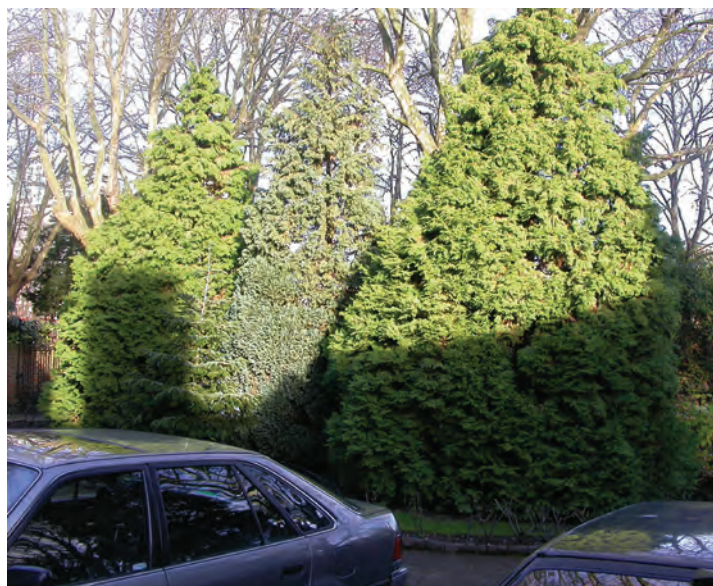
Figure 5

No.	Species	Height	Trunk dia at 1.5 m	Branch spread	Height to crown	Age class	Condition	Structure	Safe lifespan	Category	RPA m2	RRPA	Notes and Management
21	Plane	24m	900 mm	N 6 S 6 E 6 W 6	10m	m	g	good	40+	A	365.5	10.8	Pollarded at 6m and regrown to 24m. Street tree.
22	Plane	24m	900 mm	N 2.5 S 2.5 E 2.5 W 2.7	10m	m	g	good	40+	A	365.5	10.8	Pollarded at 6m and regrown to 24m. Street tree.
23	Plane	24m	900 mm	N 2.5 S 2.5 E 2.5 W 2.8	10m	m	g	good	40+	A	365.5	10.8	Pollarded at 6m and regrown to 24m. Street tree.

Trees 18 to 20 on the
Avenue Road frontage
