12, Glenilla Road

INSURANCE CLAIM

CONCERNING SUBSIDENCE DAMAGE

ENGINEERING APPRAISAL REPORT

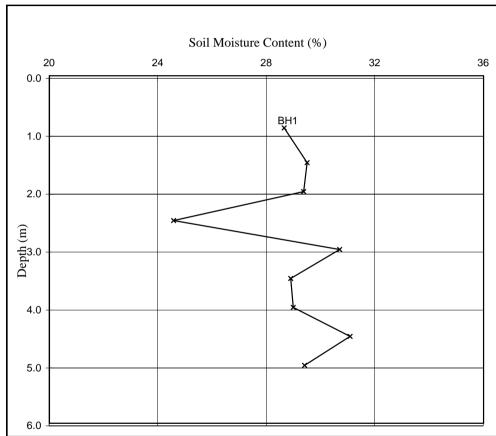
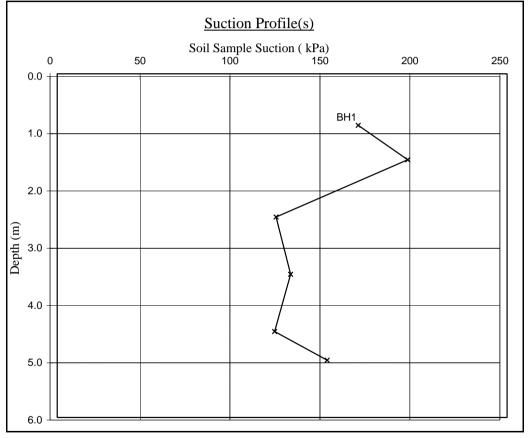
Moisture Content and Suction Profiles

Laboratory analysis of the CLAY taken at various depths confirmed that the material of very high plasticity and therefore subject to volumetric changes due to moisture removal. There was a marked reduction in moisture contents within the subsoil, which also corresponds with the increase in soil suctions in the area of the root activity.

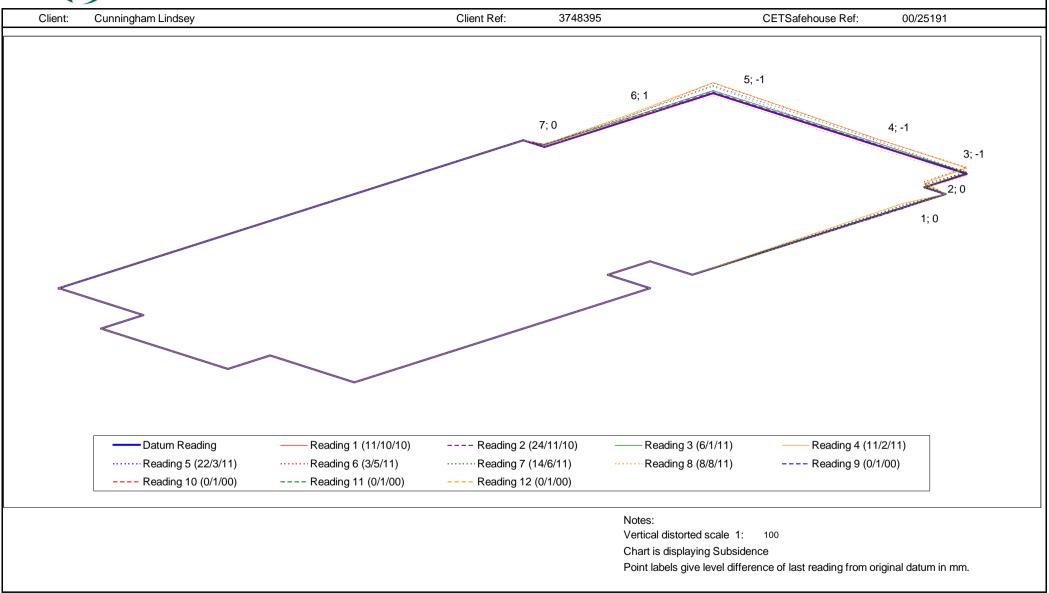
LEVEL MONITORING - RELATIVE MOVEMENT SKETCH

Deep datum level monitoring has been underway since September 2010.

Level monitoring will continue after removal of the tree in order to check for stability. A
