Client	STANLEY SIDINGS
Project	No1 HAWLEY ROAD
Job No	N1853
Dwg	EAVES SOFFIT DETAILS
Dwg No	HR_N1853_011
Dwg Type	LBC
Status	FINAL
Scale	1:100 at A3
Size	A3
Rev	*
Date	SEPT 2011

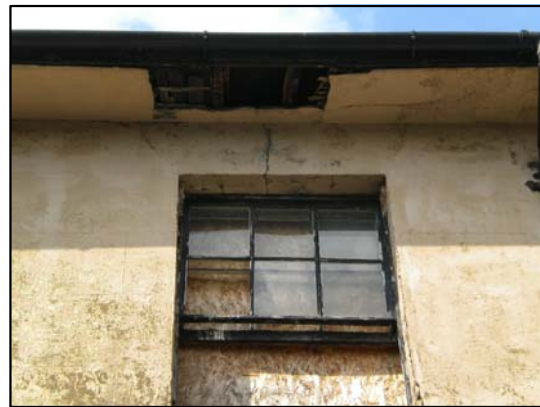
Lath & Plaster eaves prior to opening up

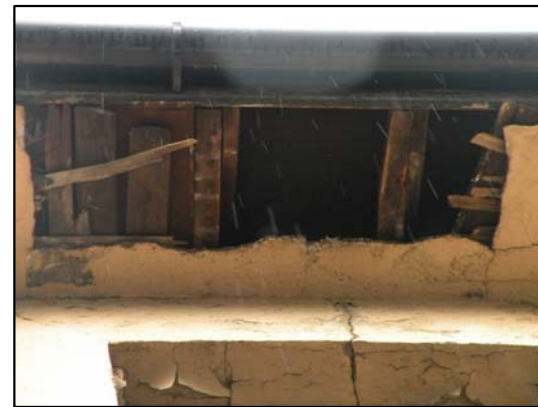
The original lath and plaster at eaves level failed due in part to the passage of time and also because of poor maintenance.

Failure of the original lath & plaster at eaves level

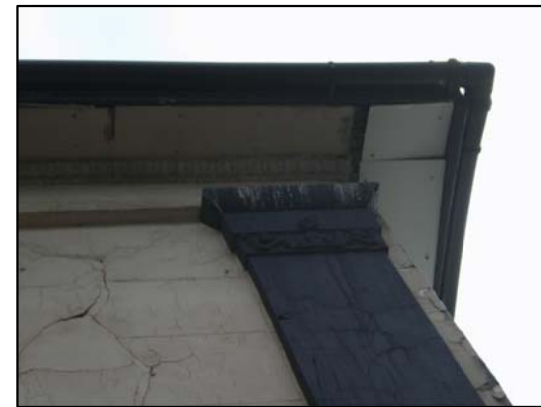
Close-up of the failed lath & plaster showing exposed rafters

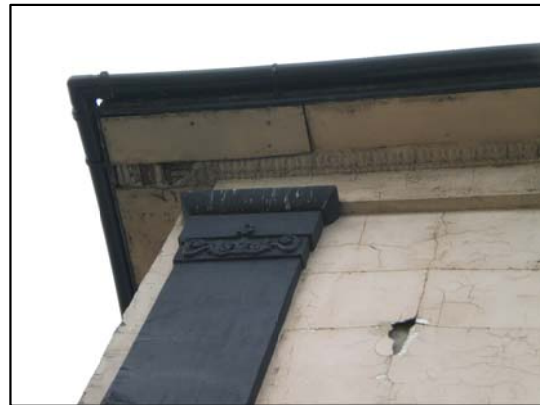
Failure of the original lath and plaster lead to the use of plywood boards to cover the exposed roof structure

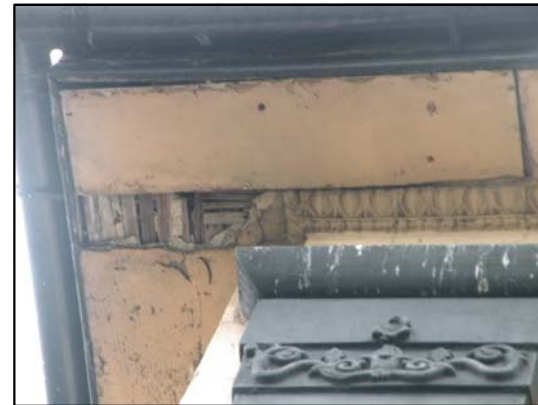
The damage lath and plaster used at eaves level was extensively damaged wherever it was used.

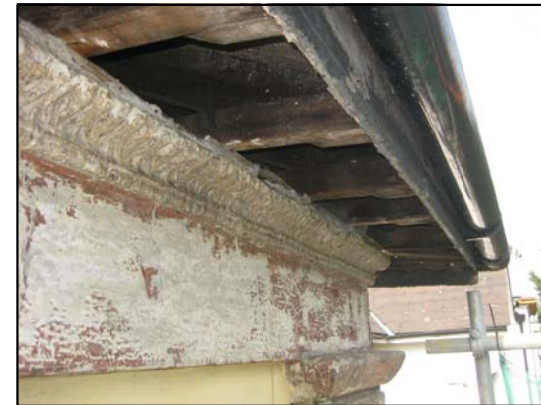
Close up of the damaged lath and plaster, and the plywood board repairs.

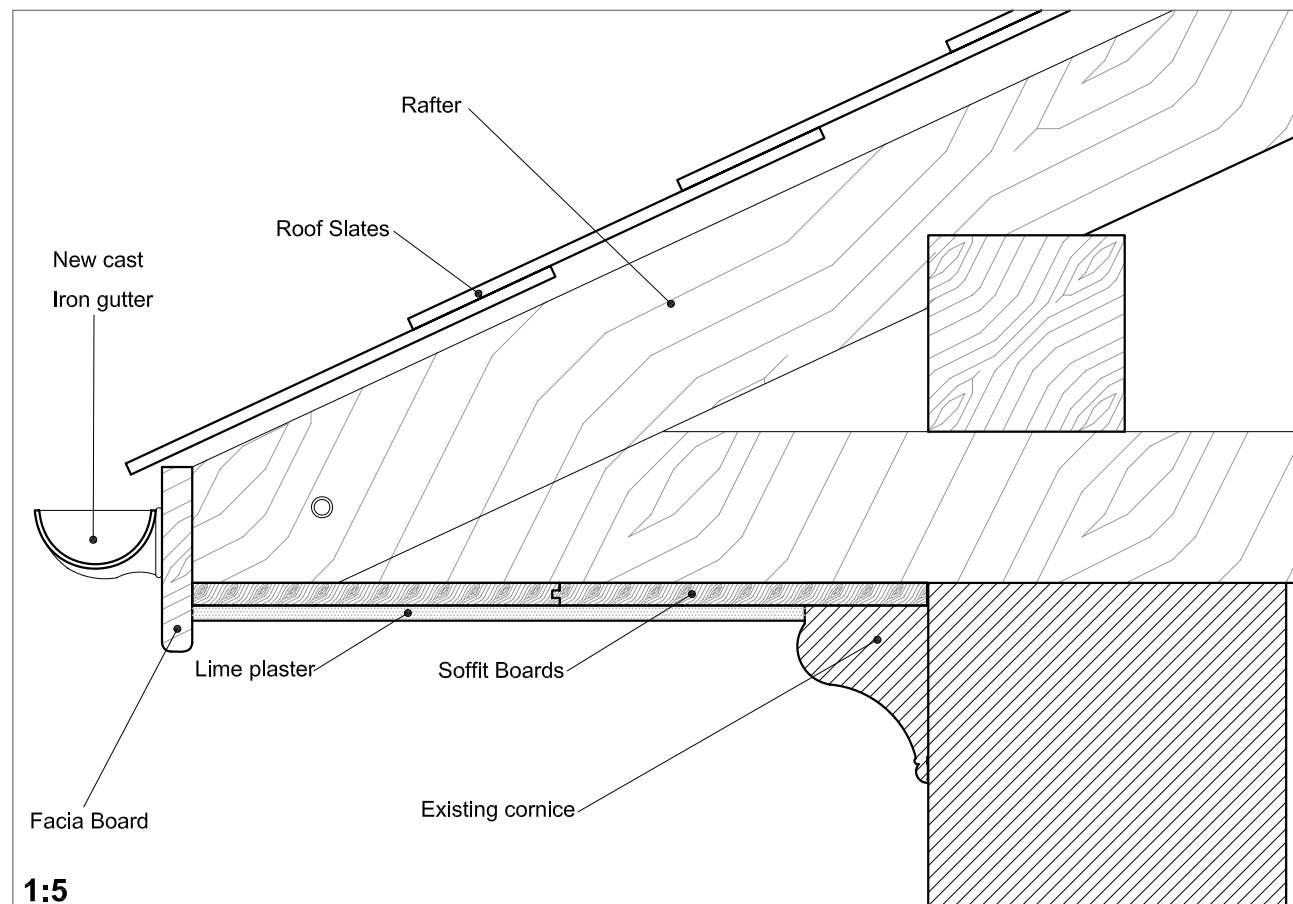
The failure of the lath and plaster has led to the ingress of water into the roof space resulting in some minor damage to the eave structure.

Failure of the lath & plaster eaves resulted in some water ingress that lead to some minor damage to the roof structure
