**PRE-ACQUISITION STRUCTURAL SURVEY REPORT**

**7 UPPER ST MARTIN'S LANE  
LONDON WC2H 9DL**

**ANGLE PROPERTY (ST MARTINS) LTD &  
TELENOMICS LTD**

**Project No. P1986**

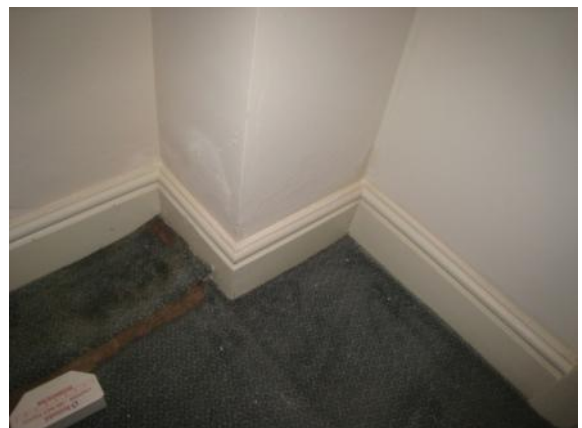
**Photograph 4.02.4**

- 4.02.4 Peeling of the finishes was observed in one location (refer key plan in Appendix A), and elevated damp levels (40% humidity) were measured here. However the cause of the damp is not clear, and will require further investigation.

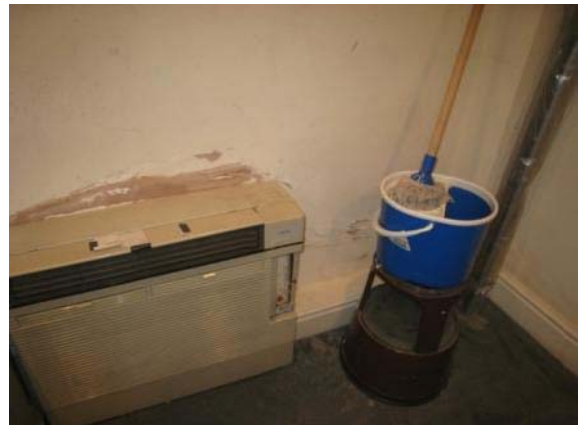
**Photograph 4.02.6b**

- 4.02.5 The lift motor room was not accessed during our visit.
- 4.02.6 There is an office to the rear of the basement, and here minor cracking was observed in two locations. Readings from damp meter gave normal readings, so it seems likely that this cracking is superficial rather than caused by any water ingress or other significant structural cause.

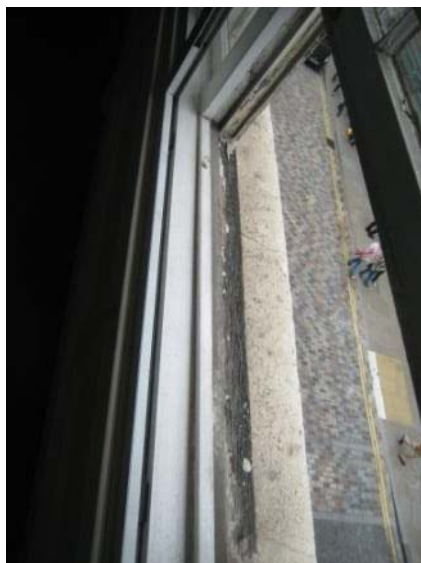
**Photograph 4.05.2a**

- 4.05.1 The second floor comprises two office areas either side of the internal party wall, with an opening between. To the rear of the left hand office there is a corridor and kitchen which are sub-divided by non load-bearing partitions.
- 4.05.2 The windows to the front elevation have rotten frames, particularly those to the left hand side. The worst are in need of urgent repairs and generally replacement will be required in due course. There is also cracking to some of the stone cills beneath the windows, which will in due course need cosmetic repairs.

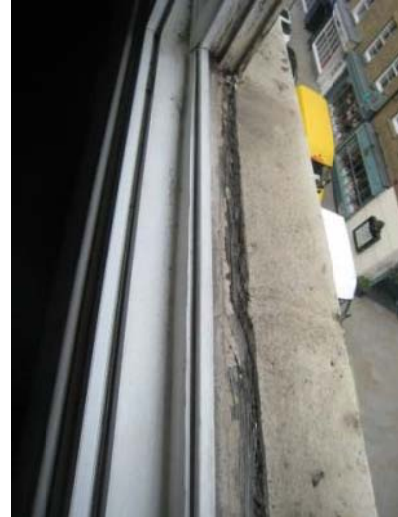
**Photograph 4.06.2a**

- 4.06.1 The third floor is laid out similarly to the second and first floors, but with no internal partitions.
- 4.06.2 The windows to the front elevation again have rotten frames, with attention required in the short term. There is also cracking to the reveals around the windows, which look to have been repaired previously – this is likely to be caused by the deterioration of the sash windows.

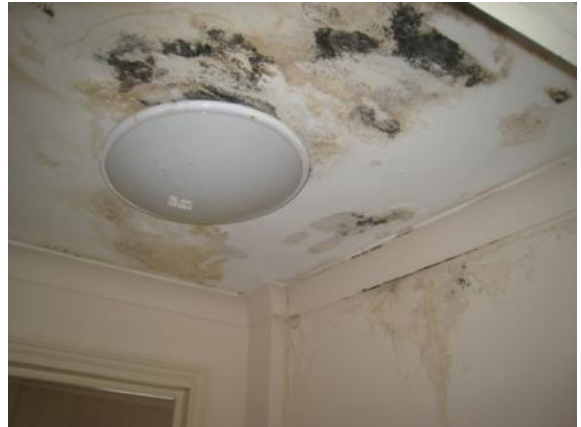
**Photograph 4.08.2a**

- 4.08.1 The fifth floor has a sloping mansard elevation and is sub-divided by partition walls to create a storage area, a kitchen, bathroom and office/bedroom area. It is connected to the main staircase by a small flat-roofed lobby.
- 4.08.2 The small lobby was extensively damp with discolouration to walls, ceiling and floor. Humidity levels of 50% to walls and 100% to floor were recorded using a damp meter.

The cause of the damp is likely to be leaks to the flat roof over. The level of water ingress suggests that urgent attention is required to prevent further deterioration of the timber structures. Due allowance should be made for replacement of roof structure to the lobby as it may have become rotten.

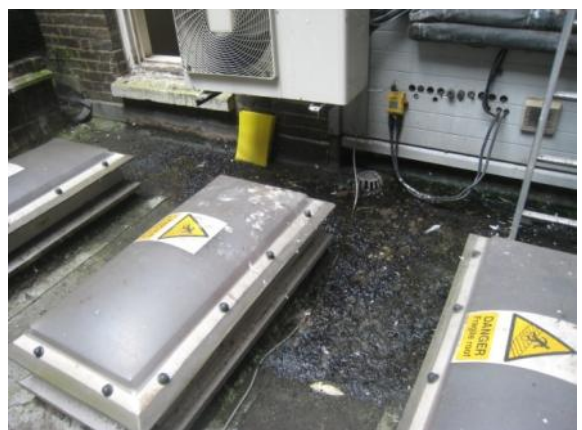
**Photograph 4.09.4a**

- 4.09.3 The main roof to the building is pitched and looks to date from the 1990s works. From viewing from the fifth floor flat roof section the roof appeared to be in reasonable condition.
- 4.09.4 There are sections of flat roof at first floor level with rooflights – refer 4.03.2 and 4.03.5 for details of rooms under. The roof finishes looked generally in poor condition and there was ponding of water adjacent to the main facade of the building. Air conditioning units are suspended over the roof, but it difficult to access them safely.

Although there is no evidence of water ingress to the floors below, the water ponding should be resolved by clearing of outlets. In the medium term it will be necessary to make more general repairs to the roof coverings to this area.

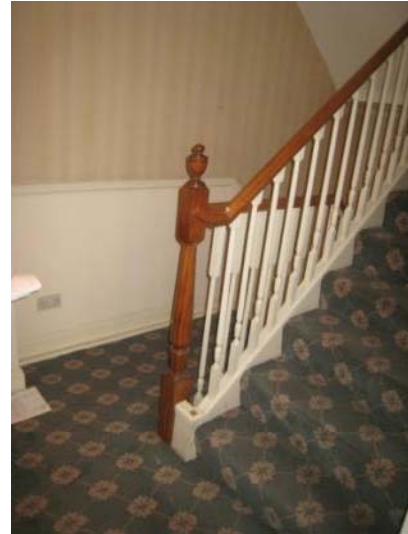
**Photograph 4.10.2**

- 4.10.1 The main staircase rises the full height of the building, with timber balusters.
- 4.10.2 Between ground floor and the half landing over the handrail has excessive movement, which is most likely to be due to a missing baluster at ground floor level. This should be replaced and additional fixings added as required to secure the handrail.

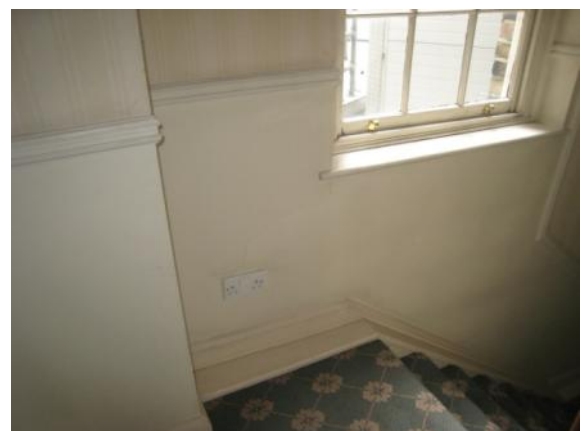
**Photograph 4.10.5a**

- 4.10.5 At all levels above ground floor there is diagonal cracking adjacent to the windows to the rear elevation. From the external elevation it is apparent that the spandrel panels have been historically re-constructed, and that the wall was extended above fourth floor level, presumably at the time of the 1990s extension. The cracking has also occurred and in some cases is more extensive in these recently constructed sections. The cause is not clear, but it could be due to movement of the lintels above the windows, or possibly due to poor restraint to the wall adjacent to the staircase.

If the staircase is to remain as is then it would be prudent to monitor the cracks to see if they are worsening. It may be that helibar crack stitching will be required in due course. If works are proposed to the staircase then it would also be prudent to introduce tying back of the wall to the floor plates.

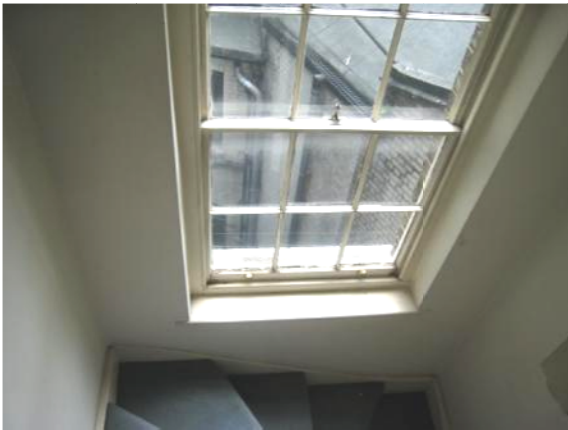
**Photograph 4.11.2a**

- 4.11.2 There is a good deal of cracking evident with the finishes to the walls around the staircase, particularly at first floor level and high level above 3<sup>rd</sup> floor.

It is probable that this cracking is due to differential movement between the staircase and the adjacent masonry walls, and is hence confined to the plaster finishes. However this should be confirmed by local removal of finishes.

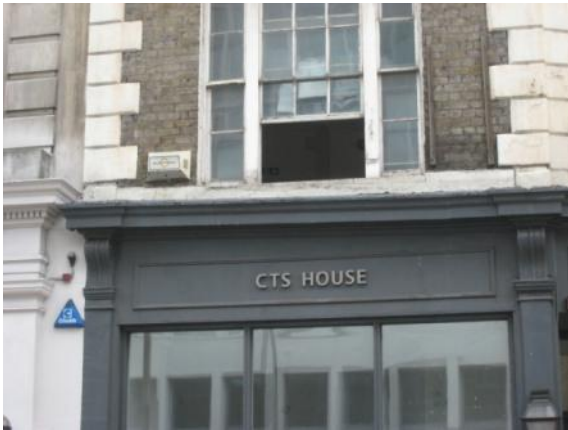
**Photograph 4.12.2**

- 4.12.2 The shop front to elevation 1 looks to be sagging whereas the elevation behind is true. It is not clear whether this was deliberately laid to a slope but it is more likely that there has been some deterioration of the timber shop front, which will therefore need repairs in due course.

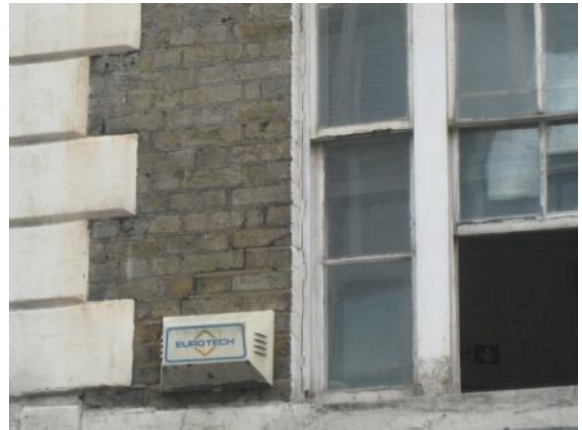
**Photograph 4.12.3a**

- 4.12.3 There is diagonal cracking within elevation 1 in the brick panel adjacent to the Equity building, occurring at first floor and second floor levels. This suggests that there has been differential movement between 7 Upper St Martin's Lane and the adjoining building, which may be attributable to failure of lintels or excessive deflection of the beam over the shop front.

This should be monitored going forward to establish whether the movement is ongoing. It would be prudent to open up the beam over the shop front at high level ground floor to check the condition and whether there is excessive deflection.

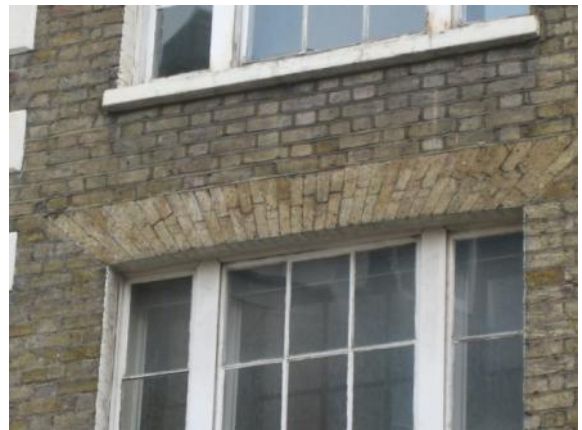
**Photograph 4.12.4**

- 4.12.4 Within the left hand side of Elevation 2 there are cracks visible within the lintels at 2<sup>nd</sup> and 3<sup>rd</sup> floor levels. This is a common problem with buildings of this age and there is a risk of the cracking becoming more widespread if the lintels start to 'slip'. The solution will be to use helical stainless steel rod repairs in the spandrel panels above the lintels.

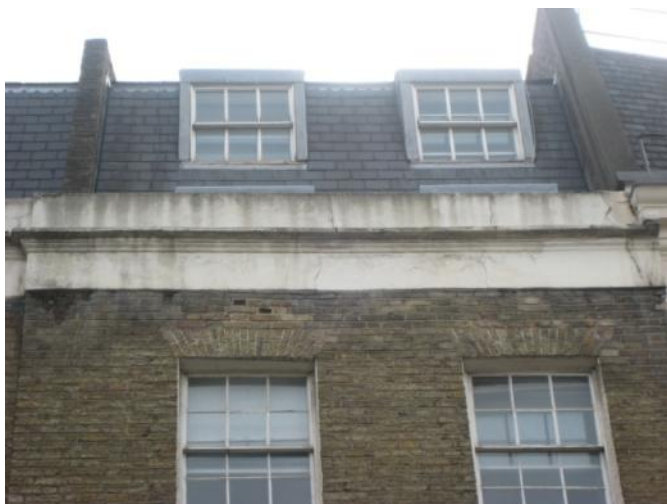
**Photograph 4.12.5**

- 4.12.5 As described in 4.07.2 there is some movement of the parapet at fourth floor to the right hand side of Elevation 2. This is also evidenced by vertical cracks to the front face of the parapet wall which are visible from street level.

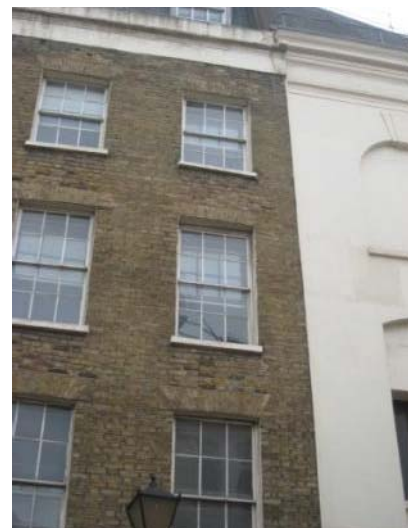
**Photograph 4.12.6a**

- 4.12.6 At 2<sup>nd</sup> and 3<sup>rd</sup> floors within Elevation 2 there has been previous rebuilding of the spandrel panels between windows. However there is diagonal cracking to the right hand side of these rebuilt sections. It seems likely this is due to movement of the lintels below, so helical stainless steel bar repairs will again be advisable in due course.

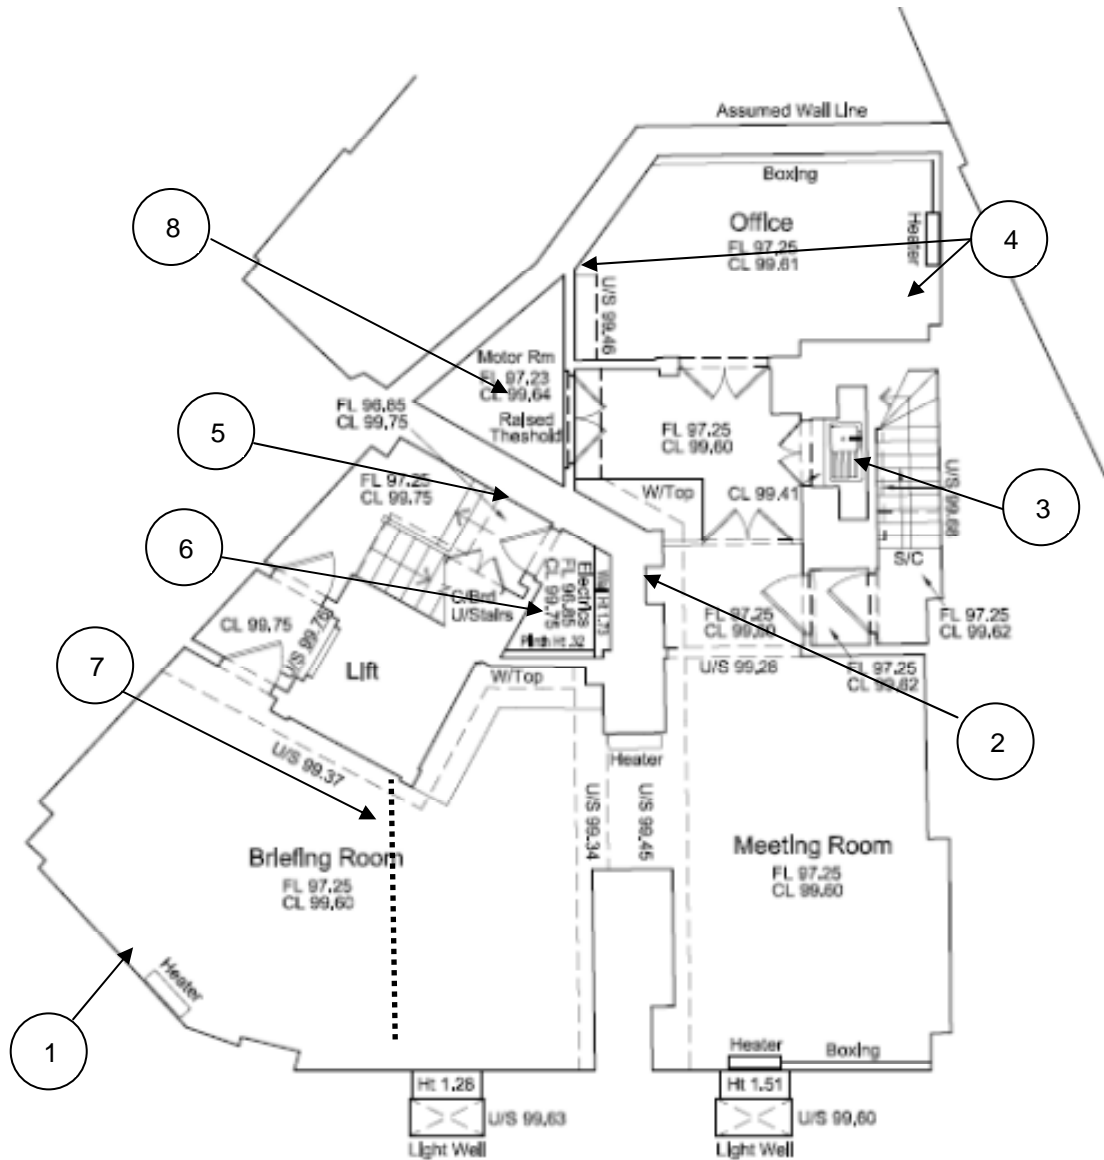
**BASEMENT LEVEL KEY PLAN**

1	Lightwell shown on earlier drawings but not evident on site	5	Damp section
2	Damp corner	6	Service intake under reconstructed half landing
3	Kitchenette surrounded by masonry walls	7	Steel beam over
4	Cracks in wall	8	Lift motor room not accessed

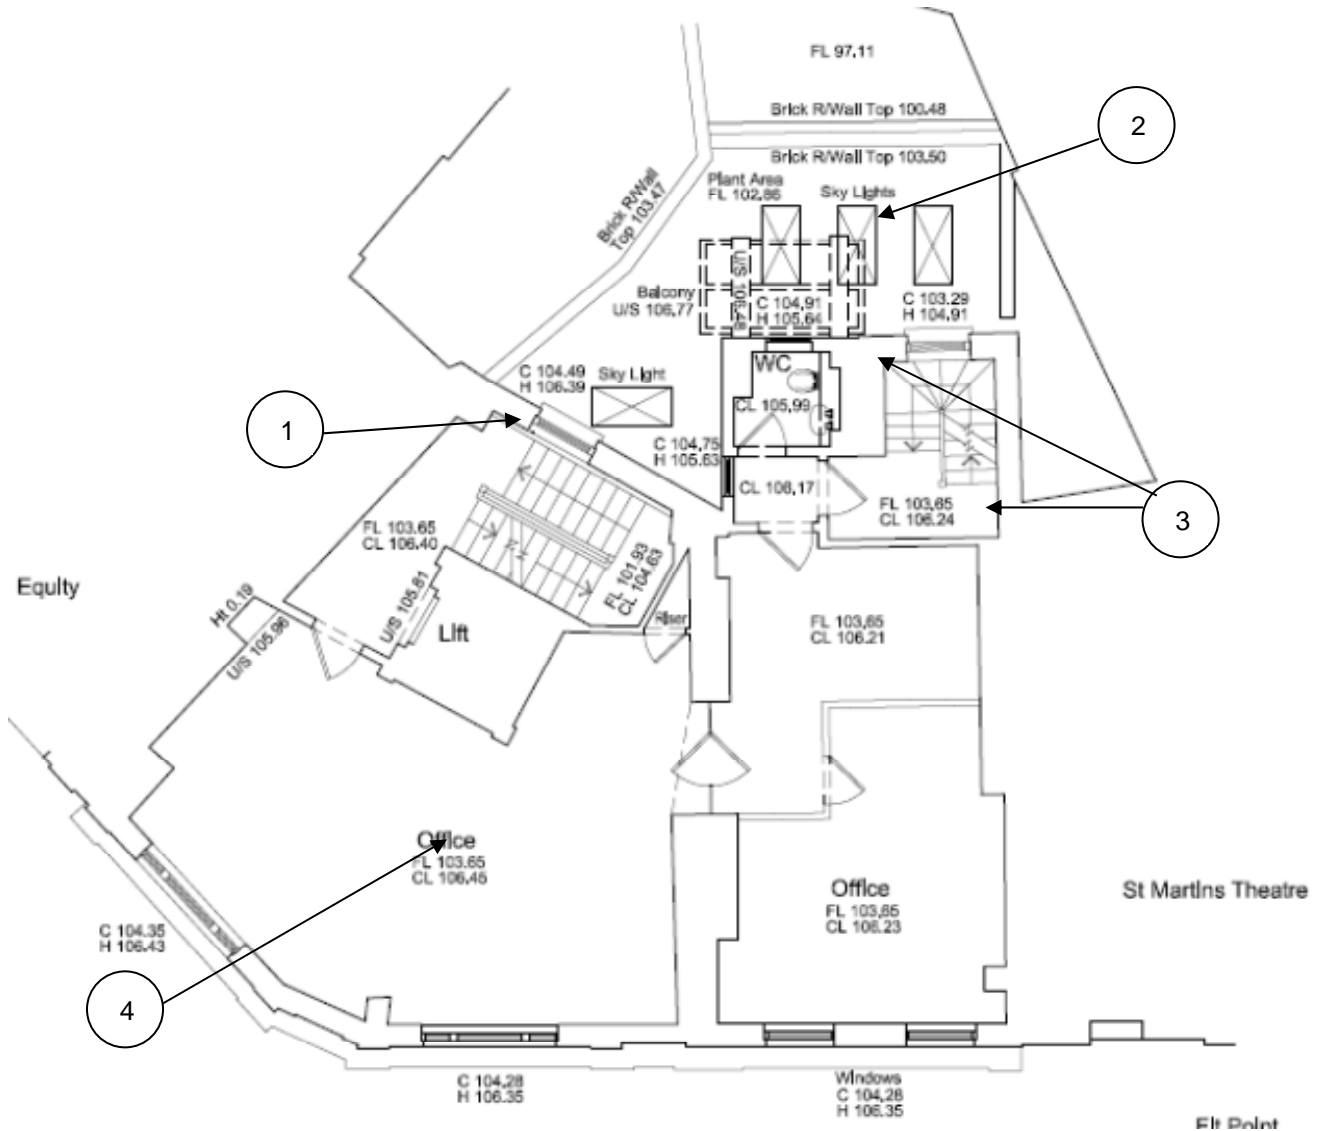
### FIRST FLOOR KEY PLAN

1	Cracking to rear wall
2	Poor condition of roof finishes
3	Cracking around staircase
4	Limited inspection to this area

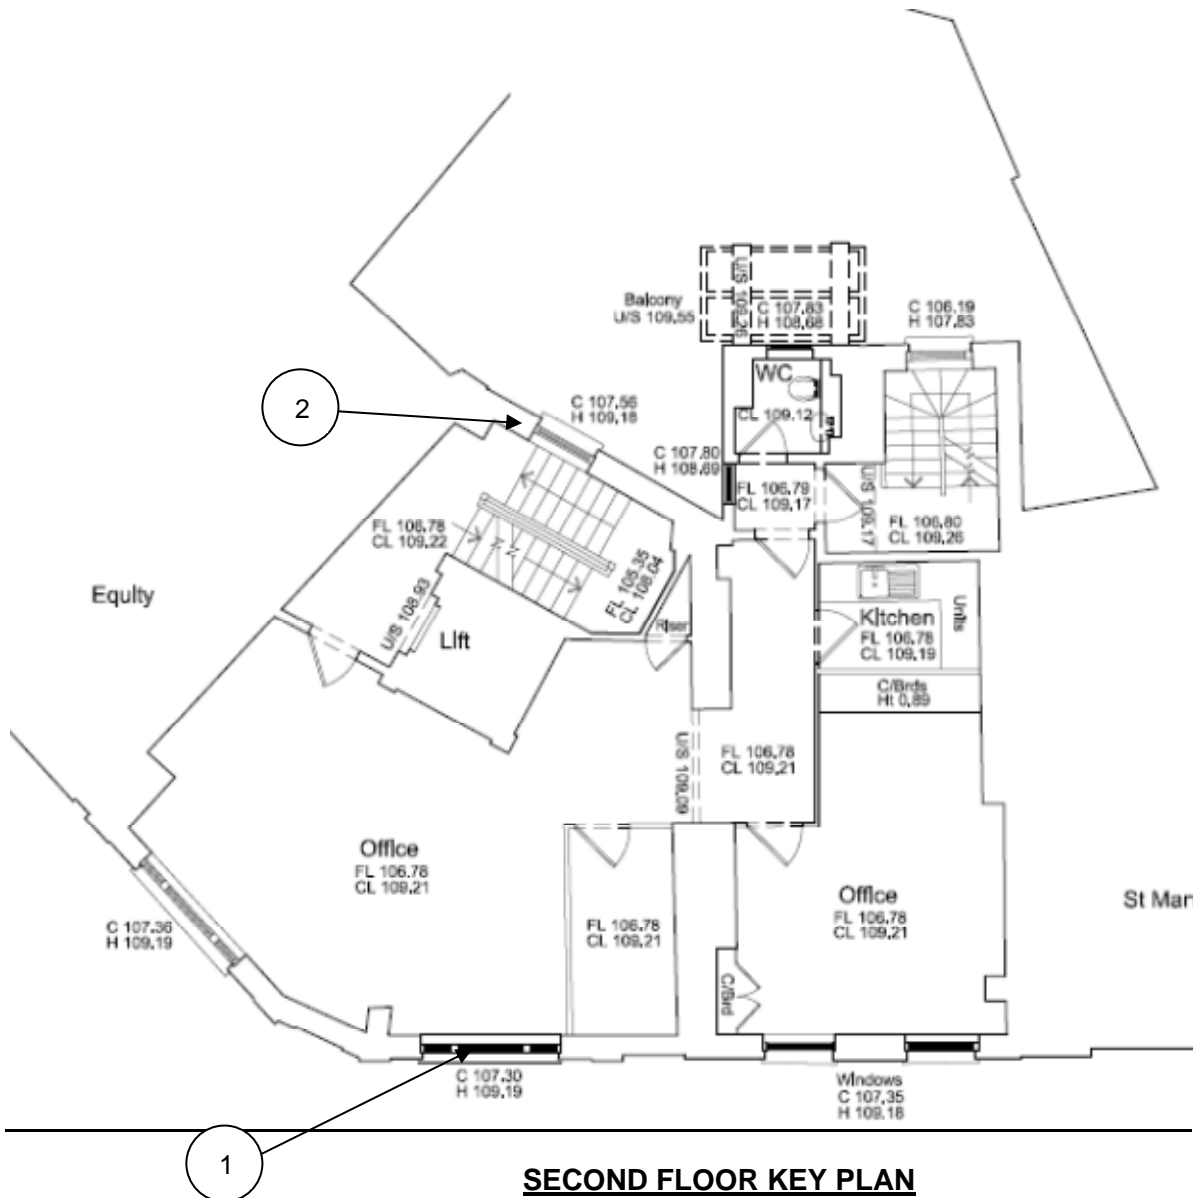
**SECOND FLOOR KEY PLAN**

1	Cracking of cill. Poor condition of window frame (typical)
2	Cracking around staircase

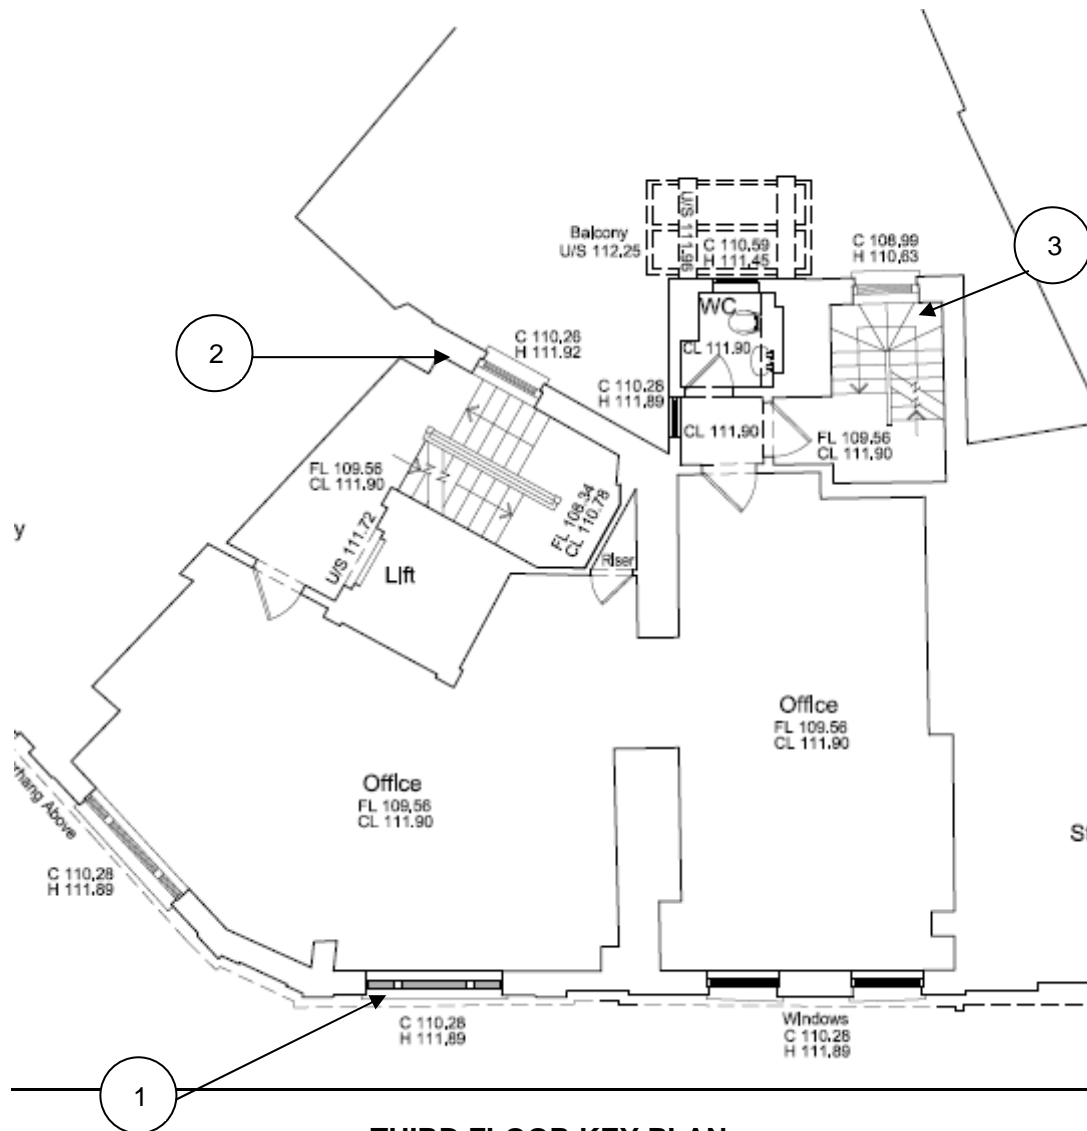
**THIRD FLOOR KEY PLAN**

1	Cracking of cill. Poor condition of window frame (typical)
2	Cracking around staircase
3	Cracking at high level between staircase and rear wall

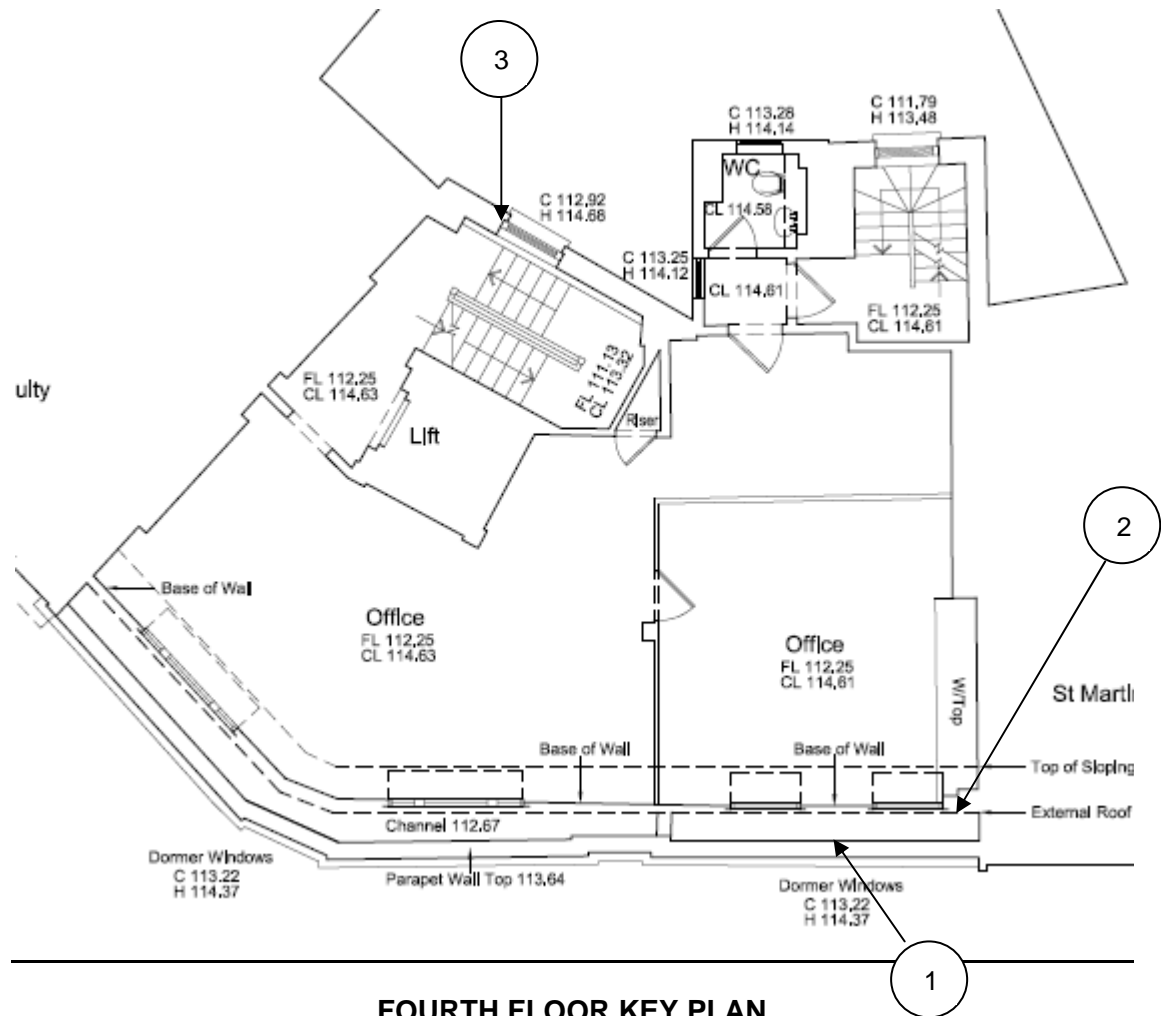
1	Lean and cracking of parapet wall
2	Cracking of party wall
3	Section of wall rebuilt but has diagonal cracks

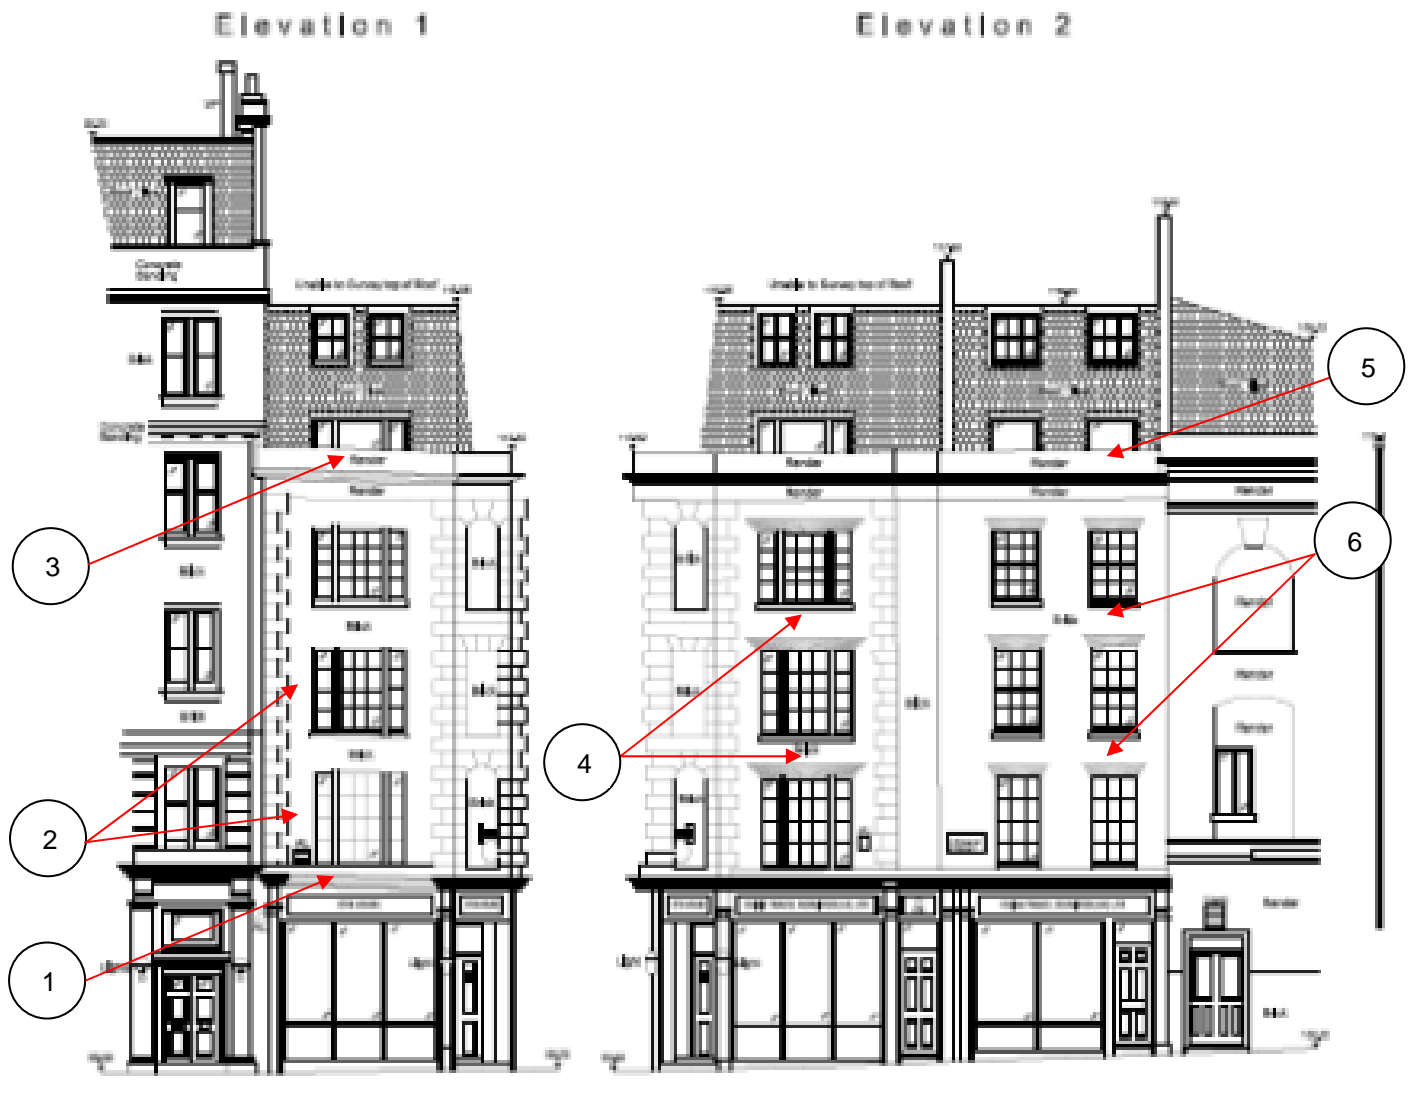
### **FRONT ELEVATIONS**

1	Sagging of shop front	4	Cracks in lintels
2	Diagonal cracking adjacent to window	5	Cracking to parapet
3	Cracking to parapet	6	Sections of wall previously re-built, new cracking.

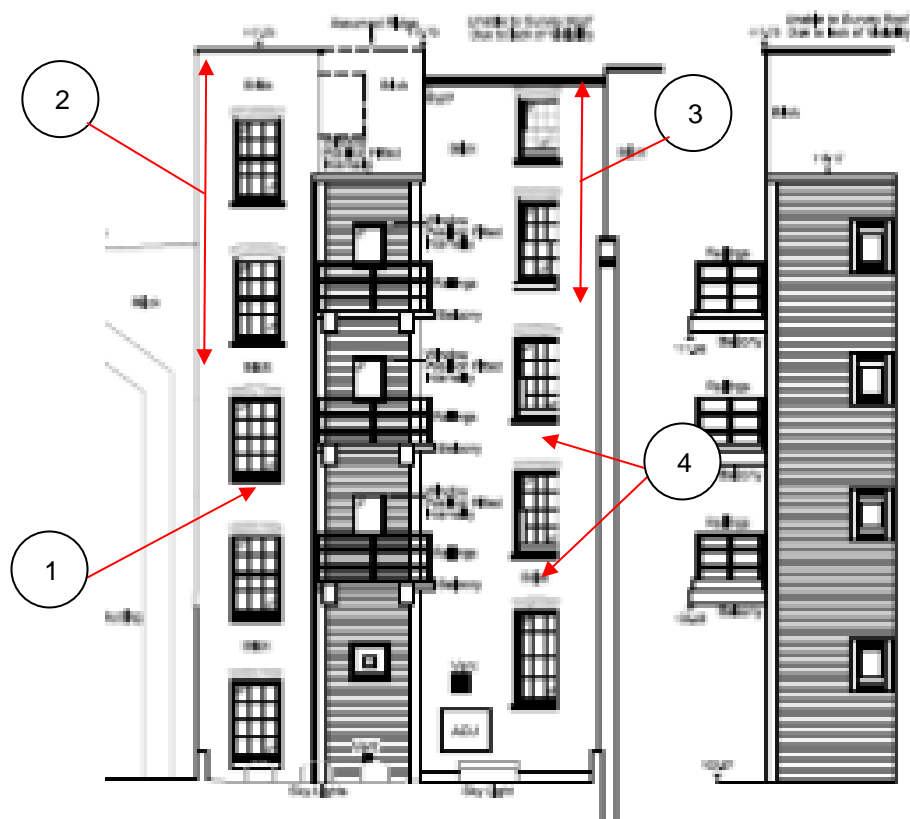
**REAR ELEVATIONS**

1	Spandrel panel has been rebuilt	3	Top two floors look to have been more recently constructed
2	Top two floors look to have been more recently constructed	4	Spandrel panels have been rebuilt
