**STRUCTURAL SURVEY  
TO  
16 – 19 SOUTHAMPTON PLACE  
LONDON WC1**

**Date:** September 2011

**Ref:** PC\13006~srep Rev B

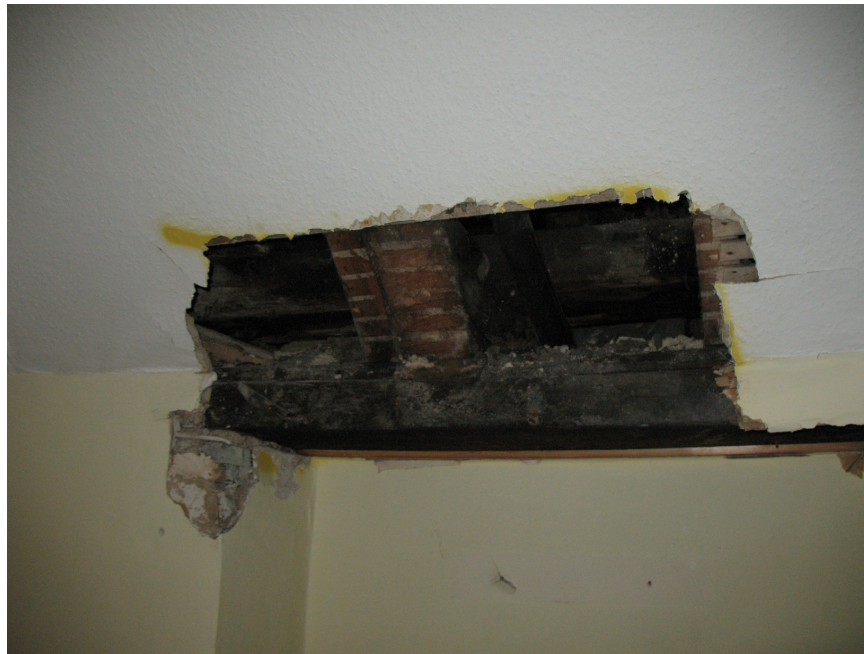
- 3.1.1 The roof structure is double pitched front to back with a central valley. There did not appear to be any evidence of significant water ingress noted to the central spine wall however opening up did expose surface decay to the valley plate (Photograph 1). There was a crack noted in the ceiling finish adjacent to the stair wall at third floor level.

**Photograph 1:** Surface decay to valley of 16 Southampton Place

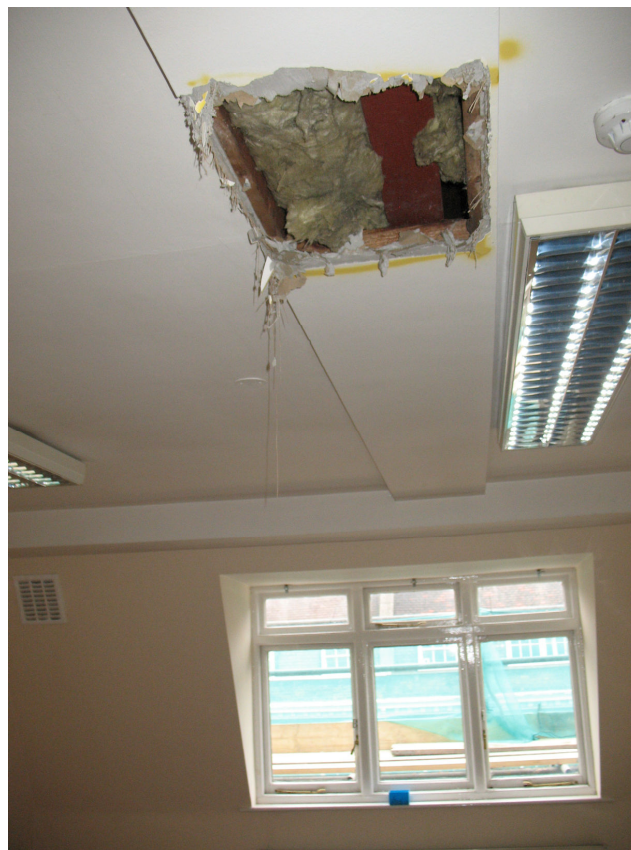
- 3.2.1 The roof of number 17 has been replaced with a steel frame at some time in the past (Photograph 2). This would have been relatively recent as the steel beams had a zinc rich primer applied. The floors were generally found to span parallel with the front wall onto front to back spanning beams.

**Photograph 2:** Exposed steel roof beam in number 17

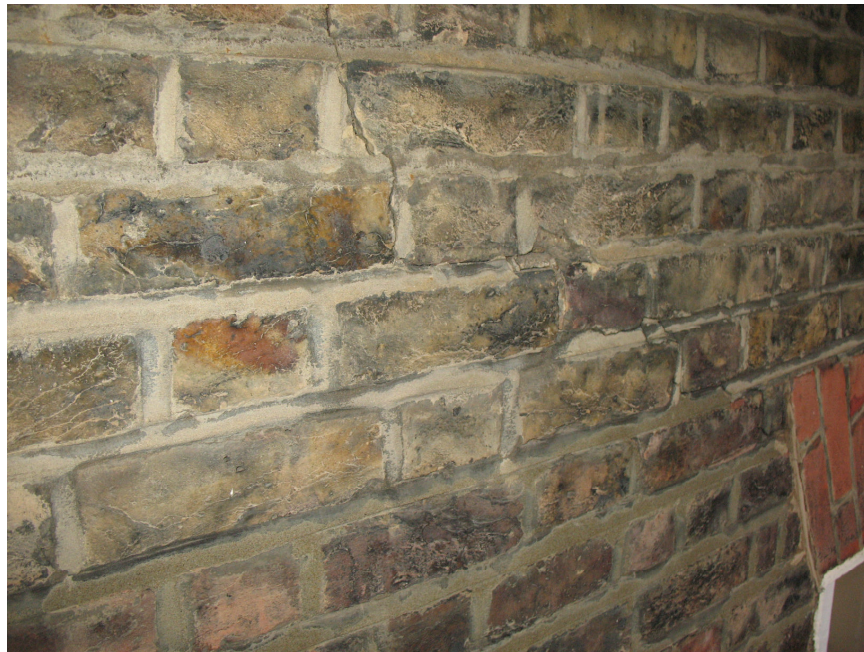
- 3.2.9 A number of cracks were noted in this building to the rear elevation in the fair faced brickwork. This was particularly evident to the heads of the first floor where the cracks measured in the order of 2-3mm (Photograph 3). We would recommend that these cracks are stitched using stainless steel helical bar reinforcement grouted into the horizontal bed joints.

**Photograph 3:** Cracking to the rear of 17 Southampton Place

- 5.4 There were a number of cracks noted in the rear elevation and we would recommend that these are repaired using a stainless steel helical bar reinforcement system.

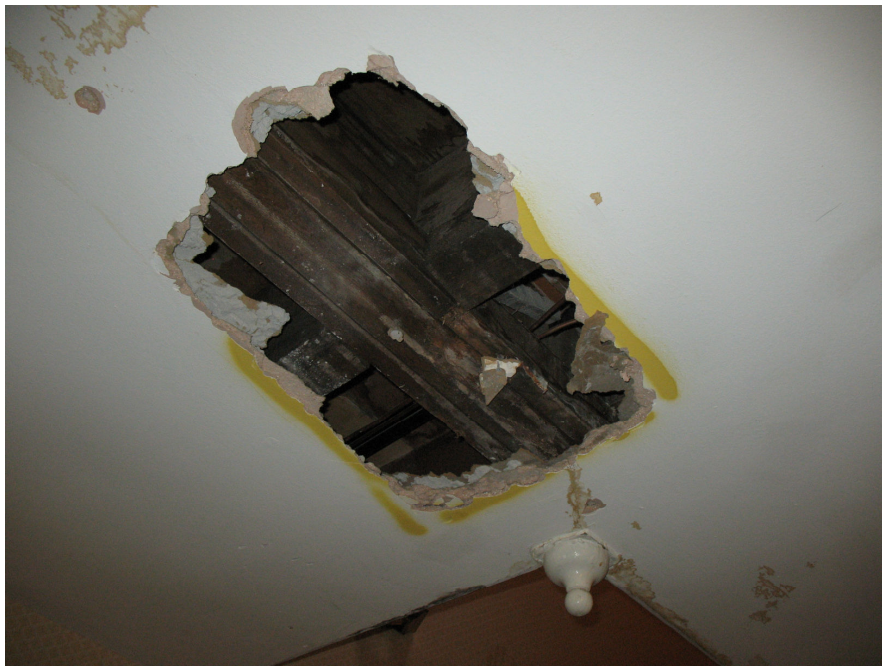
- 3.3.2 A section of sagging plaster was noted in the ceiling of the stair lobby at third floor level. This was opened up and it is likely that a former water leak caused the damage. The plaster that has been damaged is plaster board and not lathe and plaster and the water leak has dried without causing decay to the structural joists (Photograph 4). It will be necessary to replace the plasterboard ceiling.

**Photograph 4:** Water ingress to the ceiling of 18 Southampton

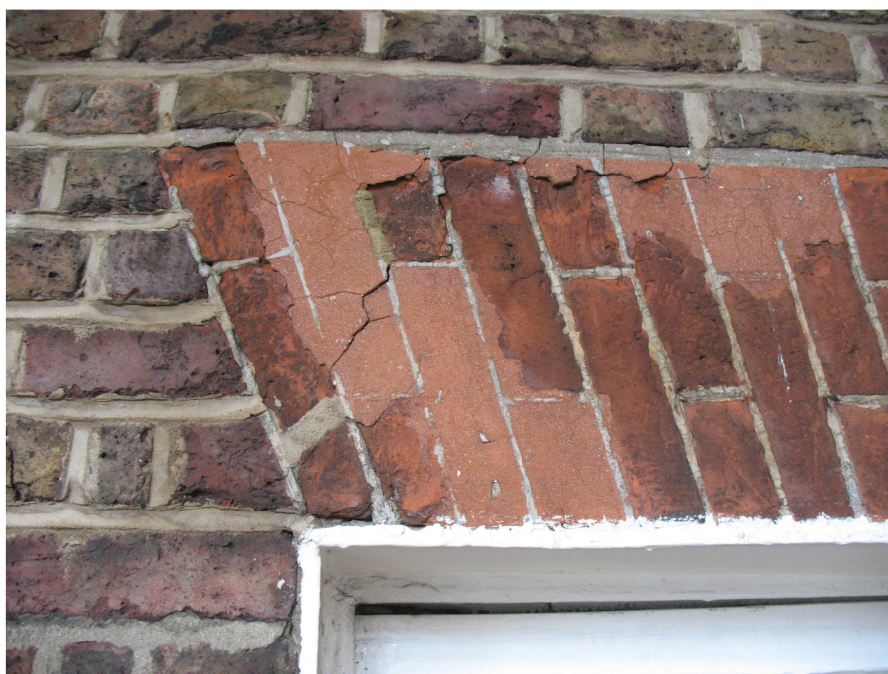
- 3.3.9 The gauged brick arch over the second floor rear window has delaminated and the majority of the faces of bricks have come away (Photograph 5). It would be a worthwhile exercise to replace these eroded bricks when access is available.

**Photograph 5:** Delaminating to the brick arch over the rear window of 18 Southampton Place.

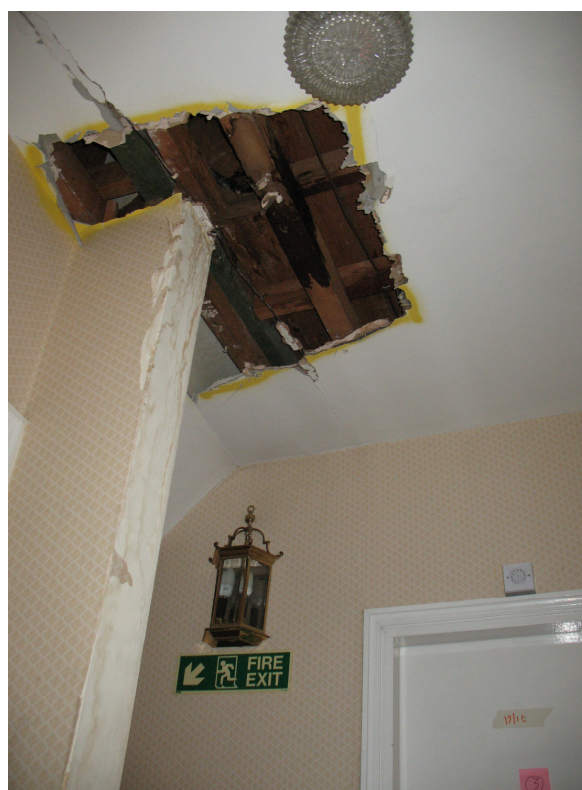
- 3.4.3 Water staining was noted in the ceiling of the third floor stairwell (Photograph 6). Opening up revealed that this is due to a leak in the valley section of the roof over and although water ingress has occurred, decay to the roof members has not yet taken place. We would of course recommend that the leak is made good.

**Photograph 6:** Water ingress at third floor of 19 Southampton Place.
