STRUCTURAL APPRAISAL REPORT ON THE EXISTING BUILDING OF 6 WEDDERBURN ROAD, LONDON NW3 5QE

RE: Geo-hydrology Screening Assessment, 6 Wedderburn Rd, Belsize Park, North London, NW3

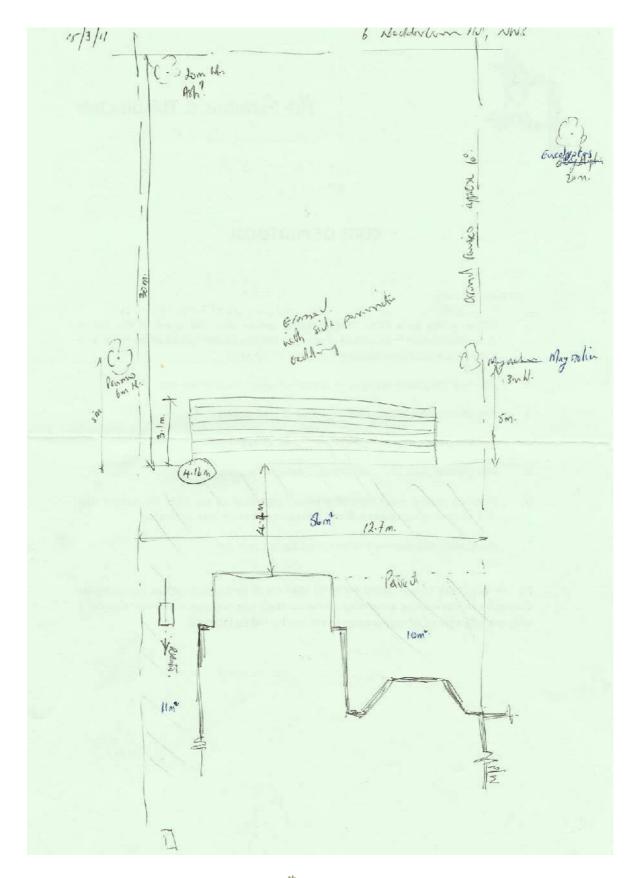
Sketch 1: Hand Notes from Site Visit 15th March 2011

- No evidence of subsidence to the property or adjoining properties was observed.
- Refer to the sketches (Enclosure 1) for hand annotated notes of the current site drainage.
 Storm water drainage is by pipe down the western side of the property and foul drainage runs from the bathroom to the utilities room at the rear of the property and then from the utilities room to a manhole in the light well area at the front of the house.

Question 3: Will the proposed basement development result in a change in the proportion of hard surfaced / paved external areas?		Conclusions & Actions : Refer to sketch 1 : current paved areas total approximately 80 m2 Refer to Question 2 above.

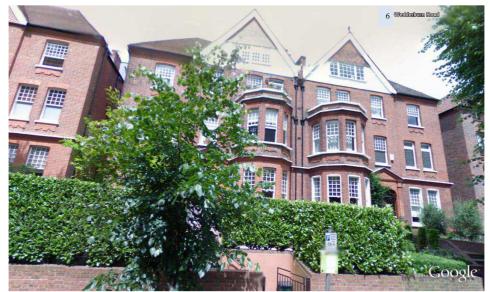
Photo 1: 6 Wedderburn Rd.

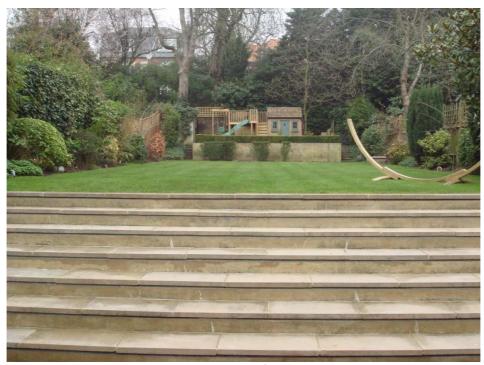
- The rear garden raises 4.16m to a terrace lawn area which gradually rises to the rear of the garden. The angle of this land gradient is greater than 7 degrees.

Photo 2: Terrace Lawn in Rear Garden (15th March 2011).

Question	Answer (Yes/No/ Unknown)	Conclusion / Likely Actions
		Slope Stability Screening Assessment
Question 1: Does the existing site include	Yes	Action
slopes, natural or manmade, greater than 7		The angle of the ground at the front of the property and at the rear is greater than 7 degrees. See photo 2.
degrees? (approximately 1 in 8)

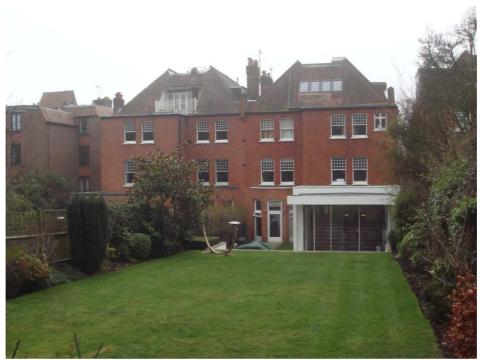
Photo 3: Rear Elevation (15th March 2011).

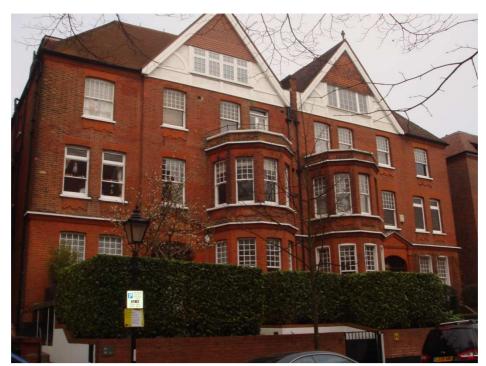
- At the front, the entrance level is 1.8m from street level, a slope greater than 7 degrees.
- There are street trees (deciduous- possible Alders pollard), of which the nearest one is some 10m away and the tree height is around 20m.

Photo 4: Front of House (15th March 2011).
