**Re: Mrs N Vincent, The Coach House, 32 Daleham Gardens, NW3 5DE -
REQUEST FOR TREE REMOVAL**

SITE INVESTIGATION REPORT

We have been asked by J R Clare Underwriting Agencies Limited to comment on movement that has taken place to the above property. We are required to briefly describe the damage, identify the probable cause and describe appropriate remedial measures.

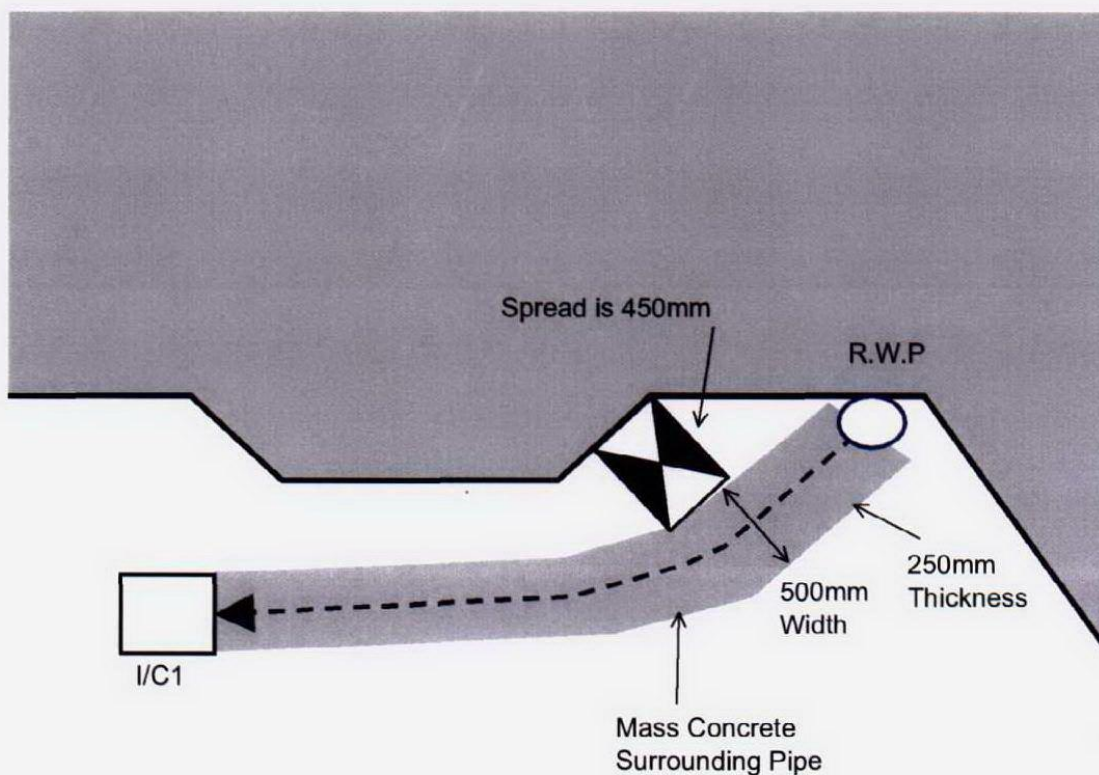
NOTE: Spread or underside not found due to mass pipe concrete surround

General Comments: RWP run has 500mm x 250mm trench filled with concrete surrounding pipework.

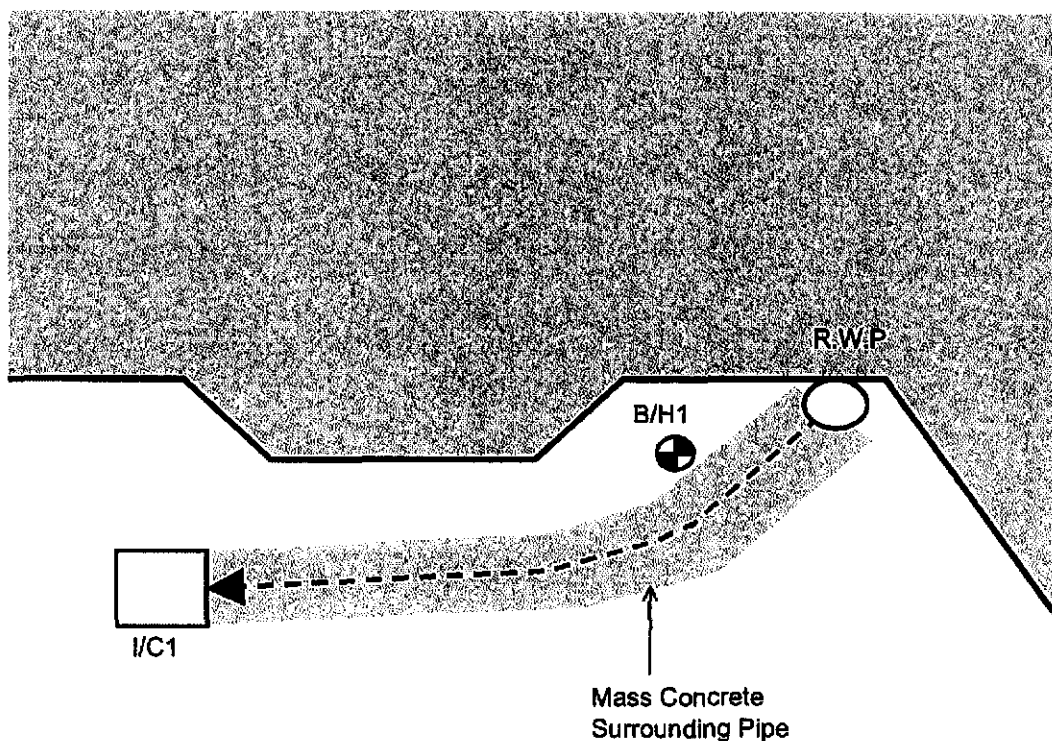
General Comments: RWP run has 500mm wide x 250mm deep trench filled with concrete surrounding pipework.

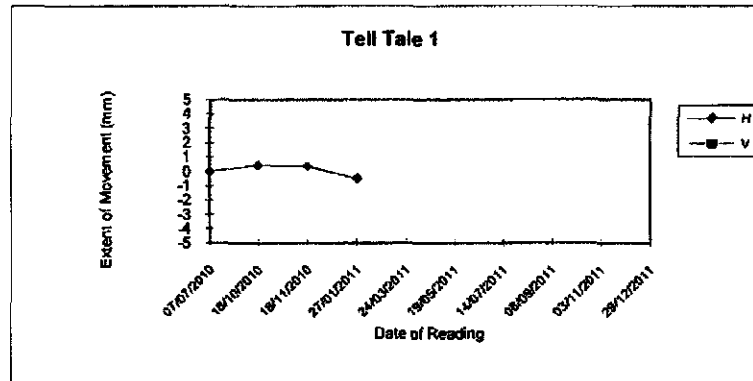
Location: Internal Bedroom

H	V
0.00	
0.42	
0.37	
-0.50

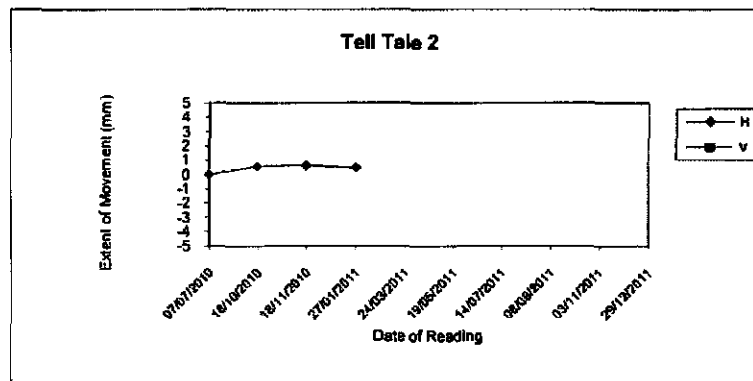
Location: Internal - Hallway

H	V
0.00	
0.59	
0.66	
0.50

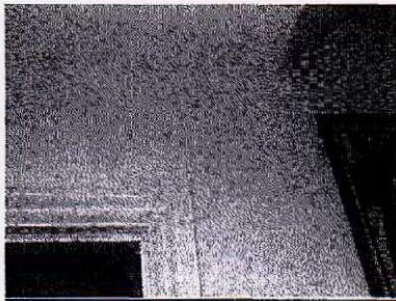
Hallway

The main cracking noted was to the entrance hallway above the door to the study, evident both within the hallway and the study and measuring around 1mm wide.

It is common to categorise damage in accordance with BRE Digest 251. In this instance, the damage falls within Category 1.

We anticipate a resolution to this claim by implementing super structure repairs only, possibly with the use of some brick reinforcement to provide additional strength.

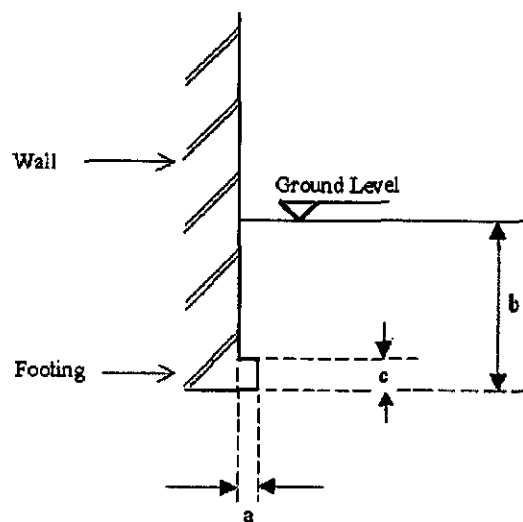
Foundation Detail
b = 600mm+

Initial site investigations were undertaken in July 2010. Access to the external walls of the property was extremely limited and attempts were made to excavate a trial pit to the rear elevation. The excavations identified a brick corbel projecting from the foundation, commenced at around 450mm below ground level. However, due to an adjacent mass concrete drain pipe surround, it was not possible to extend the trial pit the underside of the foundations. Based on our experience, we would estimate that the foundation is likely seated at between 650mm and 700mm below ground level.
