> REPORT ON INSPECTION OF LIME TREE

96 SOUTH HILL PARK LONDON NW3

> Our ref: J43.20 6th April 2011

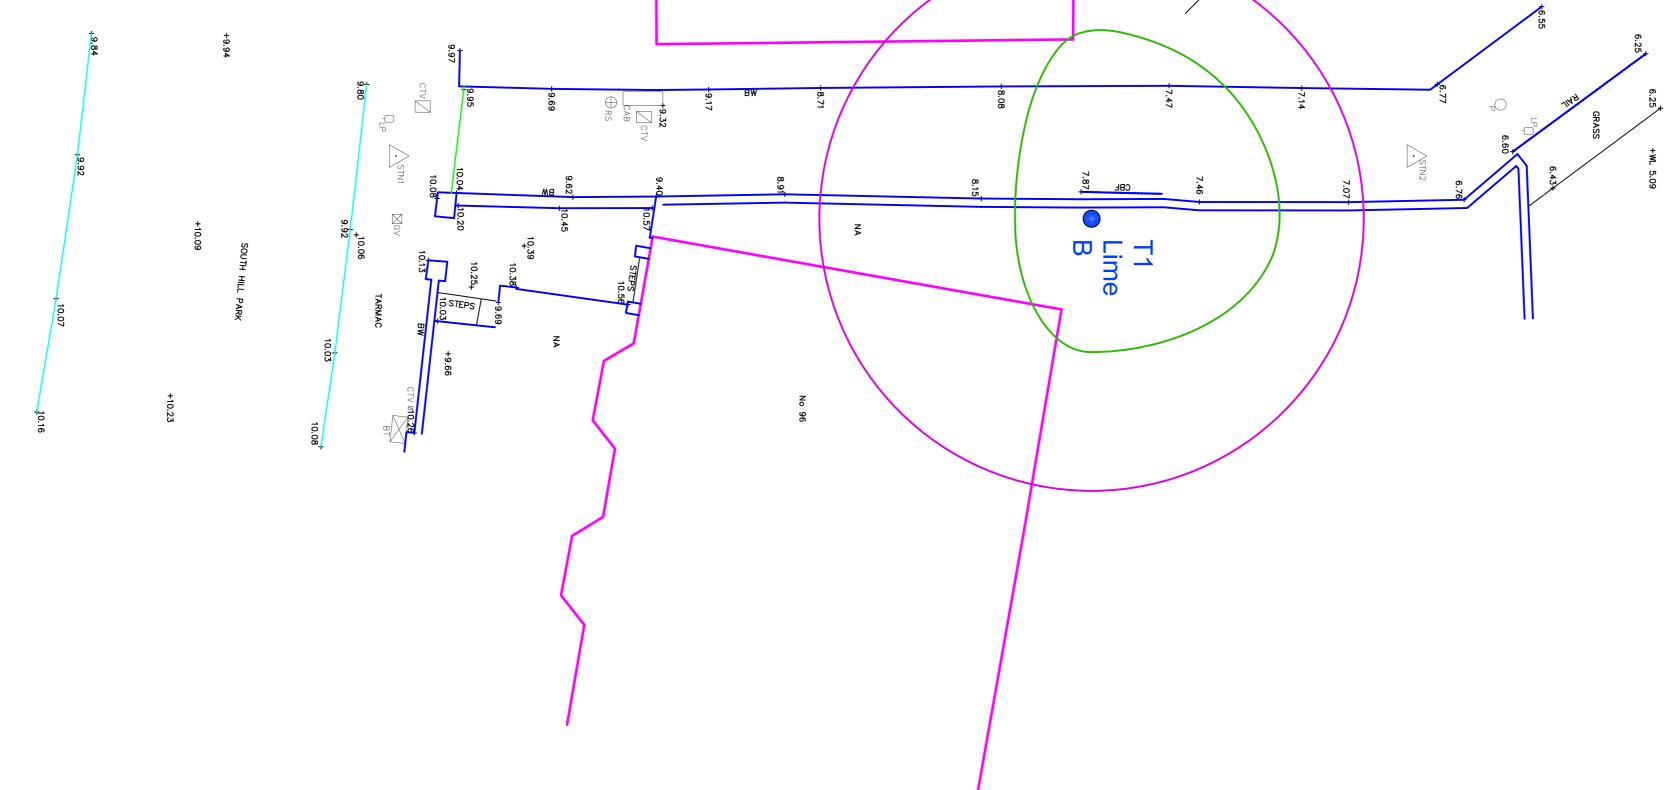
Actual rooting zone likely to be constrained by wall and building foundations and possible extension of area into open garden to west.
