3,5 & 7 Fitzjohns Avenue

Existing Boundary Wall Photographs

Mayfair Property Developments Ltd

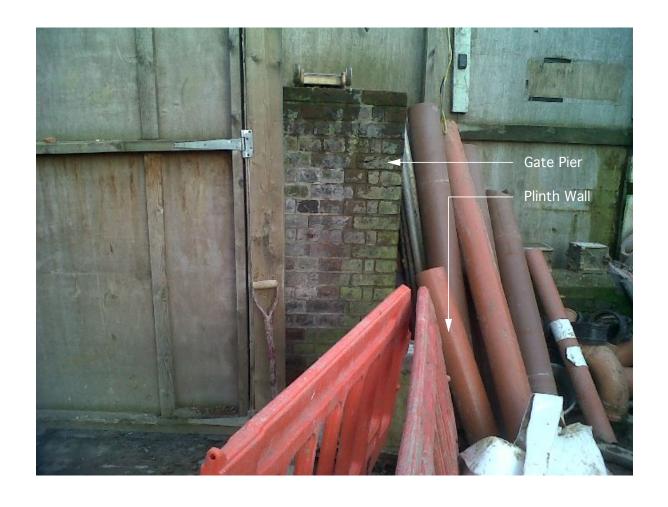
Photo 2
Original Wall Construction:
Gate Pier leaning towards south
Original twice-weathered copings to be salvaged

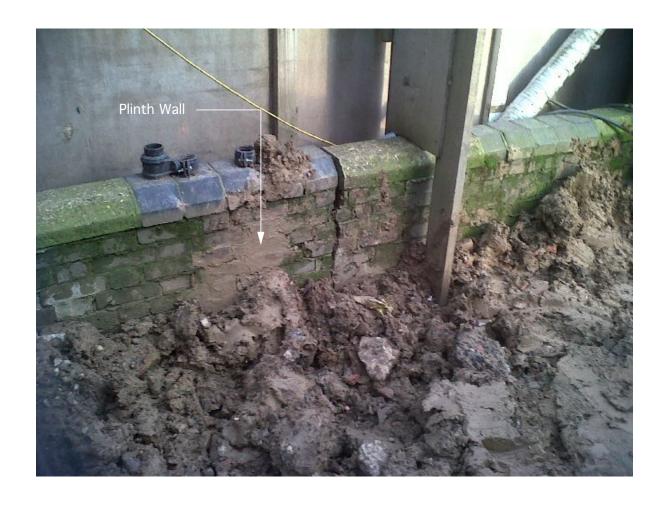
Photo 4 Original Wall Construction: Original twice-weathered copings to be salvaged Concrete coping infils where missing Cracks to plinth wall

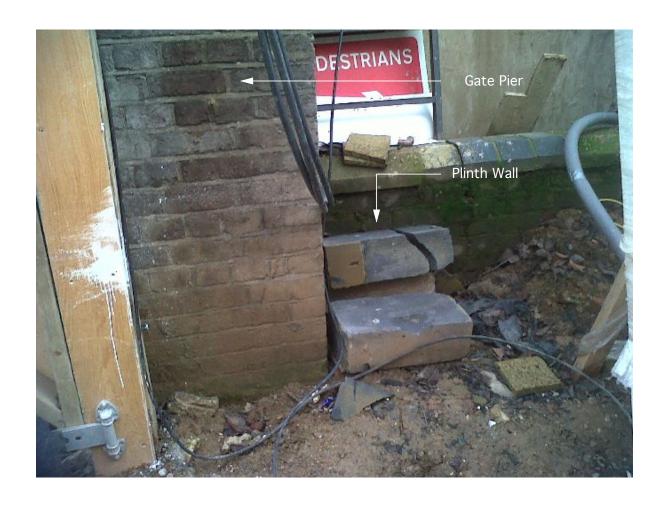
Photo 6 Original Wall Construction: Original twice-weathered copings to be salvaged Crack / displacement to plinth wall

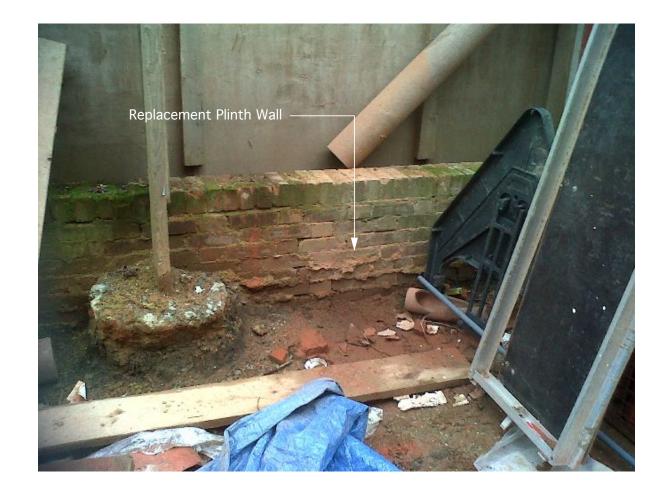
Photo 8 Non-original wall construction: Brick on edge coping Modern machine made brick Pointing not struck when re-built against ground

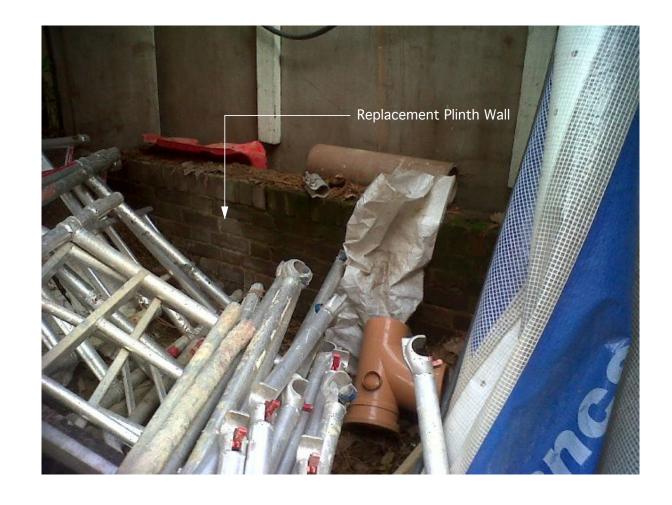
Photo 11 Non-original wall construction: Brick on edge coping Modern machine made brick

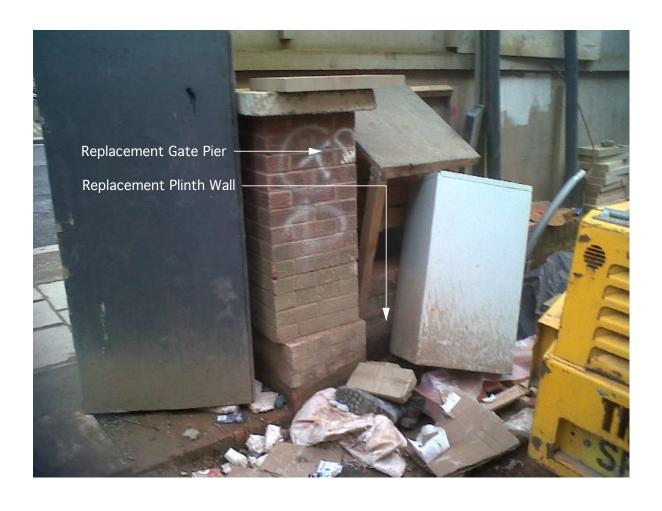
Photo 9 Non-original wall construction: Non-original pier cap Stretcher bond pier Modern machine made brick
