TREE SURVEY AND ARBORICULTURAL METHOD STATEMENT

A report to accompany a Planning Application for development
at 62 Elsworth Road, NW3 3BU

Report by Dr Martin Dobson

1 October 2010

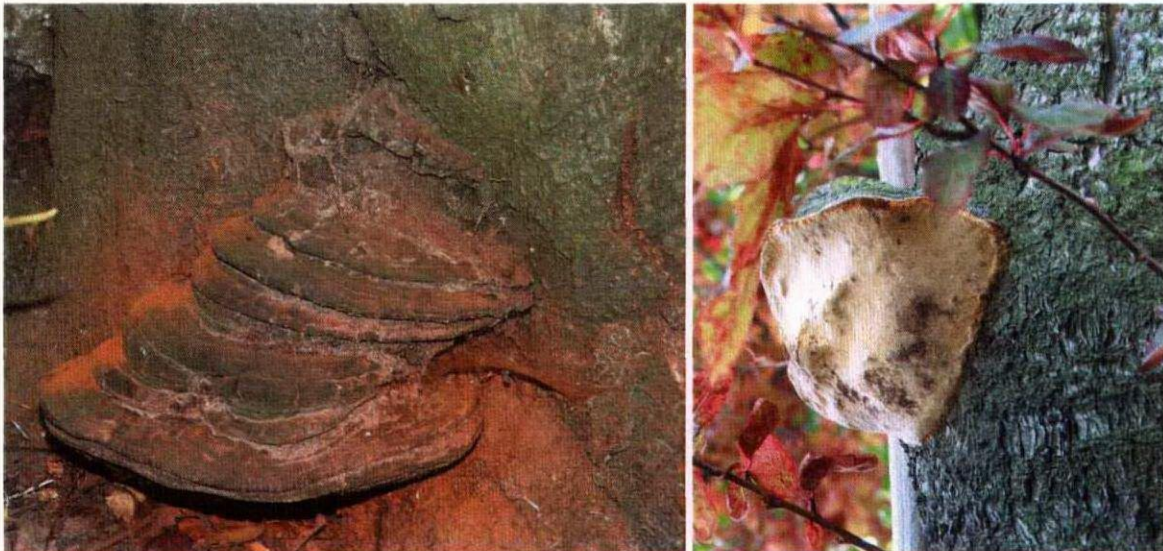
- 3.4 There is a single tree in the front garden of 62 Elsworthy Road (T4) which is a Purple plum. The tree's attractive purple foliage adds interest to the street scene but the tree has a limited safe life due to the fact that is infected with the decay fungus *Ganoderma* sp. at its base (below left) and with *Fomes fomentarius* (or possibly *Phellinus ignarius*) higher on the trunk (below right). These fungi will be degrading the strength of the wood and will ultimately cause the tree to fail. It has therefore been given a C/R grading. It is recommended that the tree should be felled and a replacement planted.

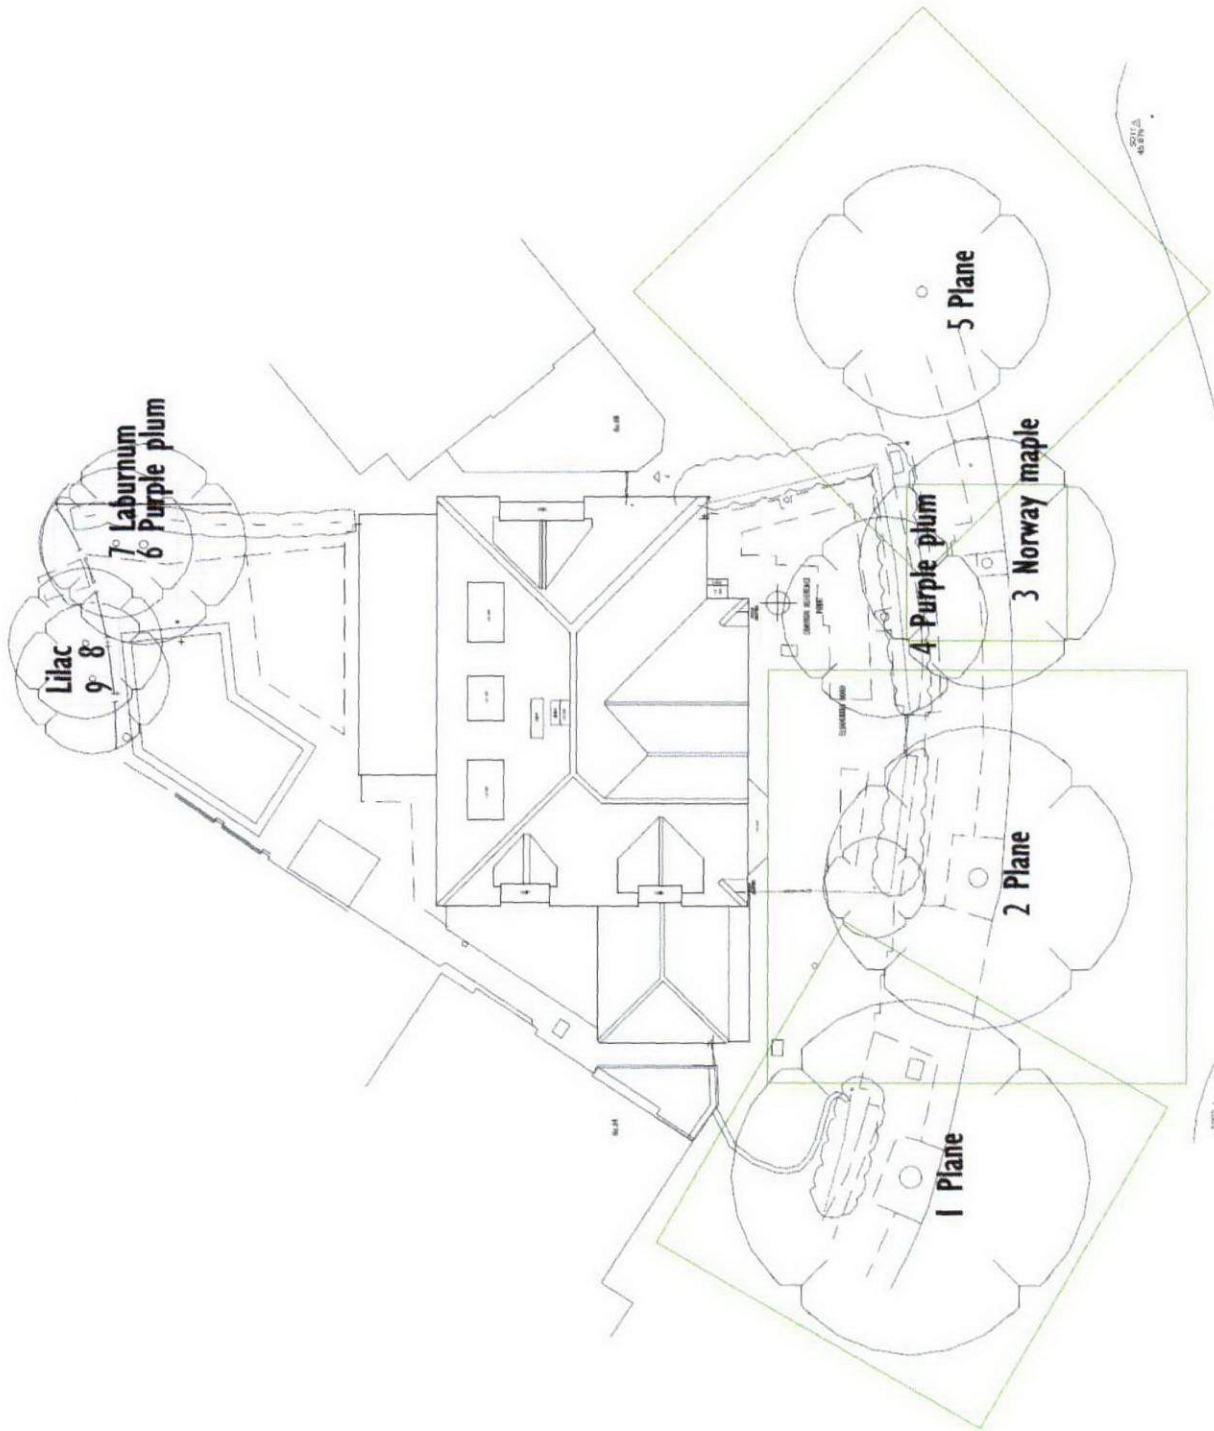
APPENDIX MD2

- 2.3 The site survey drawing appended at **MD2** shows the positions of the trees surveyed and gives a reasonable indication of their comparative branch spreads. The drawing has been colour coded as follows:

- 3.3 Immediately in front of 62 Elsworthy Road are three Council-owned mature Planes (T1, T2 and T5) together with a young Norway maple (T3). Due to their large size these trees are the dominant feature of the green landscape and together with the other street trees form an important amenity to the road which merits careful protection. All four street trees have therefore been given an A grading.
