Arboricultural Assessment Report

Summary Report on Trees

For:	Client:	Oriel Services Limited
	Insurer:	Aviva
Site:	Policyholder:	Mr Marks
	Risk Address:	166 Belsize Road, London NW6 4BJ
Refs:	OCA Ref:	44839
	Client Ref:	3702831
	Insurer Ref:	8361532

ENGINEERING APPRAISAL REPORT

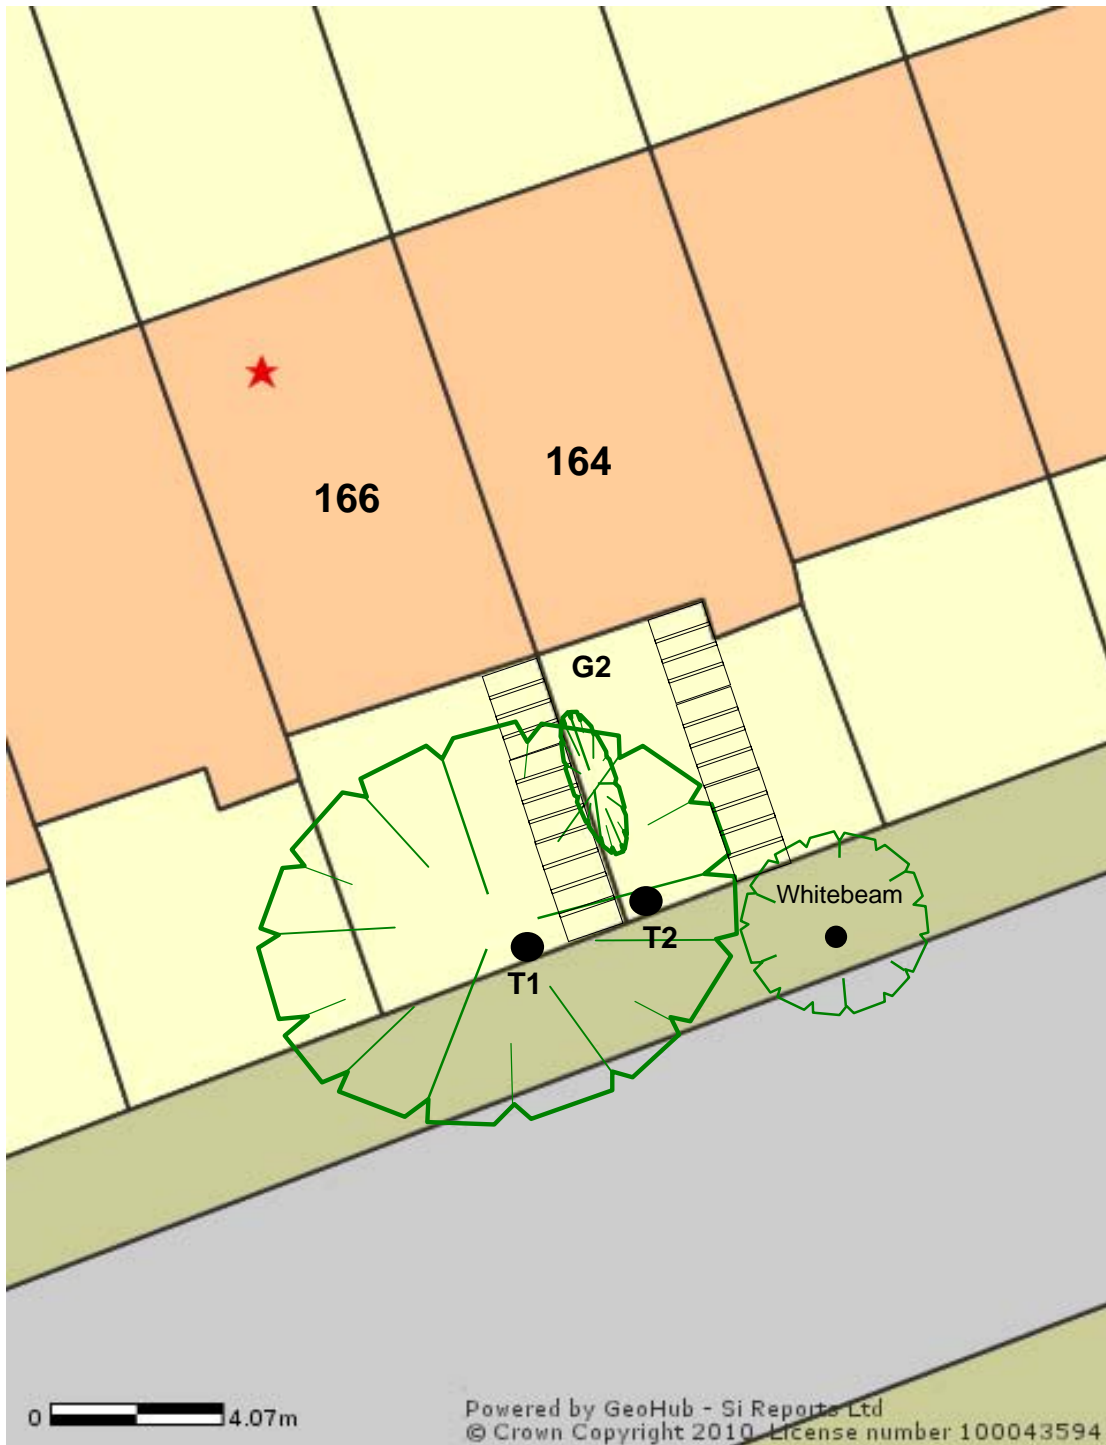
Title: 166 Belsize Road, London
NW6 4BJ

Comments: Lime T1 is situated in the front garden of 166 Belsize Road. T1 appears to have been the subject of pruning works in the past.

Comments: Lime T2 is situated in the front garden of 164 Belsize Road. T2 appears to have been the subject of pruning works in the past.

Comments: Rose & Mahonia G2 are situated in the front garden of 164 Belsize Road directly adjacent the entrance steps. This vegetation does not appear to have been subject to pruning works in the past.

Tree No:	Species	Works Required
T1	Lime	Fell to ground level and treat the stump with an appropriate herbicide
T2	Lime	Fell to ground level and treat the stump with an appropriate herbicide
G2	Mahonia	Fell to ground level and treat the stump with an appropriate herbicide

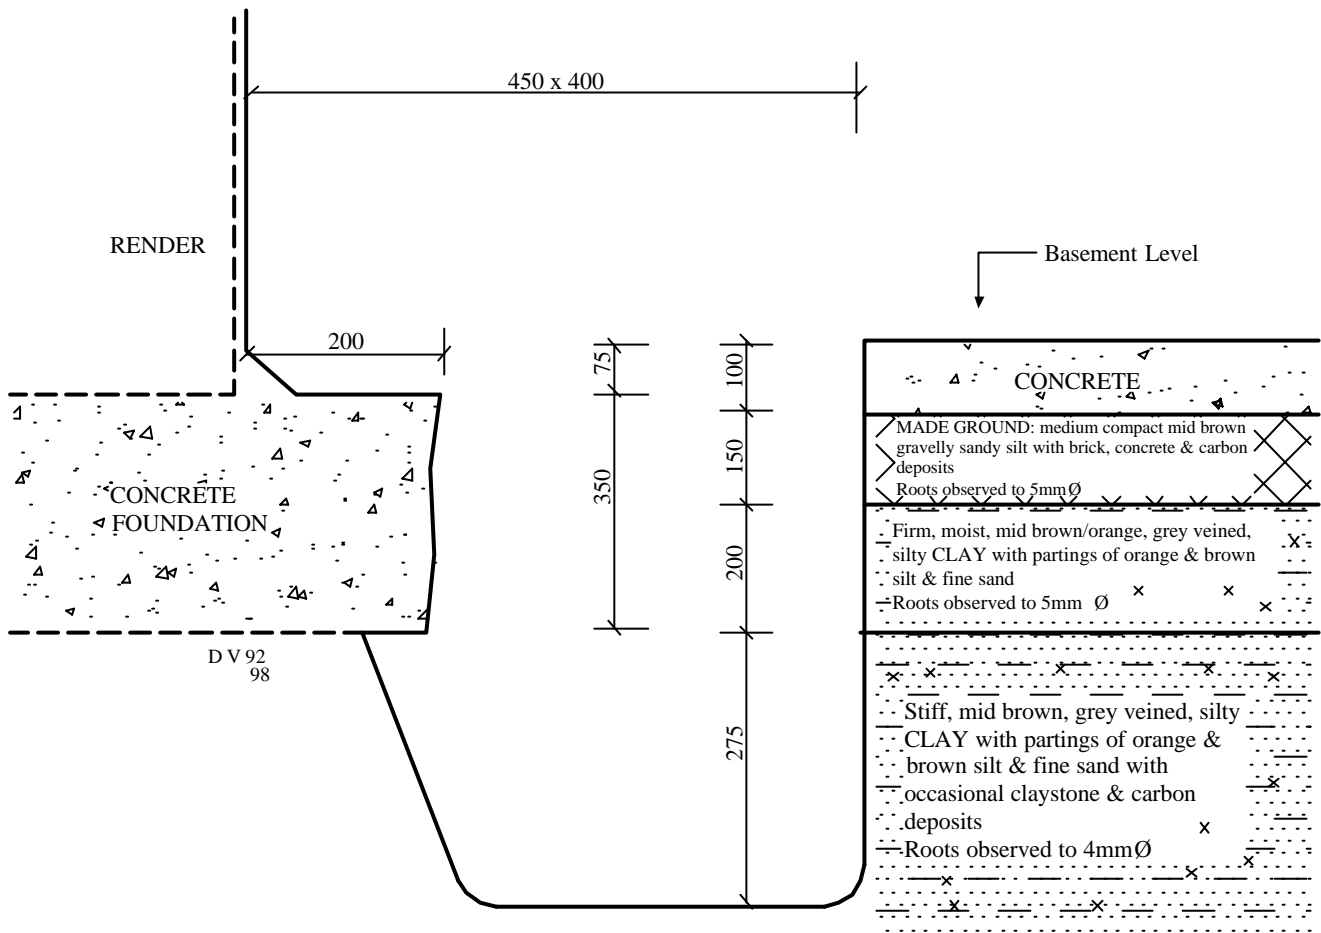
Trial Pit No: 1	Sheet: 1 of 1	Site: 166 Belsize Road, NW6
	Job No: 91132E	
Excavation Method: Hand Tools	Date: 16/08/10	Work carried out for: Cunningham Lindsey
Weather: Dry	Drawn by: NR	
	Ground Level mOD:

FOR STRATA BELOW 725mm SEE BH LOG 1
