Our Ref: 1636/DS

## **Main Entrance Door Condition Report**

**Shaftesbury Theatre  
210 Shaftesbury Avenue  
London  
WC2H 8DP**

## **Elevation Refurbishment**

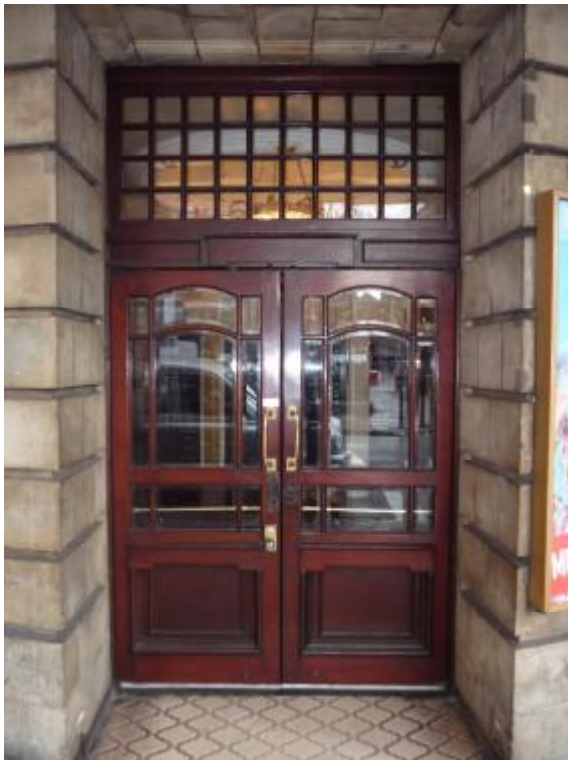
*Photo A – Typical Door*

The purpose of this document is to detail the current condition of the 3No. main entrance doors on the corner of High Holborn and Bloomsbury Street. At present the doors are constructed from softwood timber with single glazing panels to the top section of the doors (Photo A). The door furniture is brass and above the doors are small fanlights.

- Door Frames – The door frames are rotten due to water ingress. The hinges have been refitted a number of times over the years and there is now no suitable timber for fixings.
- Hinges – Currently the doors are hung with pivot hinges. Due to the weight of the doors and the rotten timber frames the hinges are failing causing the doors to drop which has left a gap of 8mm to 20mm between the doors.

- Door Alignment – The 8 to 20mm gap between each door set allows for driving rain to penetrate the building. The gap also allows for a constant draught within the box office area, thus reducing the energy efficiency of the building.
- Door Damage – The edge of the doors around the pivot hinges has deteriorated over the years. Previous repairs have been carried to pro-long the life of the doors.
- Ironmongery – The existing ironmongery is generally in a good condition with the exceptions of the push bars. At present the doors have dropped and the push bars are not aligned causing an issue with security and fire safety.

- Door Frames - The softwood timber frames are beyond repair and should be replaced with new. It is intended to upgrade the timber frames and replace them with a pre-treated hardwood to match the existing style/design.
- Hinges – Currently the doors are hung with pivot hinges which are unsuitable as they are worn causing the doors to drop. In order to provide a secure and solid door it is proposed to replace the existing pivot hinges with new butt hinges, which will be able to take the increased weight of the new hardwood doors.
- Ironmongery – All ironmongery is to be re-used with the exception of the push bars. The push bars do not align causing a problem with securing the doors and providing suitable means of escape. A like-for-like replacement is to be sourced which will ensure the door is secure and meets the current Fire Safety requirements.

Following the inspection of the doors it was concluded that they were beyond repair due to the rotten frames, inadequate hinges and the deterioration of the doors around the edges where the hinges are fixed. It is intended to replace all the deteriorated existing softwood timber with new hardwood timber, including the frames, doors and fanlights above the doors. The new hardwood timber is to be manufactured to match all the details, as close as possible, to the existing doors.
